Lloyd's Register of Shipping.

Cardiff, 8th. January 1944.

Dear Sir, Tanker "MARKAY".

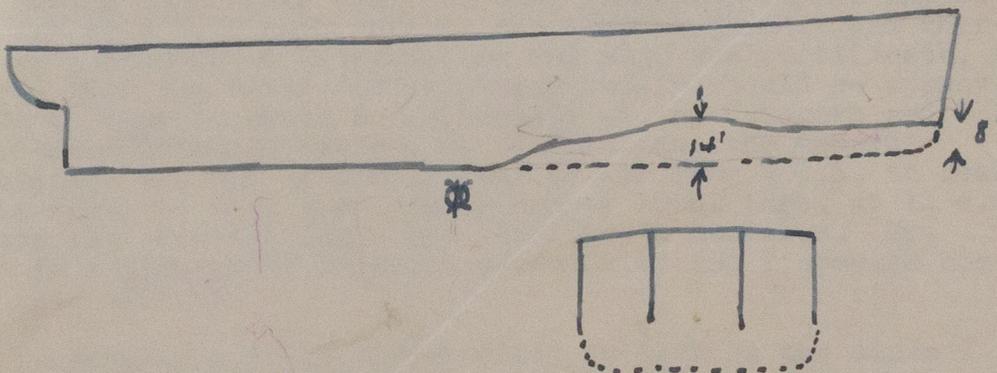
Only when she was entered in dry-dock, Swansea, was it found that the whole lower portion of bottom forward of amidship had been entirely ripped off and she presented some difficulty to get the forward half properly shored up coincident with pumping out the dry-dock:-

May Having regard for certain war contingencies the vessel ~~is~~ not be retained in Swansea dry-dock except to build stools on to the damaged structure forward so that she can be re-dry-docked elsewhere without the special difficulties presented at this dry-docking.
