REPORT of SURVEY for REPAIRS, &c.

Survey held at *London*

on the *Iron Screw Steamer ABERDEEN*

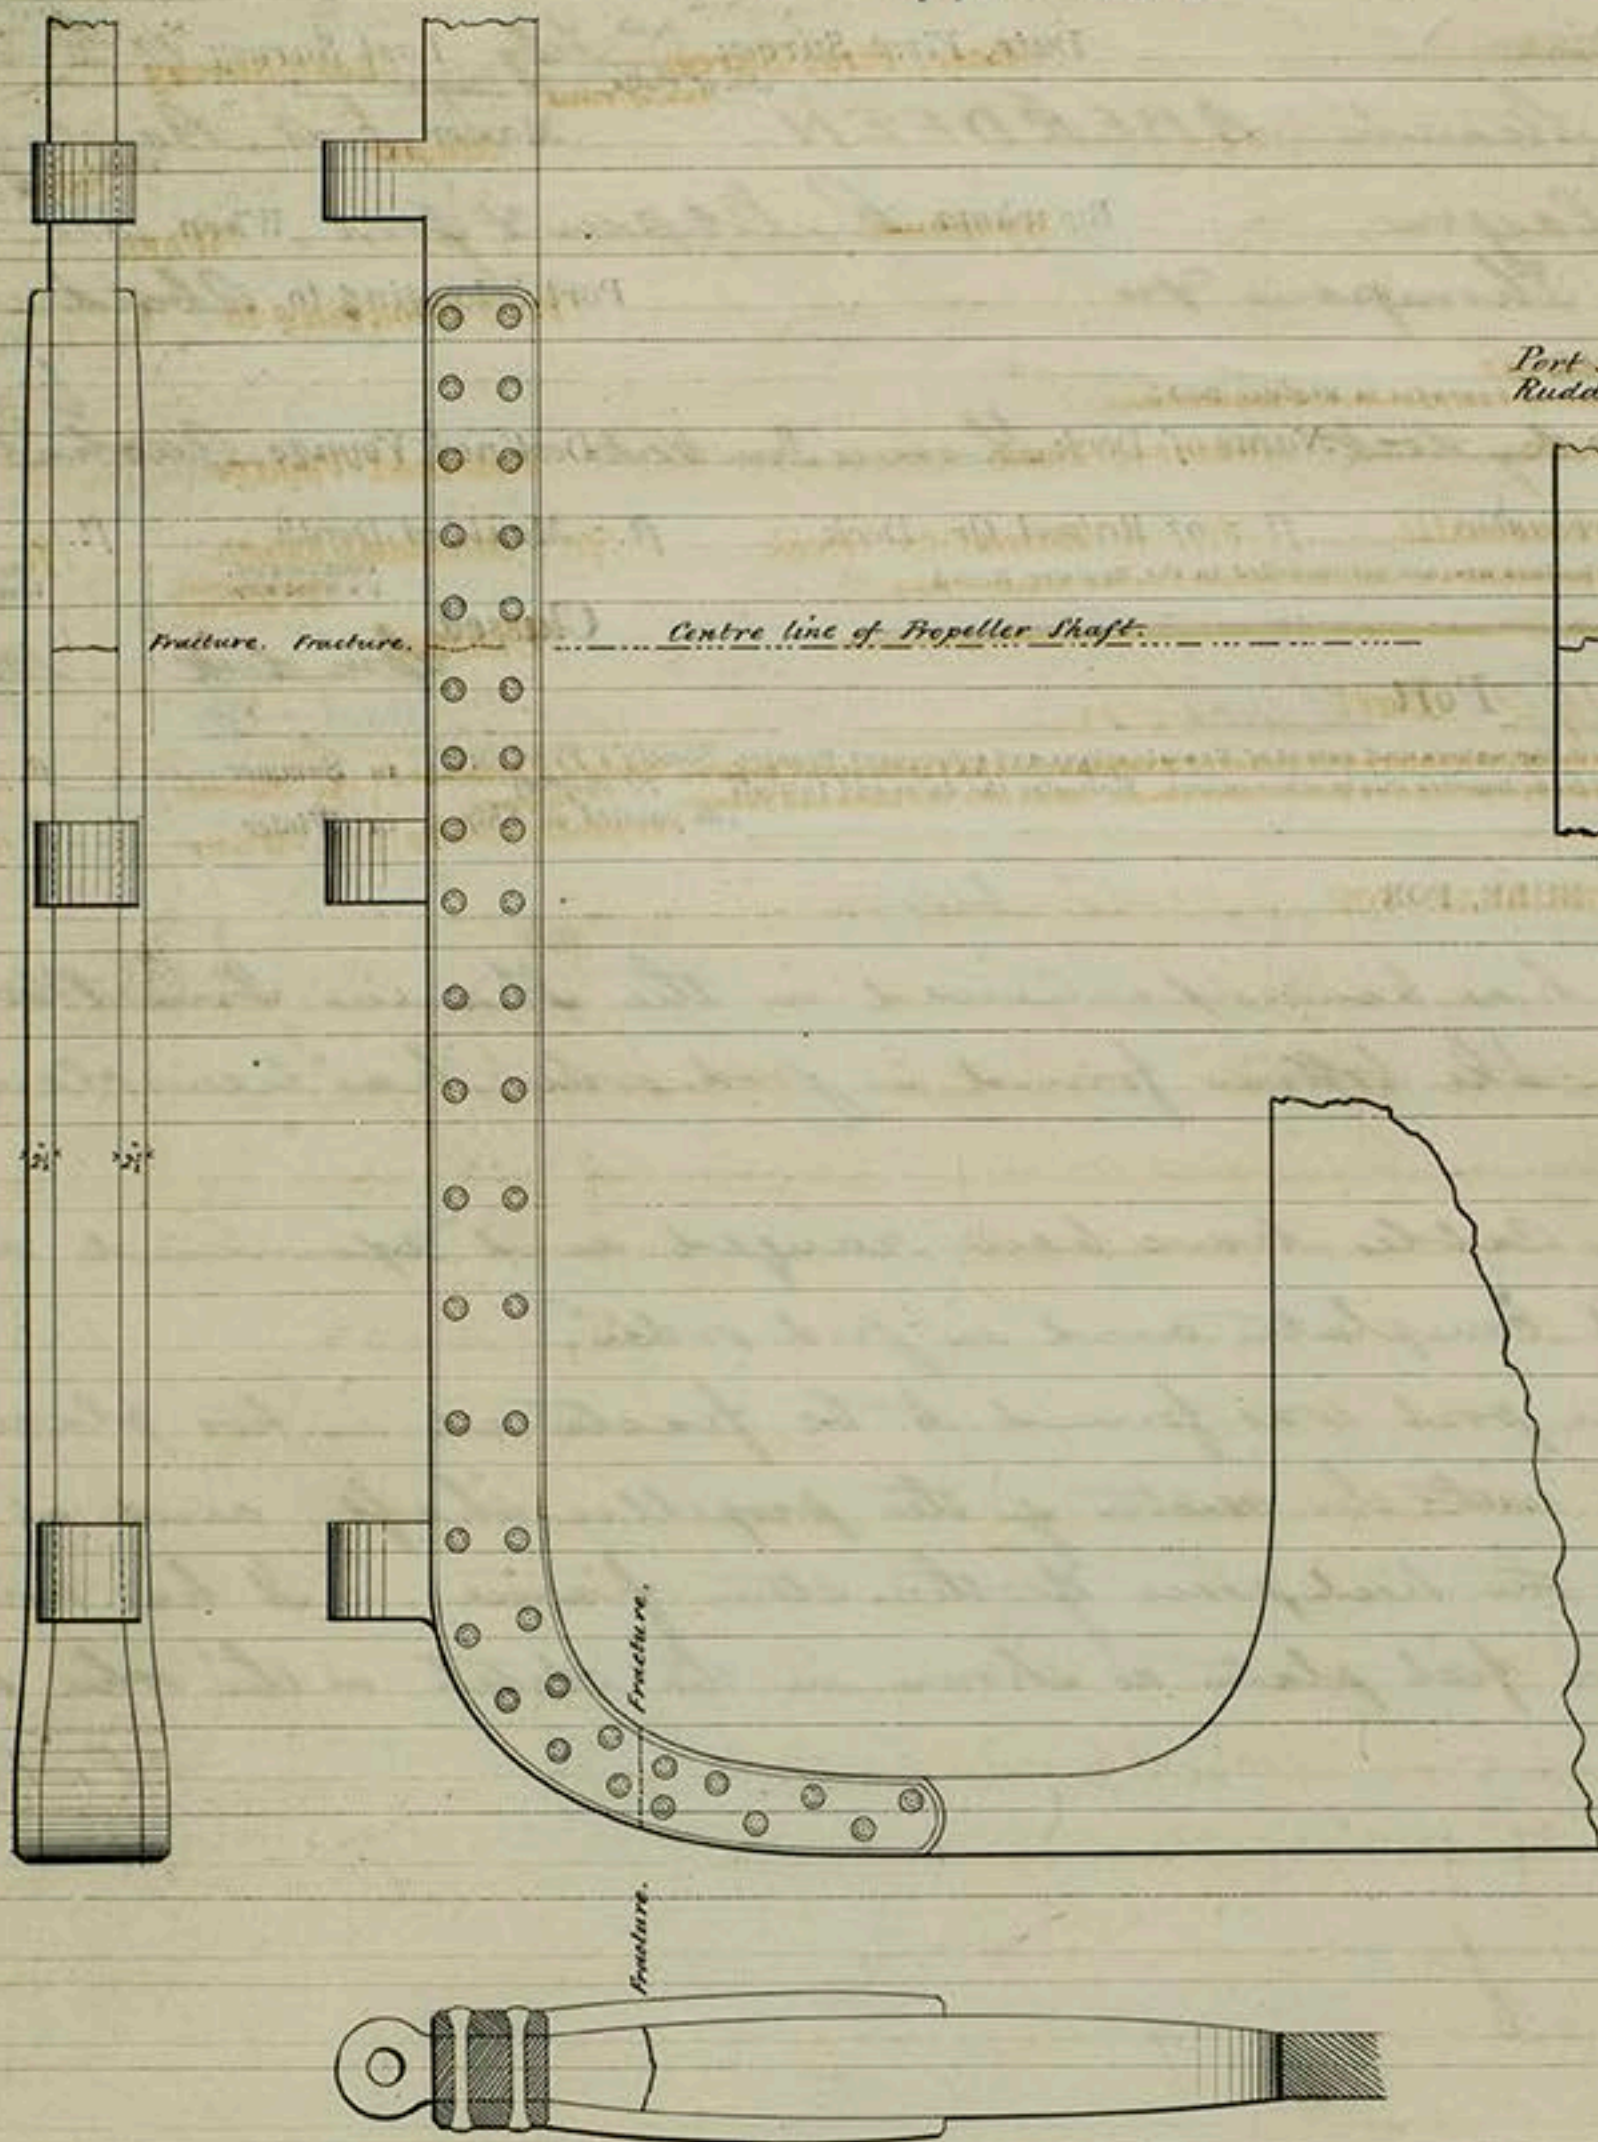
After side of
Rudder Post.

The rudder post was found to be fractured in two places, viz. in a line with the centre of the propeller shaft, and at the junction with the keel piece of the stern frame. It has now been repaired with two fish plates as shown in the sketch on the other side.

Diam of rivets 1 1/2"
