Lloyd's Register of Shipping. 14 JAN 1942

Ship's Name *"MORETON BAY"*Official No. *130169*

Memorandum of alterations reported since ship was surveyed for assignment of Load Lines in *MAY 1932.*

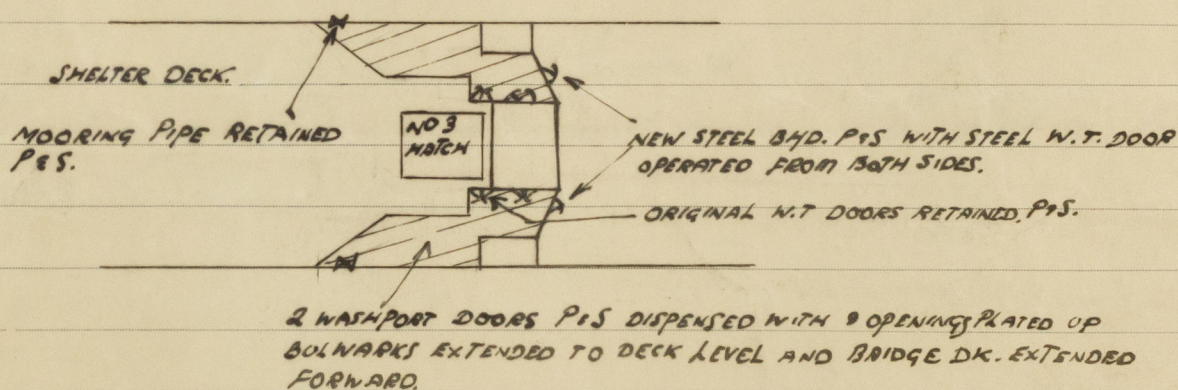
THE ALTERATIONS BELOW HAVE BEEN CARRIED OUT PREVIOUSLY.
