S.S. ANNA KNUDSEN

SKETCH SHOWING DAMAGE TO SHELL PLATING AND FRAMING

"
Anna Knudsen."
"

Sing rept No. 261.

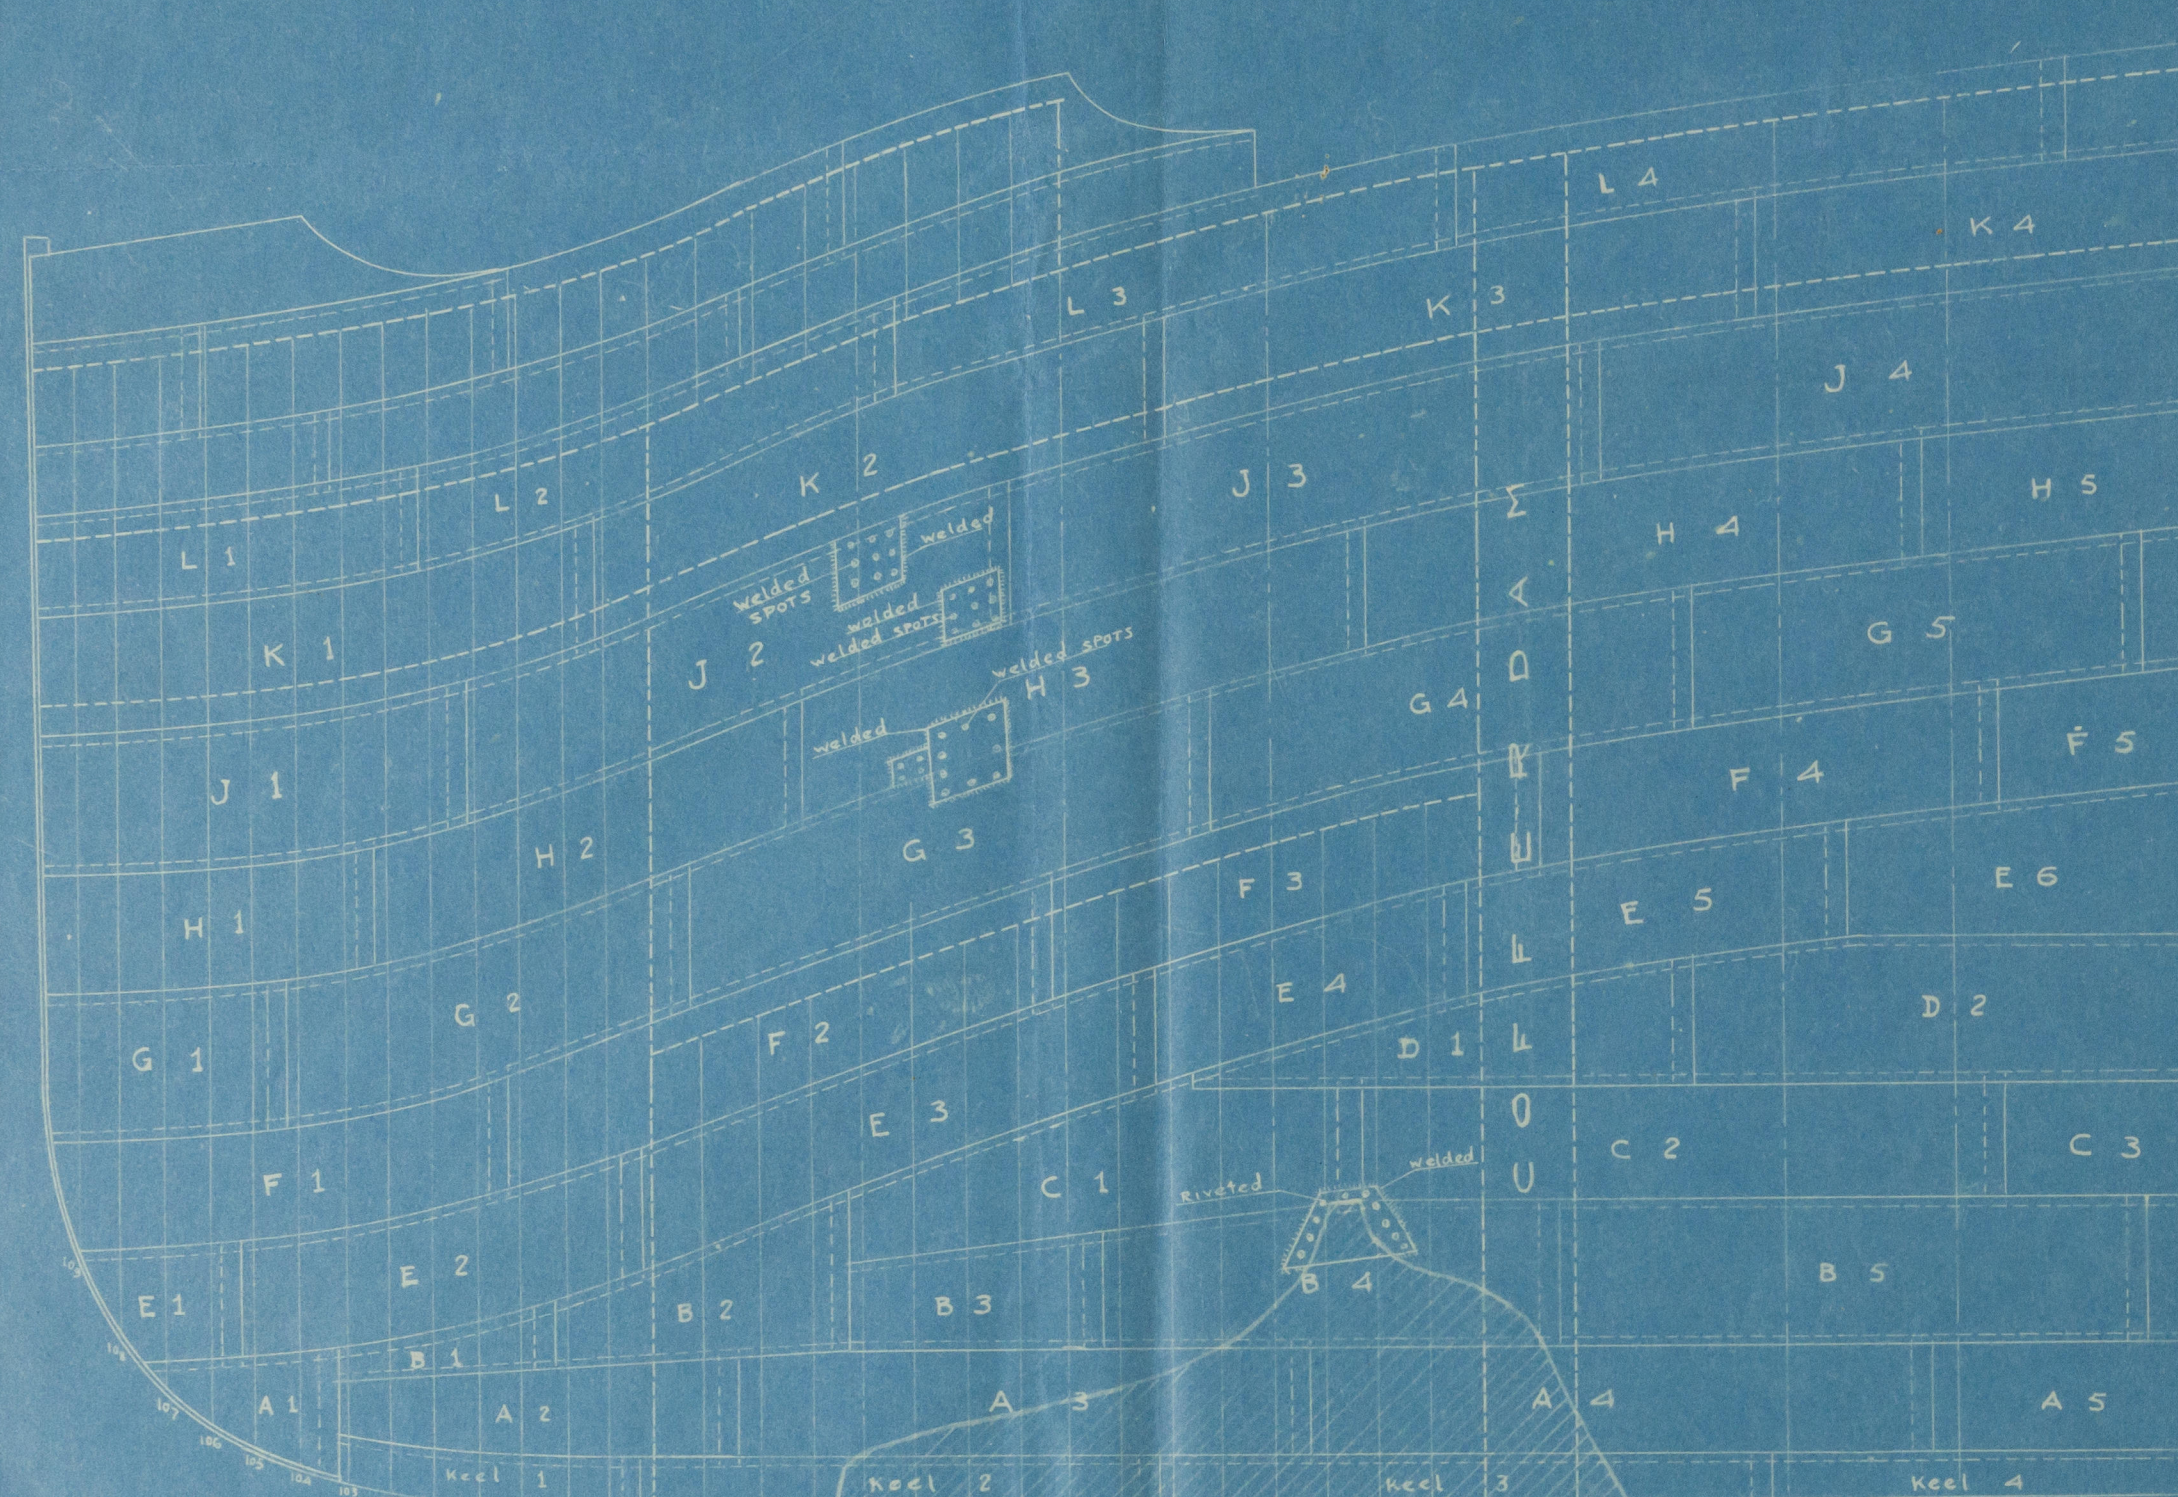
STRAKE	Nº	STARBOARD SIDE		PORT SIDE	
		1	2	1	2
Keel	1	Badly set up and after end	2	Part missing, forward end badly bent	
	3	Missing	4	Forward end of Plate bent upwards and Part Missing	
A	2	Badly set up at forward end		2	Badly buckled and set up at after end
	3	Missing		3	Part Missing
B	4	Bent upward at forward end		4	Forward end of Plate bent upwards
	1	Slightly distorted at after end		2	Badly buckled
C	2	Missing		3	Badly buckled and Part Missing
	4	Badly distorted and Part Missing at forward end		4	Forward Part of Plate Missing and remainder badly distorted
D	1	Missing		1	Set up 4 feet and pierced
	2	Forward end badly distorted and set up between floors			
E	1	Badly set up and Part Missing			
	2	Buckled and set up at forward end		3	Badly buckled and indented
F	3	After end badly set in and indented		4	Slightly buckled at lower edge
	4	Missing		2	Badly buckled and pierced
G	5	Forward end badly distorted at lap joint		3	Badly buckled and pierced

2	After end of Plate Missing		2	Slightly distorted at lower after edge
H	3	Missing		3	Generally distorted
	4	Missing at forward end		4	Set in between frames
J	2	Badly torn at after end		3	Badly buckled and pierced
	3	Lower edge of Plate torn			
K	4	Lower edge of Plate torn at forward end		2	Badly pierced in 2 places
	3	Set in at lower edge of Plate at centre		3	Distorted slightly at upper edge of Plate
				2	Buckled and rivets sheared at after end
