# LLOYD'S REGISTER OF SHIPPING

9th September, 1957.

the undersigned Surveyor to this Society did at the request of the Representative of the Ministry of Transport, survey the T.S. Transport Ferry "EMPIRE DORIC", 4291 tons gross, of London, on the 6th August, 1957 and subsequently whilst the ship lay on the blocks at Elderslie Drydock, Glasgow and later afloat for the purpose of making an examination of the ship generally, externally and internally, to ascertain as far as practicable the general condition of the ship's structure to enable a decision to be reached by the Owners as to whether or not the overdue Special Survey "C" ( due 9,56) should be carried out.

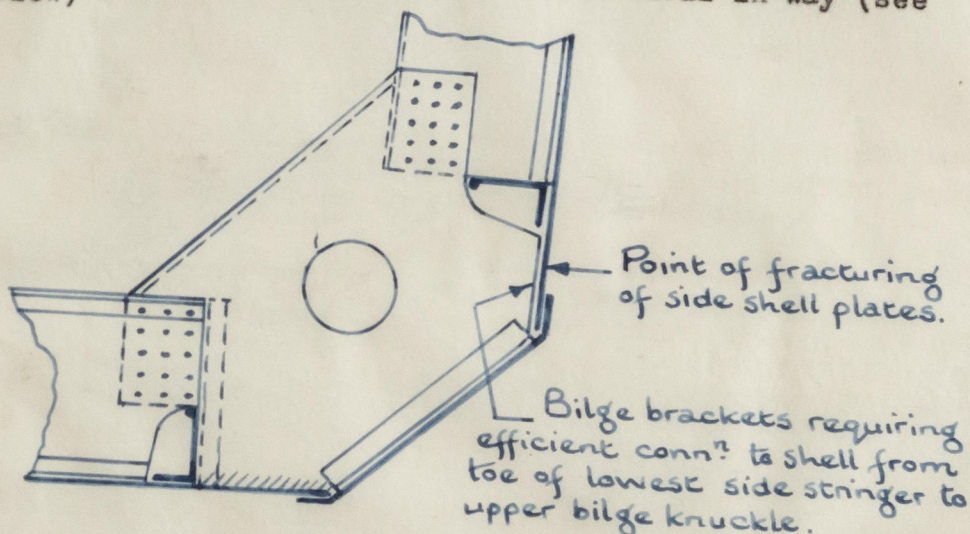
A tendency to fracture was noted in the side shell plates in the strake above the bilge in way of the side transverse webs amidships (p & s). Internal examination revealed that the bilge bracket portions of the web frames required to be efficiently connected to the shell in way (see sketch below)

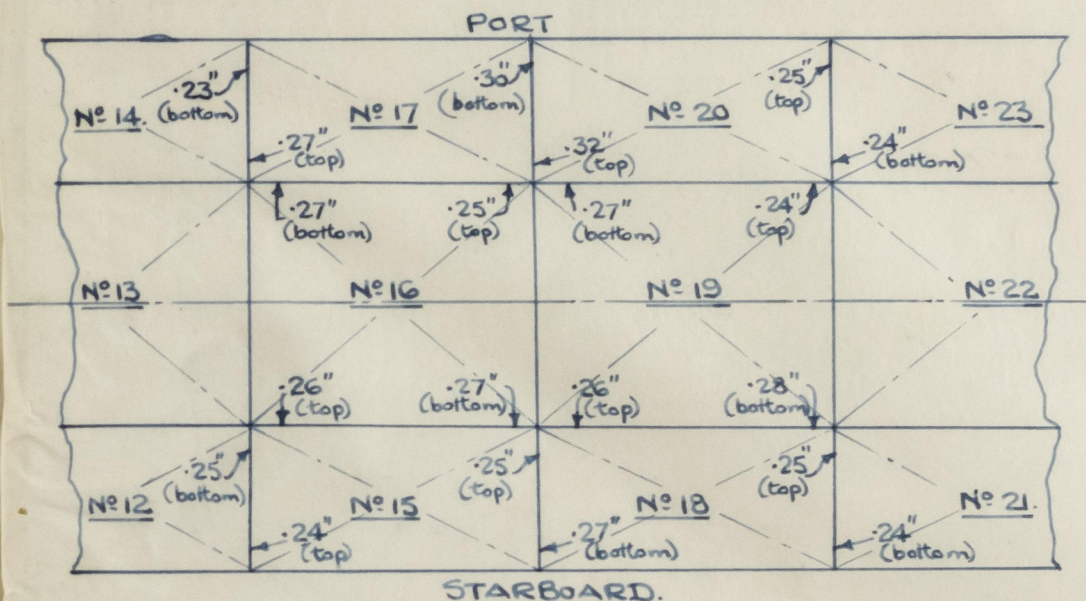
Note:- A provisional test hole was drilled in both strakes of plating of each of the transverse and longitudinal bulkheads between the deep tanks amidships and gauged as shown in plan below.

Original thickness of above bulkhead plating as per builders drawings is 12 lbs (approx. .30" plating).
