s.s. THORNBURY

PHOTOGRAPHIC RECORDS OF DAMAGE TO FORE-PEAK AND No 1 D.B. TANK

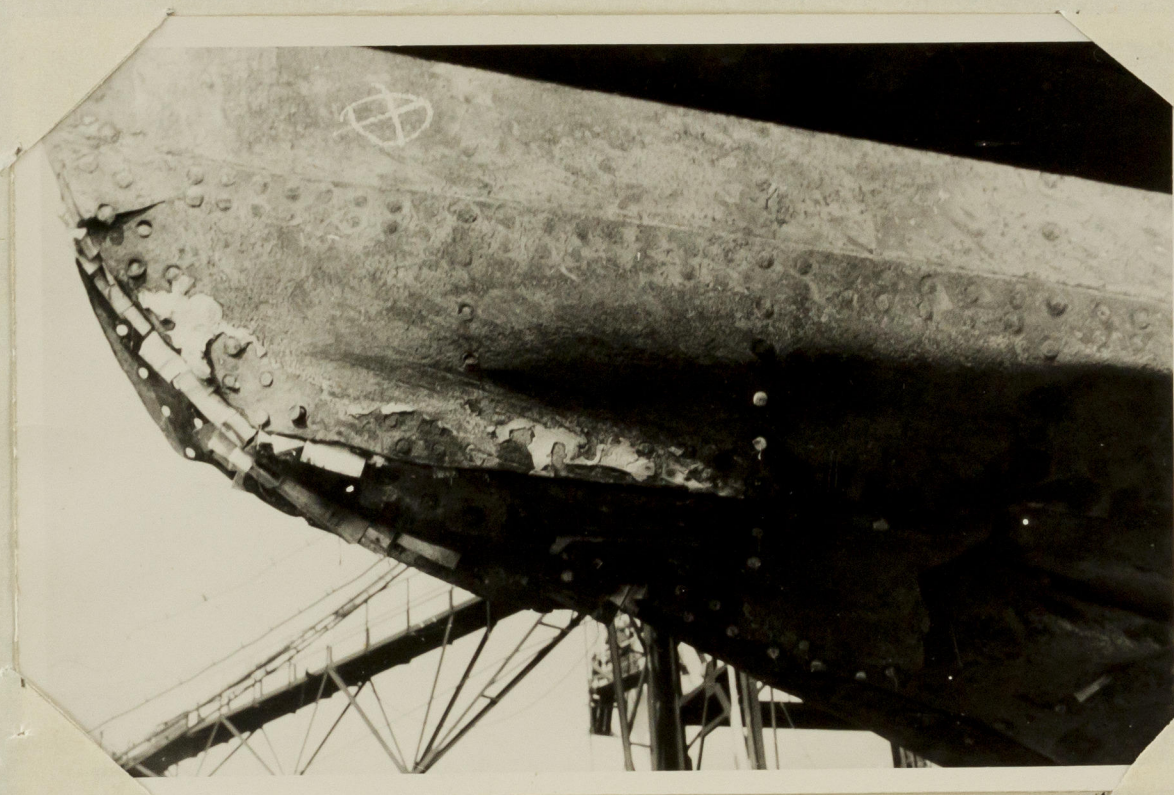
- 1 -

1. Before commencement of repairs- wooden plugs, cracked stem bar and cracks of plates clearly visible

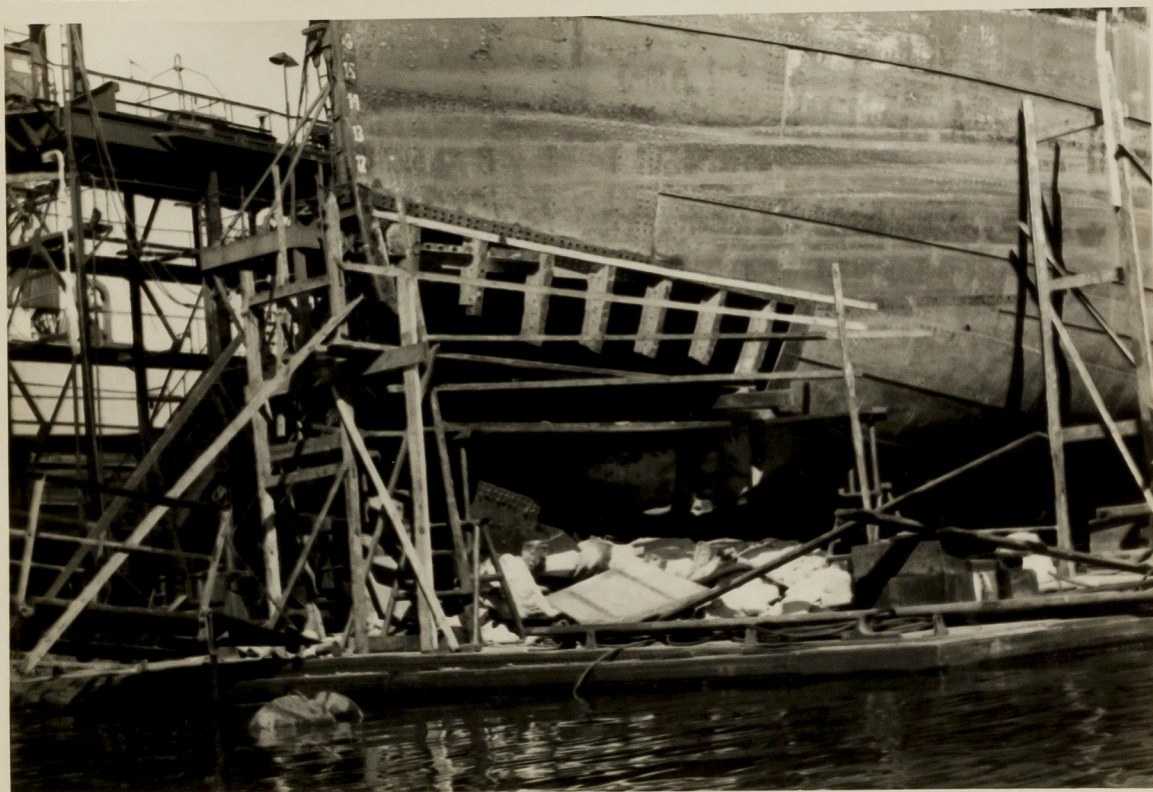
- 2 -

2. Closed-up view of cut frames

CLOSED-UP VIEW OF
CUT FRAMES

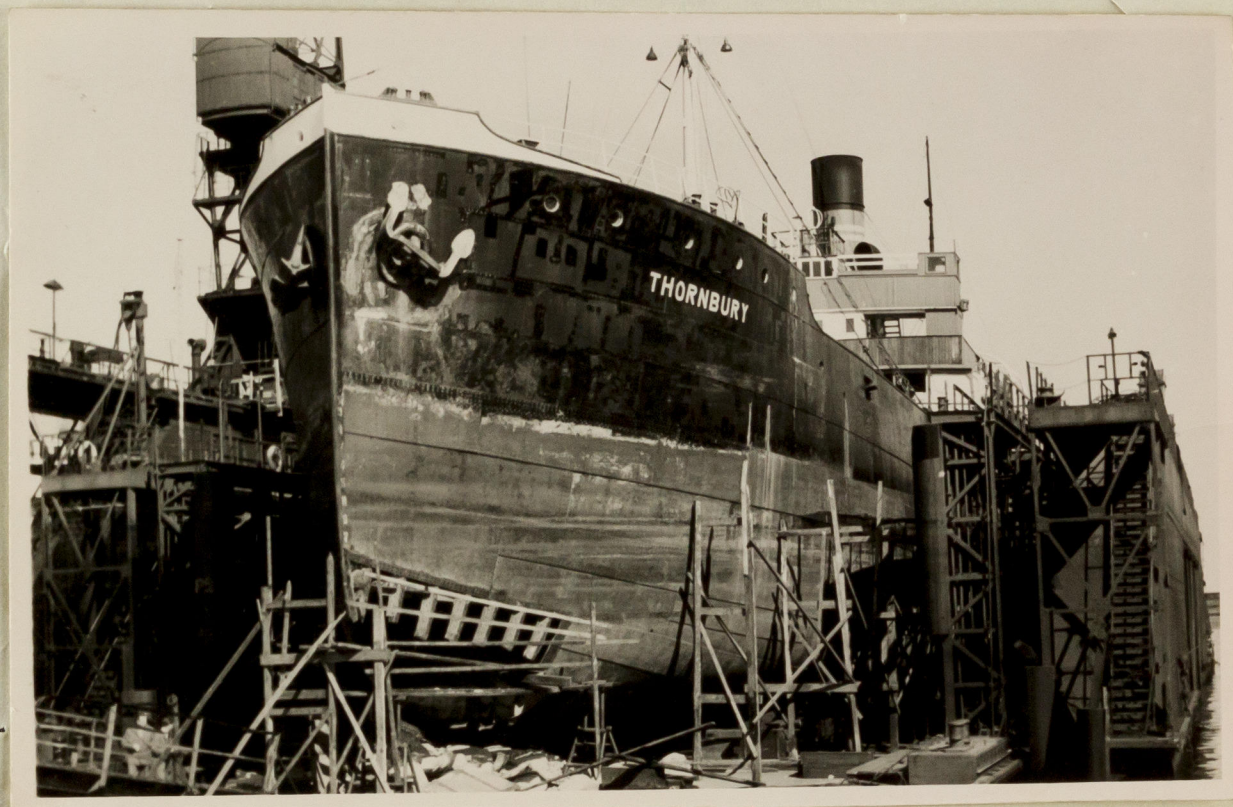
- 3 -

3. Part of shell plating removed, damaged ends of frames cut off.

PART OF SHELL PLATING REMOVED
DAMAGED ENDS OF FRAMES CUT OFF
