hull of the motorship "Axel Johnson", of Stockholm, No. 69110 in the Register Book.

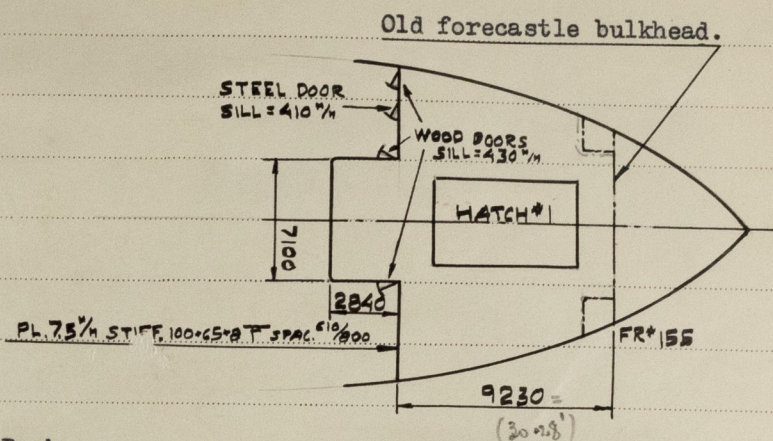
Forecastle increased in length as per sketch on the next page, and No. 1 hatch trunked through the forecastle.
