Ship's Name SS/M/S "JANANI" Gross tons 4111
 Is there a rpt. 9? Yes Port Calcutta Rpt. No: 124
 No. of visits 7 First date 1/2/63 Last date 20/2/63
 Interim Cert. issued & copy herewith? Yes Damage rpt. issued & copy herewith? Last rpt. (H.Q. only) CML 4212
 Date of completing rpt. 20/2/63 Surveyed at, if different from Port above -
 Surveyed afloat and/or in D.D. both Last date of examination in D.D. 10/2/63
 Has a Load Line Survey been held? Yes Freeboard Marks verified Yes
 State which additional Rpt. 8 is attached: (Cont); (PS); (DR); (EQ); (Rig) (Cont) (PS)
 Survey fees Damage fee. Expenses
 Docking Rs. 260/- W/T Repairs Rs. 350/- Travelling Rs. 70/-
 Cablegrams Rs. 96/- S.A. fee -

have surveyed the above ship in accordance with the Rules for Docking, Conditions of Class, and Periodical Loadline Surveys.

Minimum essential permanent and temporary repairs now carried out as hereunder.

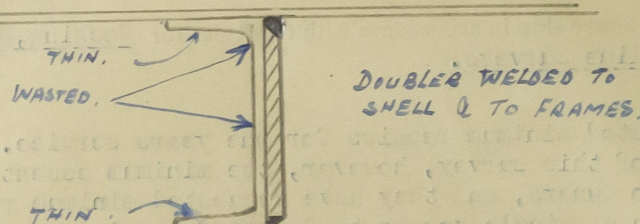
- (2) Main side frames (P&S) found thickly scaled, and in Nos.4 and 5 lower holds (Stb) these frames found wasted through on webs, thin on flanges, and beam knees buckled and weak. These frames and knees in No.4 and 5 hold (stb) require to be renewed, but at Owners special request temporary repairs only now carried out as follows:-

- (a) Thirteen side frames in No.4 lower hold (Stb) now doubled by $3/8$ " plate for full depth of webs where completely wasted, and doublers welded to inner shell to provide support for plating, (see sketch).

- (b) beam knees at these frames stiffened by welded flat bars full depth of throat.
- (c) As additional support to all side frames in No.4 hold (Stb) and to prevent further deformation and tripping of these frames, a new side stringer (runner) comprising $8 \times 6 \times 1/2$ " angle now run all fore and aft at half depth of hold welded to toes of frames and deep bracketed to terminal bulkheads.

These temporary repairs considered efficient for the single voyage only Calcutta to Bombay.

It is submitted side frames in No.4 hold (Stb) be renewed, side frames in No.5 hold (Stb) be examined and renewed as found necessary, and all other side frames in holds throughout ship be thoroughly scaled, examined, and dealt with as found necessary on ships arrival at Bombay.
