REPORT OF SURVEY FOR REPAIRS, &c.

Writing Report 2nd Oct. 1947 When handed in at Local Office..... 19..... Port of Liverpool
Survey held at Liverhead Date, First Survey 25/8/47 Last Survey 23/9/1947
(No. of Visits..... 8.....)on the Wood, Iron or Steel ss TENAGODUS EX "Horseshoe"Built at Mobile, Ala By whom Alabama B.O. & L.B. Co When 1944 MONTH.Owners Anglo Saxon Petroleum Co. Owners' Address.....
(If not already recorded in Appendix to Register Book).Managers..... Port belonging to LondonAfloat or in Dry Dock? Both Name of Dock b. Lds & Alfred. Destined Voyage.....Bor DBa..... feet; uE & B..... feet; f..... feet
Capacity..... tons. FPT..... tons; APT..... tons; MT..... feet..... tons.

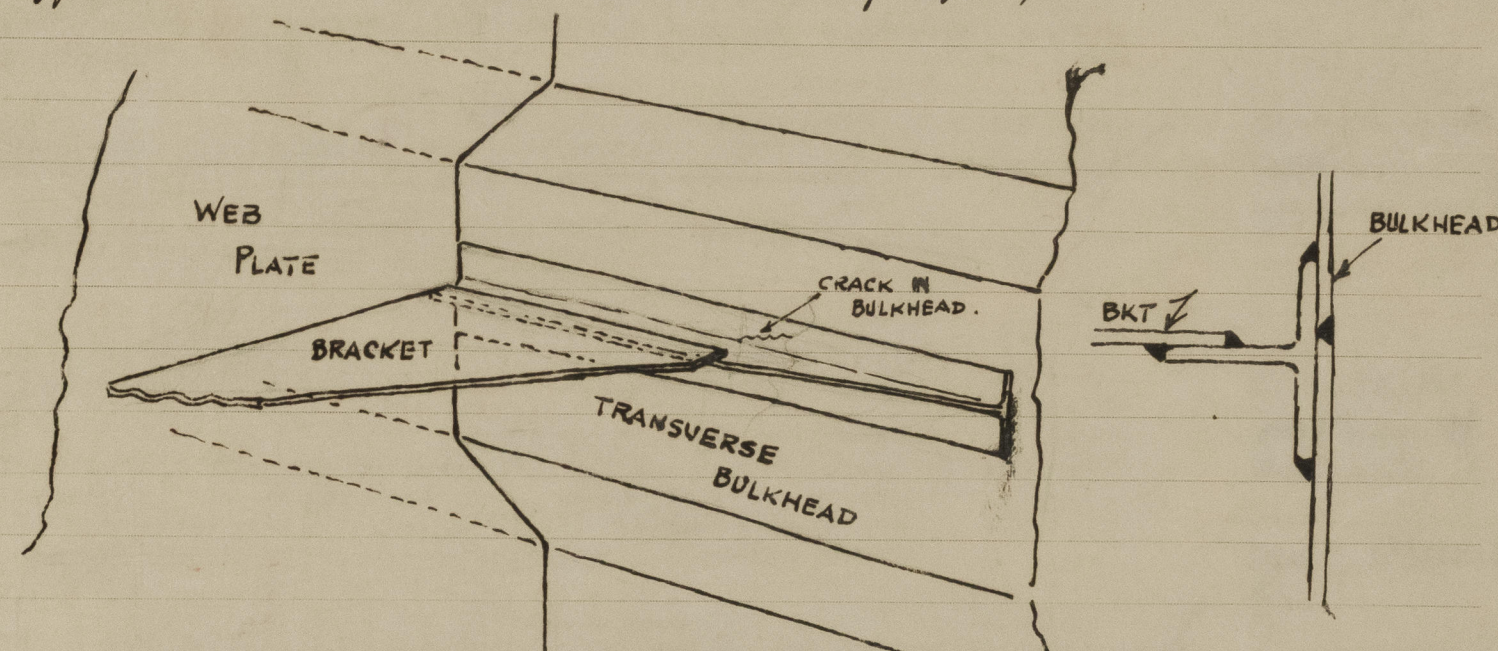
Sketch showing method of reattachment of tripping brackets to bulkheads. Brackets cut out & welded to tee bar. Tee bars twice breadth of bracket, standing flange reduced from toe of bracket to end of bar

Two W.T. doors in forecastle bulkhead replaced by 5'-0" x 3'-0" openings closed by portable plates with hook bolts. Small W.T. hatch fitted over starboard forecastle alleyway. Additional rail fitted round weather decks. Lifting bracket off for a web in No 7 (er), 7(a) & 8(c) refitted to bulkhead by means of welded T bar. Gun emplacements, spar deck and sundry war time equipment removed and ship's structure made good. Minor leaks in rudder made good by welding.
