SS "GLESSULA"

SHEET 2.

SHEET No 3

SKETCH SHOWING CRACKS IN MAIN ENGINE BEDPLATES

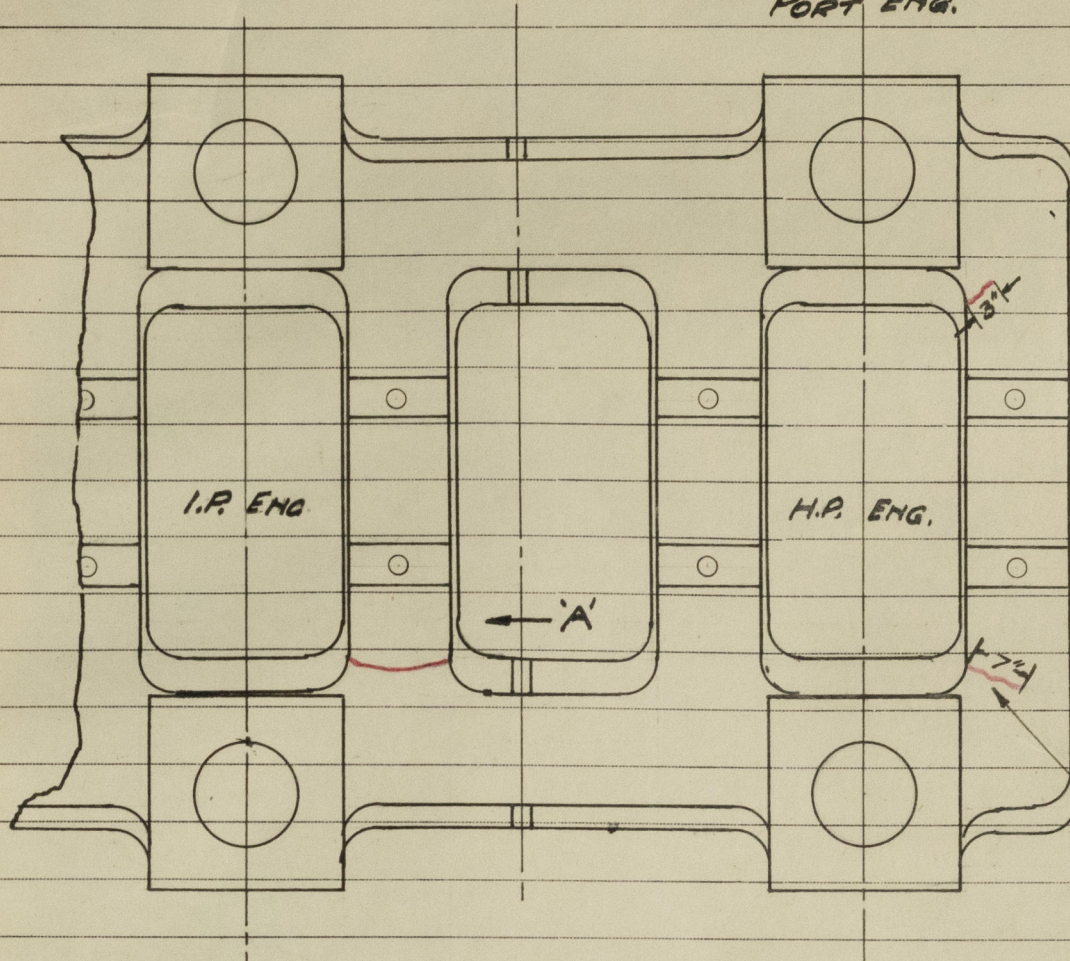
PORT ENG.

Sketch on following Sheet No 3 Shows details of all fractures found, including those repaired earlier.

CRACKS SHOWN IN RED

All fractures now repaired by "METALOCK"

Crankshaft deflections checked. All main bearings opened out, examined and re-metalled and adjusted as required and satisfactory alignment of crankshafts and thrustshafts obtained.
