# REPORT OF SURVEY FOR REPAIRS, &c.

on the Wood, Iron or Steel Turbo electric "ESSO PURFLEET" Tanker.

Continuation of Report No. 18411 dated 13th January, 1948. on the

"ESSO PURFLEET". (Hull).

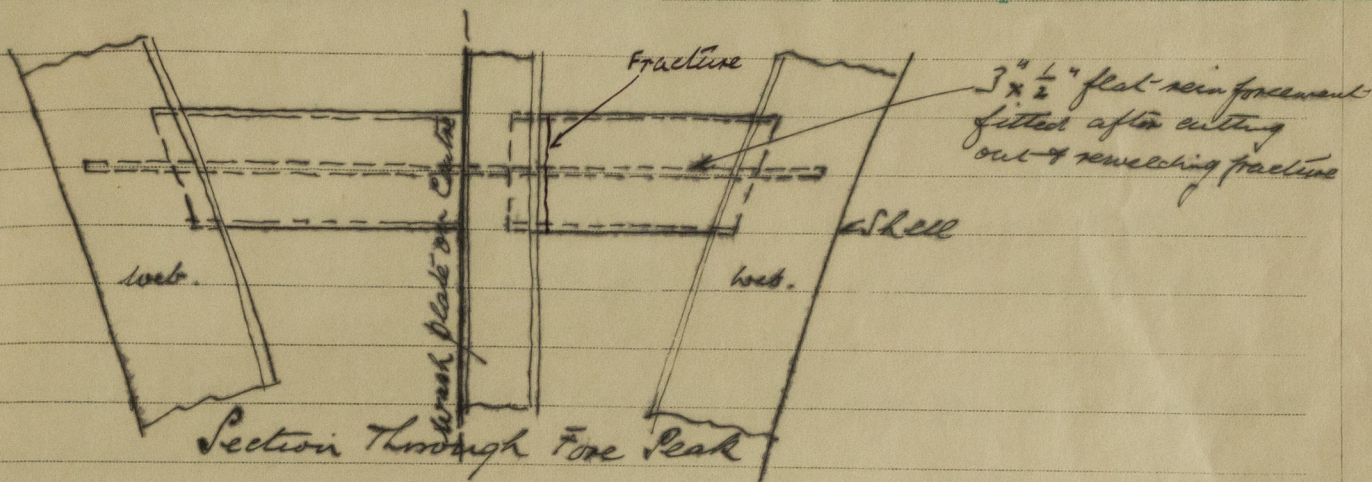
Fore Peak:- Starboard flanged plate cross tie from centre wash plate to deep side web fractured. Fracture cut out, rewelded and a 3" x .50" flat fitted p & s as reinforcement.
