ETTRICK BANK

DAMAGE & REPAIR PLAN OF RUDDER

HULL REPAIR SECTION
REPAIR DEPARTMENT
KOBE SHIPYARD & ENGINE WORKS
MITSUBISHI HEAVY INDUSTRIES LTD

Repair to rudder,
Yka rept No. 110.

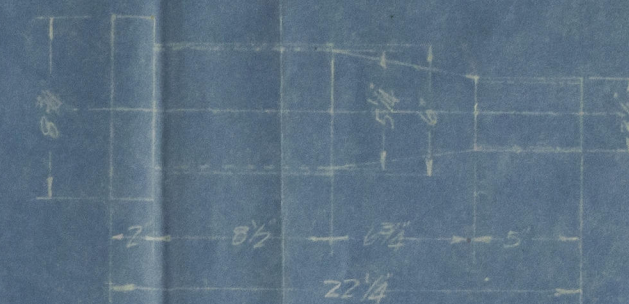
RENEW LOCKING PINTLE BECAUSE RUDDER
DARKER HOLE BADLY WORN OUT

BORING AND RENEW BUSH
4" x 3/4" x 5" (CAST STEEL)

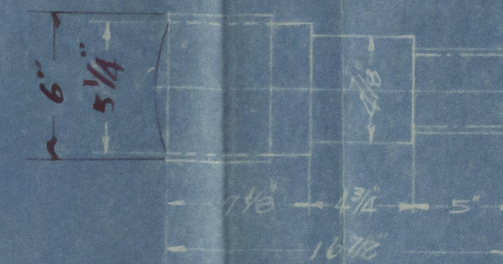
RENEW COMMON PINTLE BECAUSE
BADLY CORRODED

BORING AND RENEW BUSH
4" x 3/4" x 5" (CAST STEEL)
