Port belonging to **LONDON**

EXAMINATION AS PER RULE, FOR DAMAGE, SPECIAL SURVEY (COMMENCEMENT) AND GENERAL EXAMINATION.

## "AVISMERE" Ex "OCEAN VISION"

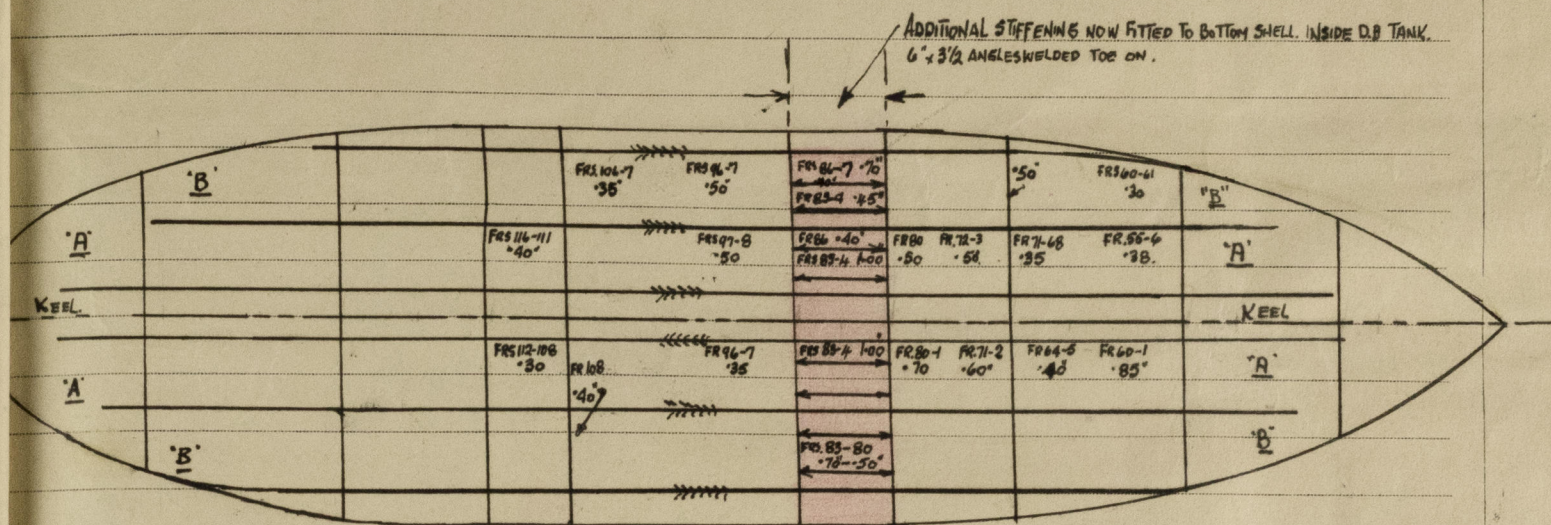
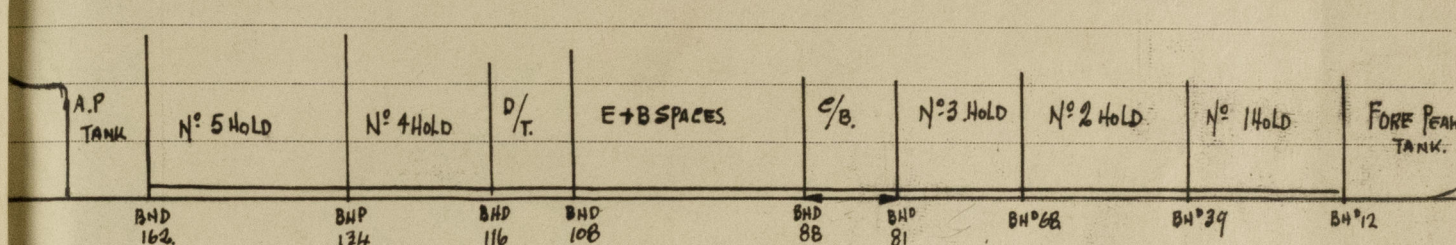
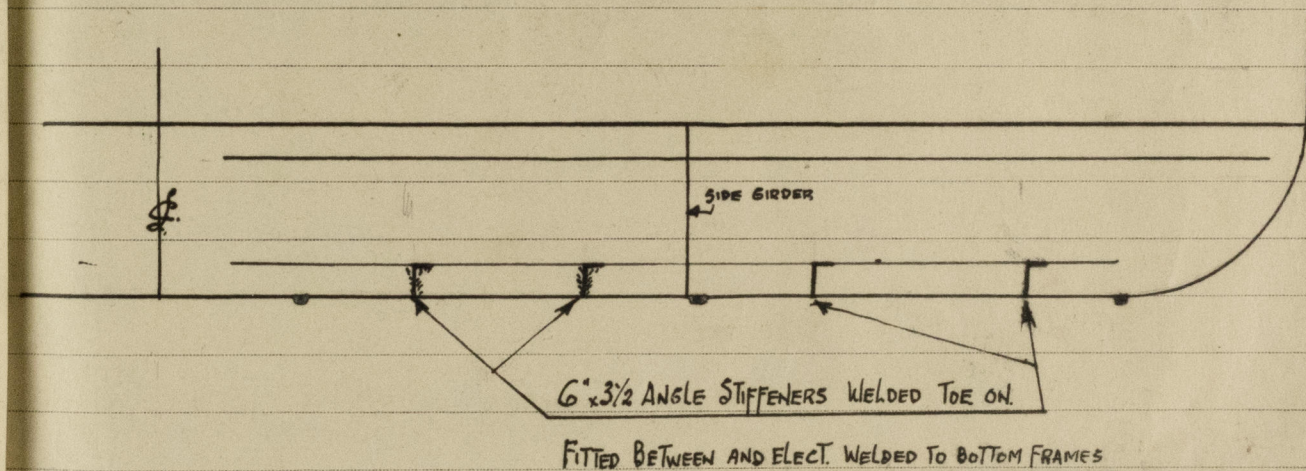
DIAGRAM SHOWING CORROSIONS AT SHELL, BOTTOM PLATING AND ADDITIONAL STIFFENING NOW FITTED.  
IN WAY OF CROSS BUNKER.

NOTE A request has been made for information regarding the character and distribution of the cargoes carried during the time that the corrugations of the bottom have been developing. This information will be forwarded in due course.
