REPORT OF SURVEY FOR REPAIRS, &c.

Survey Report 6-3-1948 When handed in at Local Office 9-3-1948. Port of Swansea.
Survey held at Swansea. Date, First Survey 20-2-48 Last Survey 26-2-1948
on the Wood, Iron or Steel S.S. "IVYBANK". (No. of Visits 6.)

NAME: Built at Baltimore. By whom Bethlehem Fairfield Shipyard Inc. When 1943.
7256. Owners Bank Line Limited. Owners' Address -
DK. 6729. Managers A. Weir & Company. (If not already recorded in Appendix to Register Book).
4448. Port belonging to Glasgow.

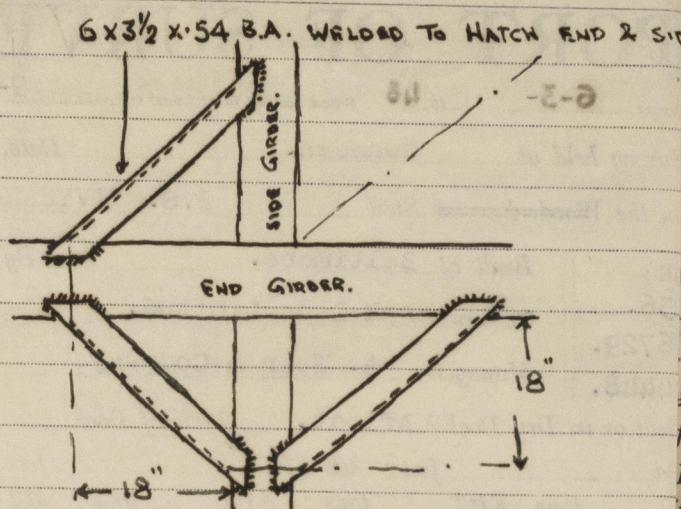
Reinforcements in way of upper deck main hatchway corners have been carried out at some P.T.O.

time previously as per Sketch:-
