MANCHESTER DRY DOCKS CO. LTD.		
M.V. "ROTULA."		
FRACTURES ON RUDDER POST.		
SCALE	DATE	DWG. NO.
—	DEC. 9. 52.	1455

"
Rotula"

Rpt. NO. Rot. 36580,

Fractures on
rudder post.

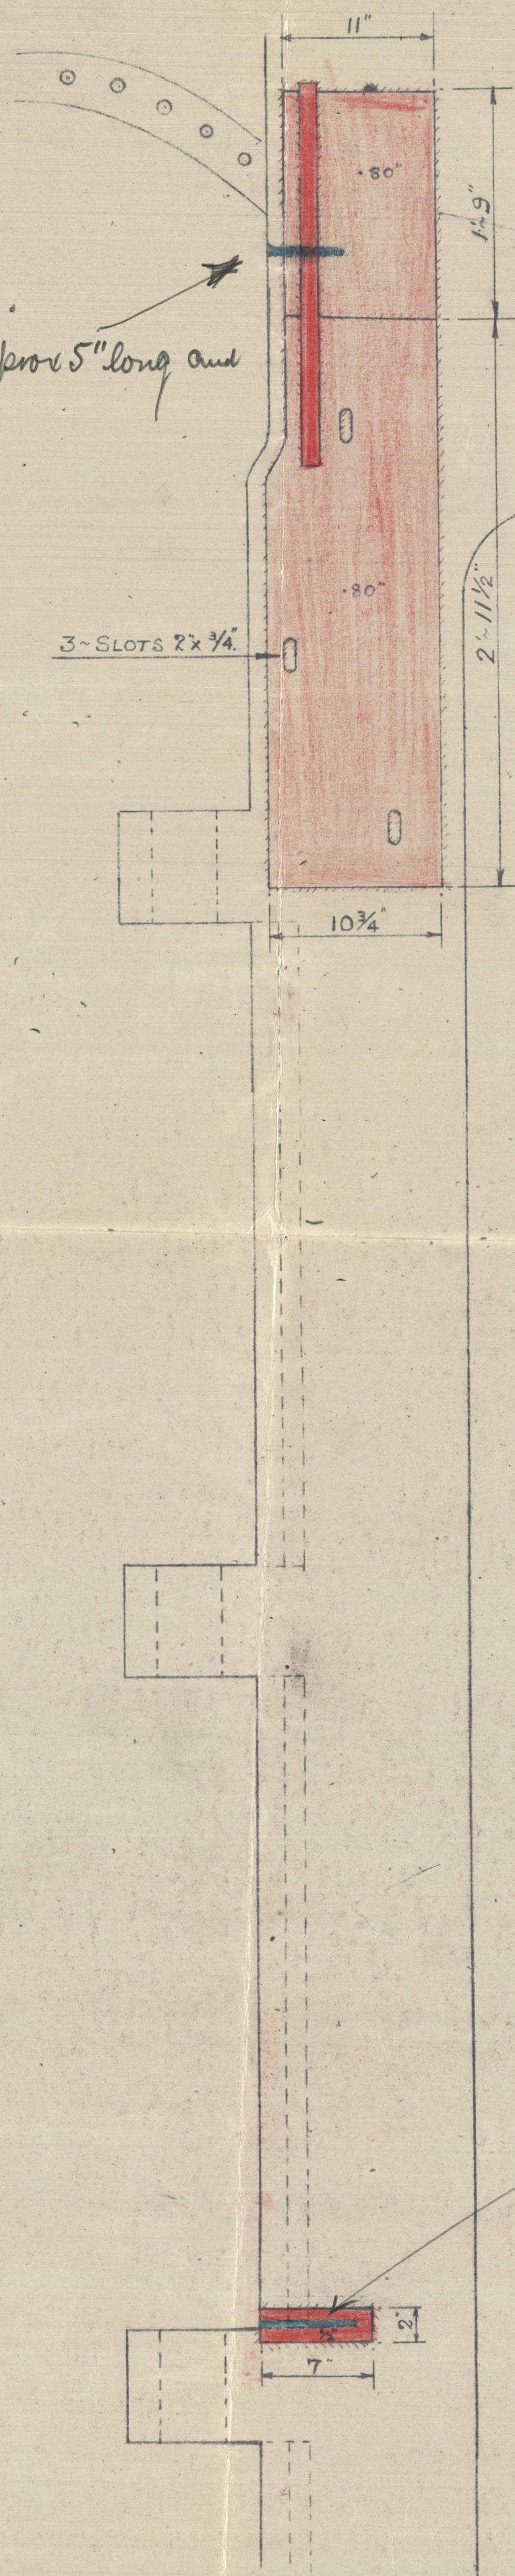
Fracture approx 5" long and 1 1/4" deep.

Fracture 5" long and 3/4" deep

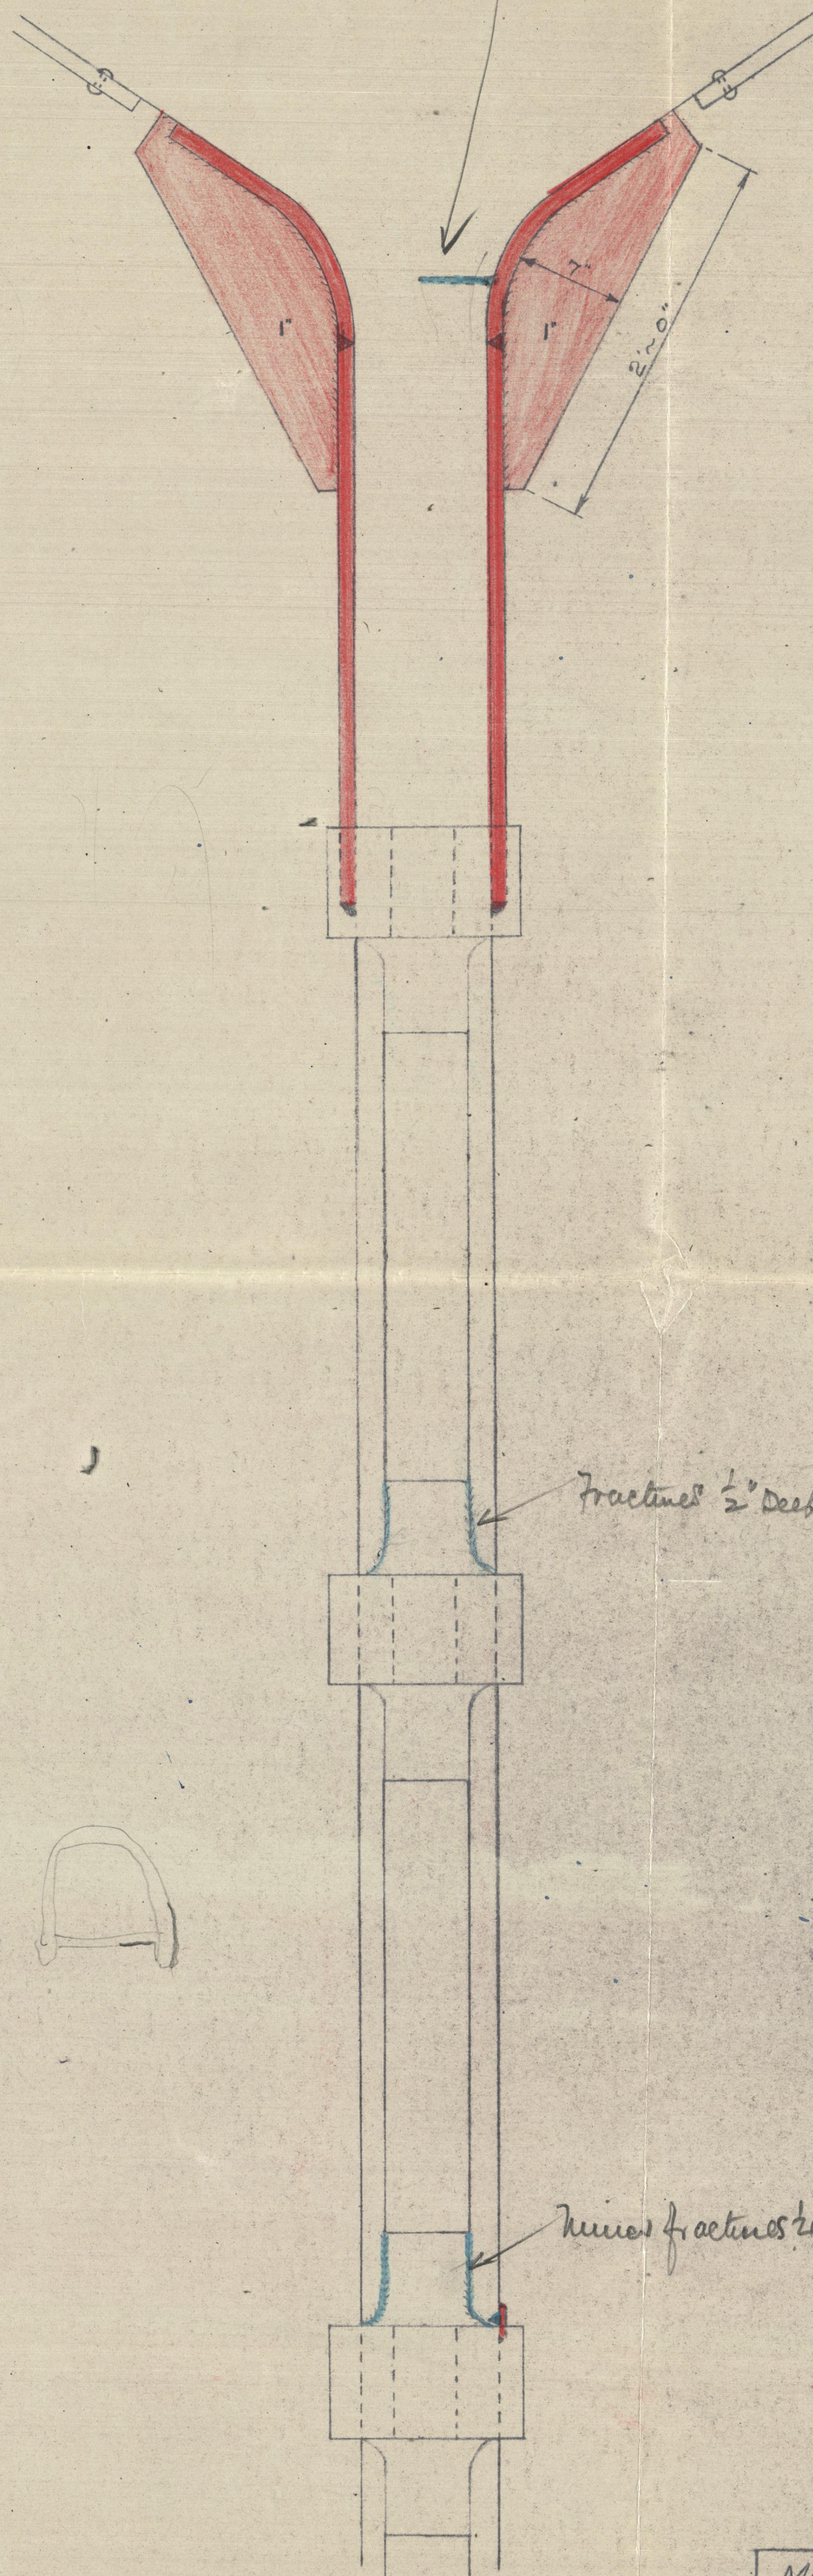
Fracture approx 4" long and 1 1/4" deep.

Fractures 1/2" deep

Minor fractures 1/4" deep

FRACTURES.
NEW PLATES.
