## REPORT OF SHIP SURVEYS AND REPAIRS

"WINNEBA" Ex "UNIGENI"

EXAMINATION AND REPAIRS AS PER RULE FOR

SPECIAL SURVEY &amp; ALTERATIONS.

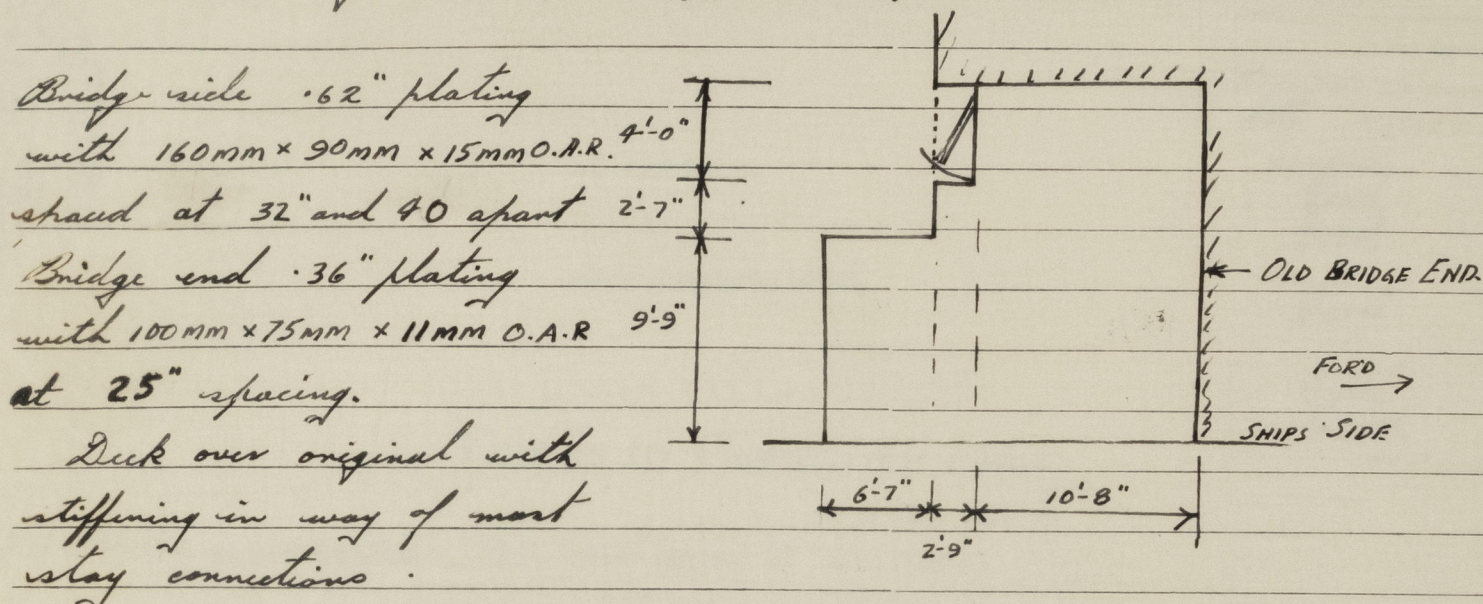
Bridge extended aft on (SS) as shown in sketch.

Accommodation aft modified, pillars modified  
 as shown on plans attached to report.

Bridge deck (SS) aft, stairway opening plated in  
 in way of extension to bridge
