REPORT OF SURVEY FOR REPAIRS, &c.

Date of writing Report 2/10 1945 When handed in at Local Office 2 NOV 1945 Port of London
No. in Survey held at London Date, First Survey 27-6-45 Last Survey 26-10-1945
Reg. Book. 32357 on the Wood, Iron or Steel S.S. "EMPIRE TAGINDA" (ex "Rudolf ALBRECHT")
TONNAGE: Built at Kiel By whom Fr. Krupp Akt. Ges. When 1922
GROSS 3846 Owners Ministry of War Transport Owners' Address
UNDER DK. Managers Hadley Shipping Co. Ltd. Port belonging to London
NET 2110

REPAIRS, OR EXAMINATION AS PER RULE, FOR GENERAL EXAMINATION, in accordance with instructions relating to German prize-ships.

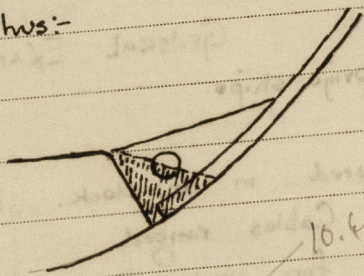
Condition:- Structure generally is in good condition except floors and internals in double bottom tanks under E. & B. which are showing signs of considerable wastage. Floors in these tanks had been stiffened, on some previous occasion, with channel or bulb angle vert^l stiffeners, welded.

at this time. When the double bottom tanks were tested, leakage was found in way of a large number of frame bkt. lugs to margin plate, on pass. of the two after D.B. tanks. As a temporary measure, in view of lack of time and labour, cement box was thus:- //

Efficient drainage arranged to
bilge strums. Tanks retested
and found satisfactory.

It is recommended double bottom tanks under E. & Bs. be further examined at the next G.E. (due 10/45), being efficient in the meantime.
