Ship's Name *MS "TASSIA"* Port *LONDON.*

Processing Number: LR *501914.* Gross tons *2321* Rpt. No. *156110*

I have surveyed the above-named ship in accordance with the Rules for **ANNUAL DRYDOCKING**; THE SUPPLY OF **45 FATHOMS OF CHAIN CABLE AND DAMAGE** STATED TO HAVE BEEN CAUSED BY CONTACT WITH DOCK WALL WHEN LEAVING SURREY COMMERCIAL DOCK UNDER TUGS ON 15th FEBRUARY, 1966.

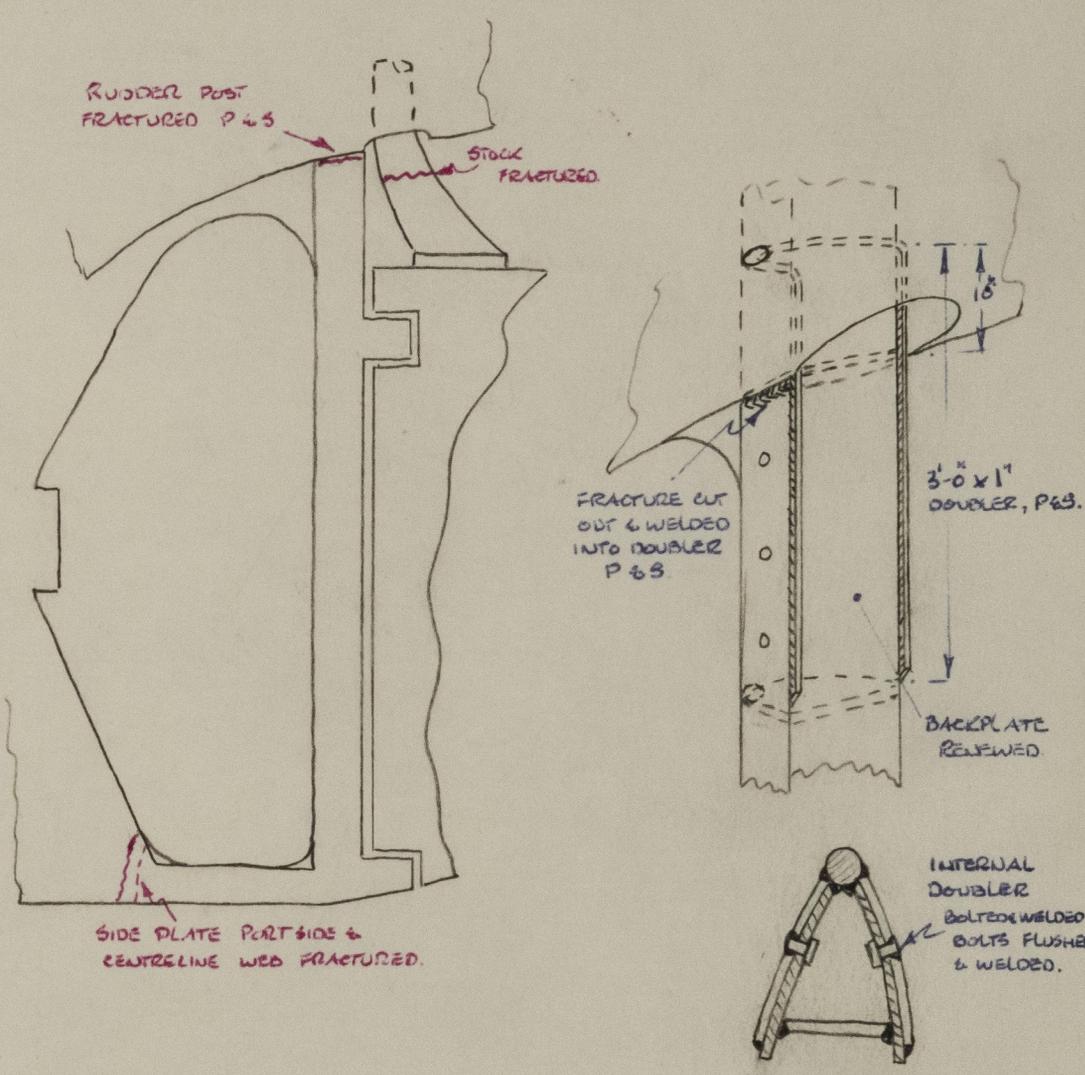
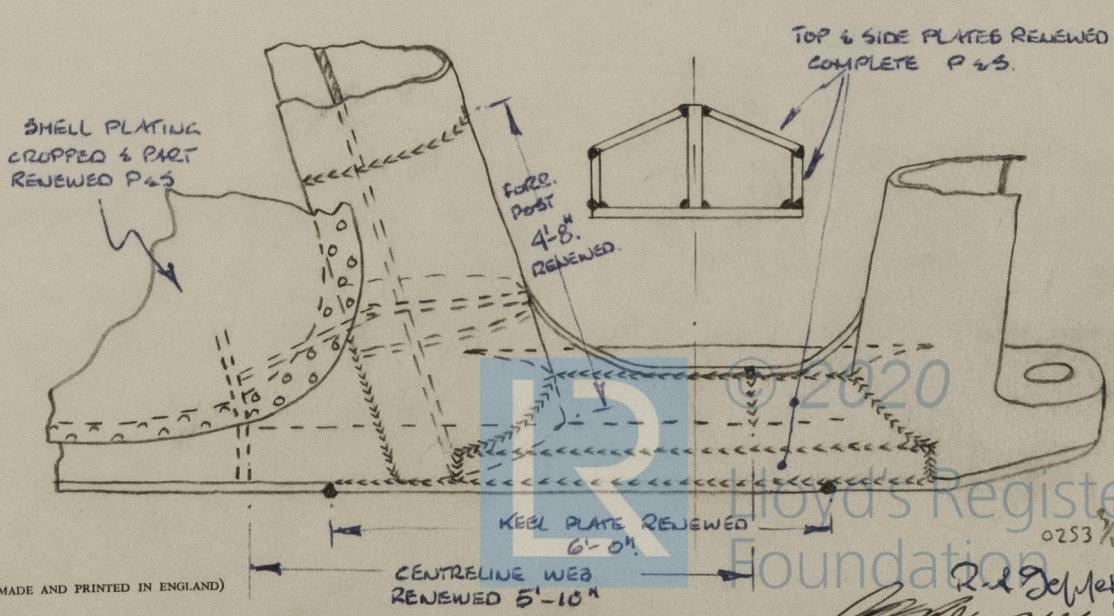
(SEE SKETCH OF REPAIRS ON SHEET II.)

ON EXAMINING IN DRYDOCK FOUND TRAILING EDGE OF RUDDER SET OVER ABOUT 3", PINTLES AND BUSHES DISTURBED; RUDDER STOCK COMPLETELY FRACTURED JUST ABOVE THE PALM RADIUS; RUDDER POST SIDE PLATES FRACTURED AT TOP IN LINE WITH SHELL PLATING AND STERNFRAME SOLEPIECE SIDE PLATE, PORT SIDE AND CENTRELINE WEB BOTH FRACTURED AT JUNCTION WITH SHELL PLATING. SOLEPIECE AND POST SET-OVER APPROX 6" TO STARBOARD.

SHELL PLATING ADJACENT TO STERNFRAME SOLEPIECE CROPPED AND PART REMOVED FOR ACCESS, P & S.
 TAILSHAFT WITHDRAWN AND ALIGNMENT OF STERN TUBE CHECKED.
 SOLEPIECE AND POST FAIRED AND RE-ALIGNED WITH RUDDER STOCK BUSHES AND STERN TUBE. AFTER RE-ALIGNMENT THE RUDDER POST WAS SECURELY FIXED BY SHORES FROM THE SIDES OF DRYDOCK DURING REPAIRS TO STERNFRAME.

SOLEPIECE :-
 (FABRICATED) KEEL PLATE CROPPED AND PART RENEWED 6'-0" IN LENGTH.
 (BOX) SIDE PLATES RENEWED COMPLETE, APPROX 6'-2", PORT & STARBOARD.
 (SECTION.) TOP PLATES RENEWED. COMPLETE, P & S.
 INTERNAL CENTRELINE WEB CROPPED AND RENEWED 5'-10" IN LENGTH.

STERNFRAME FORWARD POST :-
 CROPPED AND PART RENEWED AS WRAPPED PLATE FOR 4'-8" FROM KEEL PLATE. INTERNAL WEBS RENEWED.

SHELL PLATES PORT AND STARBOARD PART RENEWED, BUTTS WELDED, RIVETED TO STERNFRAME, TESTED WITH A.P. TANK & FOUND OR MADE TIGHT.

RUDDER POST TOP :-
 " UPPER BACK PLATE REMOVED FOR ACCESS.
 1 THICK DOUBLING PLATES FITTED INTERNALLY TO SIDE PLATES OF POST 3'-0" IN LENGTH AND EXTENDING 10" MINIMUM INTO RUDDER TRUNK. FRACTURES IN SIDE PLATES CUT OUT AND WELDED THROUGH TO INSIDE DOUBLERS.
 ADDITIONAL HORIZONTAL WEB PLATE FITTED INSIDE POST IN LINE WITH SHELL CUTTING LINE.
 BACK PLATE RENEWED WHERE REMOVED.
