71980 on the Wood, Iron or Steel Sc. Steamer SAINT-BONIFACE Master  
TONNAGE:— Built at Caen By whom Chantiers Navals Français When 1924

REPAIRS, OR EXAMINATION AS PER RULE, FOR the Recommended Repairs of Damage stated to have been sustained by vessel coming in contact with some submerged objects during voyage from the Builders' Yard at Blainville to entry into Dry Dock at Cherbourg, from 23rd to 27th November 1922, for the purpose of having the ship's bottom cleaned and painted before undergoing her speed and other trials (See Caen Report N° 80); and for the recommended repairs of further damage stated to have been sustained by vessel coming in contact with some submerged object while afloat from the 10th to 28th December 1922, during which time her speed and other trials were undergone (see Caen Report N° 84).

Continuation of Report No. 86

dated 6th February 1923 on the S.S. St BONIFACE  
N° 71980

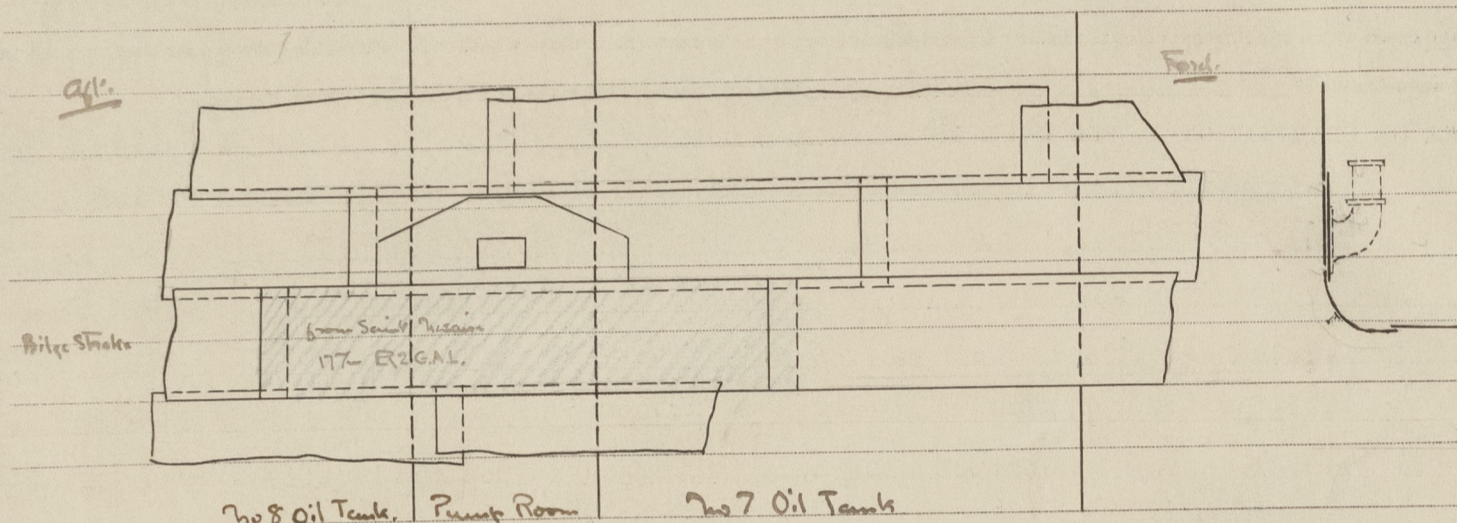
Sketch from Dry Dock showing position of new shell plate. Starboard Side

ON STARBOARD SIDE IN WAY OF N° 7 OIL TANK,

1 indented and scored shell plate on	
round of bilge, extending from N° 7 to	A new plate fitted in place
N° 8 Oil Tanks, removed.	
1 set in longitudinal frame in way of same.	faired in place
1 indented shell plate in strake above.	faired in place
1 buckled length of bulb plate bilge	faired, the scores welded u
keel removed	and replaced

Nos 7 & 8 Starboard Oil Tanks were filled with water to Rule pressure; the riveting and caulking in way of repairs examined, and found satisfactory.

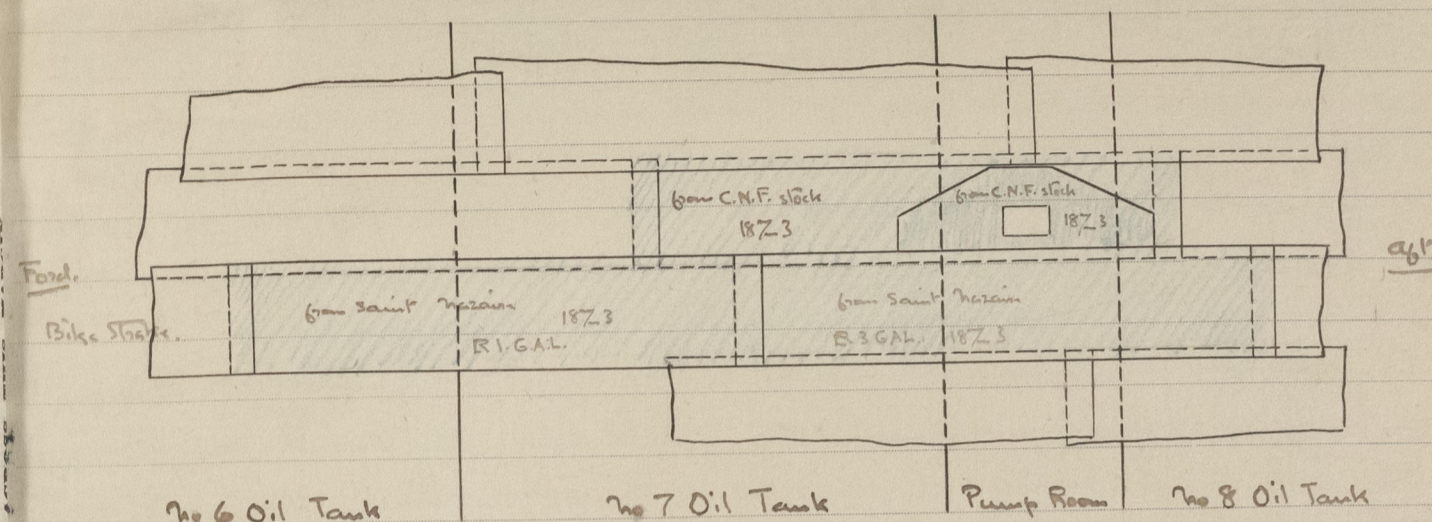
Sketch from Dry Dock showing position of new shell plates. Port Side

ON PORT SIDE IN WAY OF N° 7 OIL TANK

1 indented and scored shell plate on	}	
round of bilge, extending from N° 7 to		A new plate fitted in place
N° 8 Oil Tanks, removed		
1 set in longitudinal frame in way of same removed, faired, and replaced		
1 indented and scored shell plate in	}	
strake above, extending across Pump Room,		A new plate fitted in
removed.		place.

The scored doubling plate, in way of	}	A new doubling plate fitted
Pump Room sea-connection, removed		
1 scored shell plate on round of bilge,	}	A new plate fitted in place.
extending from N° 6 to N° 7 Oil Tanks		
removed	}

The steam heating coils, which were removed and replaced in Nos 7 & 8 Oil Tanks Starboard, and in Nos 6, 7 & 8 Oil Tanks Port, in way of the Damage Repairs, were all satisfactorily tested under steam to 14 Kgs per CM<sup>2</sup>.
