REPORT OF SURVEY FOR REPAIRS

Port of BOMBAY.

Continuation of Report No. 7311 dated 4. 6. 1943 on the

S.S. "ASHRIDGE"

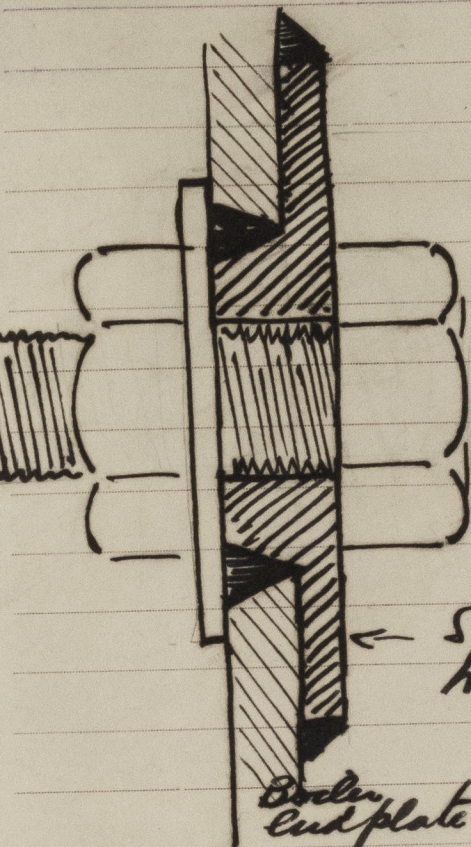
Leakage having been reported from the ~~top~~ top most of the longitudinal bottom

lays on the starboard side of the port main boiler, the nut was removed and the boiler was opened for inspection. It was found that in addition to fairly deep radial cracks running outwards from

the longitudinal stay on the water side of both end plates, there were circumferential cracks forming

complete circle round the stay nut. This crack had developed through the end plate locally.

These stays are fitted with outside nuts only and no washers, there being 5 stays in the vicinity of the
The boiler is secured on the boiler back plate.

The fractures had developed too far to be made good by veeing out and welding and

Spigoted Washer of tested boiler plate welded on.

circular piece had to be cut out and all fractured material was removed except the radial fracture.

one of which were vee'd out and welded. A spigoted steel washer was made and welded in place, P. T. (

both outside and inside. The longitudinal stay which could not be renewed owing to lack of suitable material was re-screwed fitted with new inside and outside nuts and an inside washer. The end plates in way of the upper most stay on the port side of the boiler was also developing in the same way, and was similarly dealt with.

The original longitudinal stays now ^{refitted} were longer than was necessary, so that the actual loss of depth of the new outside nuts is only about $\frac{3}{4}$ ". The boiler was afterwards tested by hydraulic pressure at 210 lbs. per sq. inch. and examined under full steam pressure and found tight.
