Report of Survey for Repairs, &c., of Engines and Boilers.

Date of writing Report 4 April 1927 When handed in at Local Office 19 Port of Hanse
 No. in Reg. Book 8455 Survey held at Hanse Date, First Survey 11 March Last Survey 2 April 1927
 Tonnage Gross 5790 Net 3708 on the Machinery of the Wood, Iron or Steel Tergerstea
 Vessel built at Manfalcone By whom Cont. Nav. Grestino When 1926-9
 Engines made at Grestino By whom Stabilimento Benico When 1926
 Boilers, when made (Main) (Donkey) 1926
 Owners Sa. Onam, Di. Nav. a. Vap. G. L. Parnada Owners' Address (if not already recorded in Appendix to Register Book)
 Managers Port Grestino Voyage Voyage
 No. of Main Boilers 2 If Surveyed Afloat or in Dry Dock Afloat
 No. of Donkey Boilers 1 Steam Pressure in Main Boilers 100
 in Donkey Boilers 100

Repairs effected to engine seating
N.B. - If this Report is copied by copying Press, especial care must be taken that the copying paper is not so much damaged as to spread the ink, or to cause it to show through to the other side.

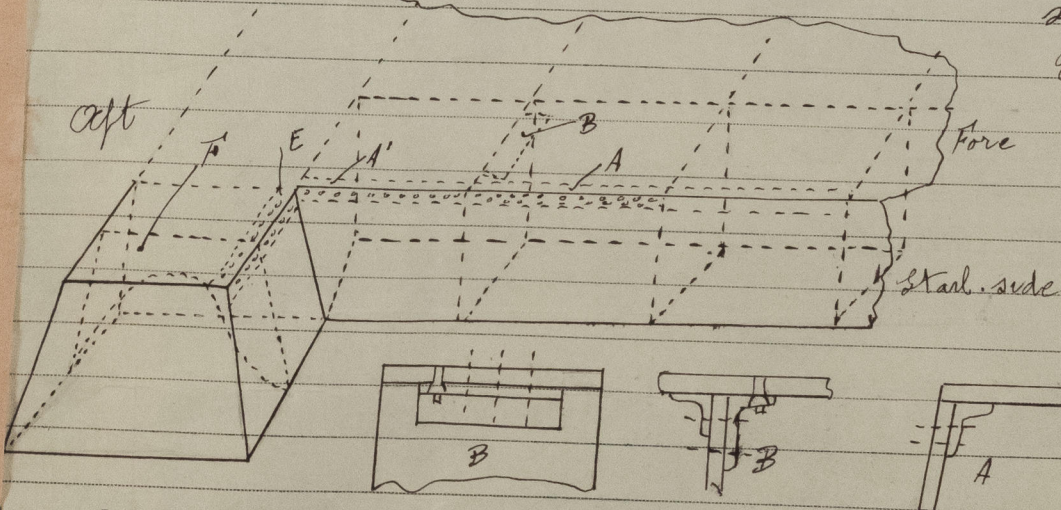
A Survey is not complete, state what arrangements have been made for its completion and what remains to be done? This survey is complete
 is survey has been made at the request of the Master for damage to the engine support structure.
 Several rivets in the engine support structure have been found slack; more on starboard side than on port side L.E.

On the angle bar A attaching the vertical and the horizontal plate one side. On the angle bar B attaching the inside support vertical plate and the horizontal plate. At this place, it has not been possible to renew the vertical rivets, these have replaced by

screws, and the screw heads welded.

Seven of these angle bars have been renewed and in this case 2 rows of rivets have been made in the vertical flange and the angle bars have been welded around.

In every case where it has been necessary to renew the rivets by screws in the angle bar B, these have been welded, also the angle bars.

In the turning gear platform, all rivets of angle bar E were slack, they have been renewed and reinforcement plate is maintained in the vertical sense by angle bars riveted.

238 rivets have been renewed - 39 rivets replaced by screws - 7 angle bars renewed - 16 rivets caulked.
