REPORT of SURVEY for REPAIRS, &c.

Reg. Book. 40373 on the Wood, Iron or Steel Ship "TERNEUZEN" (No. of Visits 122)

IRS, OR EXAMINATION AS PER RULE, FOR Damage repairs, reclassification and 2nd Special Survey No. 2. The Vessel arrived at this Port in Damaged condition, towed from Lisbon. see your letters H-8th February 1938.

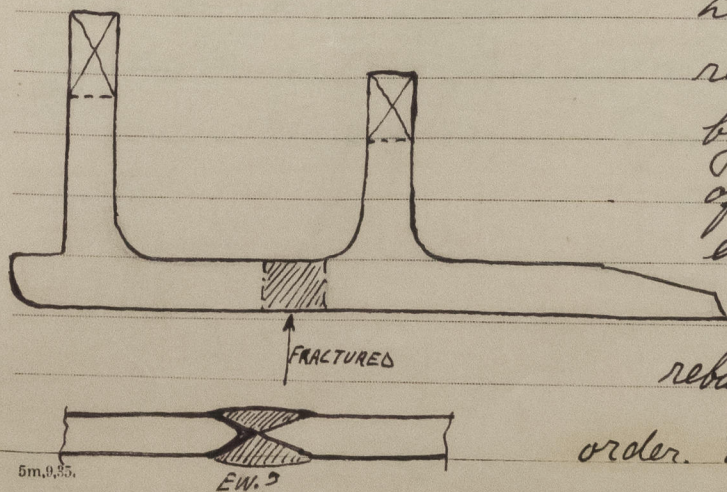
Rudder and stern frame:

STATE OF DAMAGE REPAIRS:—	Shell Plates.	Frames.	TOP PLATES OF BOTTOMS OF SOLID OR BR. FLOORS.	Floors and Deck Plating.	INTER-CEILING STAYS SIDE KEELSONS	Inner Bottom Plates.	Dk. Plates.	Other Items:—
Renewed	7	17	3	55	29	18	27	7 Plates of after peak bulkhead renewed.
Removed and Faired or Repaired	15	17	121	4	35			4 Centre keelson plates renewed.
Faired or Repaired in place	21	4	45	7	12	7		sole piece of stern frame, fracture cut out and built up by plate welding.

Rudder unshipped, pintles renewed.
Lower part of stern frame (see sketch)
removed, fracture cut out, built up
by electric welding, afterwards lower part
of stern frame annealed as required,
exd. found good and replaced on board
in good order. All gudgeons aligned,
rebushed and rudder replaced in good working
order. Bottom and rudder now in a good condition.
Please see 4th Continuation sketch.
