S.S. " POINT CLEAR "

EXAMINED:-

All holds, tween decks, fore and after peak spaces, coal bunkers, engine and boiler spaces, under engines and boilers, plating in way of sidelights decks, hatchways with their closing and securing appliances, anchors, cables, chain locker, masts and rigging, steering gear, auxiliary steering gear, windlass, general equipment, hand pumps, watertight doors, ventilator coamings and covers, air and sounding pipes, lifeboats, cargo battens and casings.
Renewal Freeboard Survey carried out.
Shell plating drilled and gauged (Copy attached herewith).

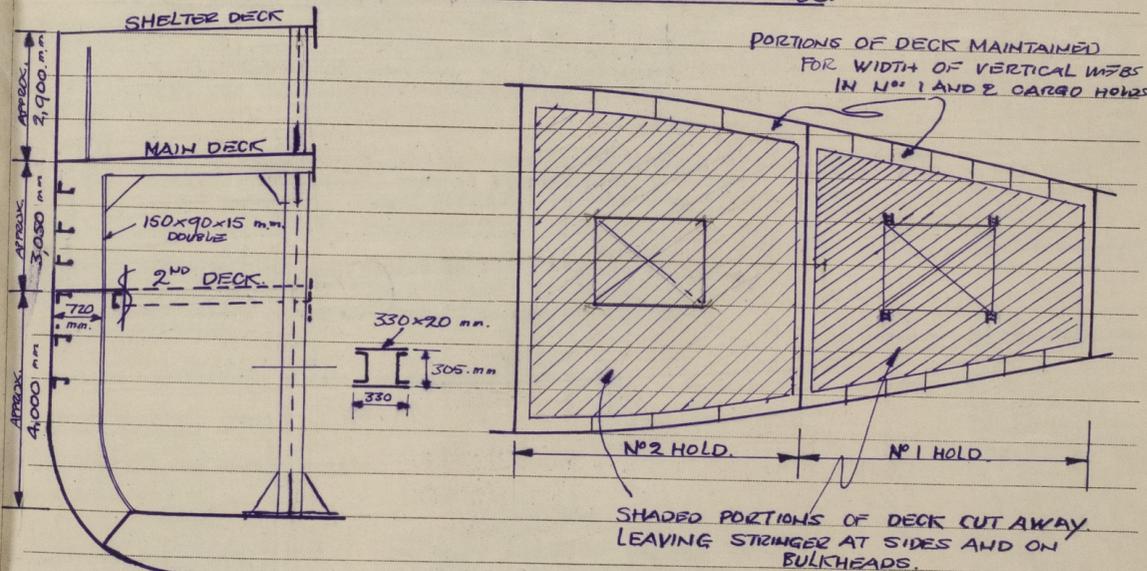
2ND DECK IN NOS 1 AND 2 CARGO HOLDS.

The lower deck in Nos. 1 and 2 cargo holds has been cut away leaving a stringer for width of vertical webs at ships' side and at after bulkheads of Nos. 1 and 2 cargo holds.

Prior to the deck being removed the scantlings of longitudinals shell framing vertical shell webs, bulkheads and hold pillars and girders were checked and found to be satisfactory without the support of 3rd deck.

The vertical webs at shell and bulkheads and pillars at hatch corners are continuous up to the Main Deck and the 2ND Deck has been built round these members.
 It appears therefore, that the ship was originally built as a Shelter Deck vessel and the part 2ND Deck added after the original design was completed. 89.

It was recommended however to leave stringers at shell and bulkheads
