REPORT OF PERIODICAL SURVEYS & REPAIRS OF MACHINERY

No. in R.B. 93093 Name M.V. "PACIFIC PEARL" (ex "Holmdale").

Continuation of Report No. 7444 dated 18/4/57.

DONKEY BOILER WEAR AND TEAR REPAIRS: - NOW DONE:-

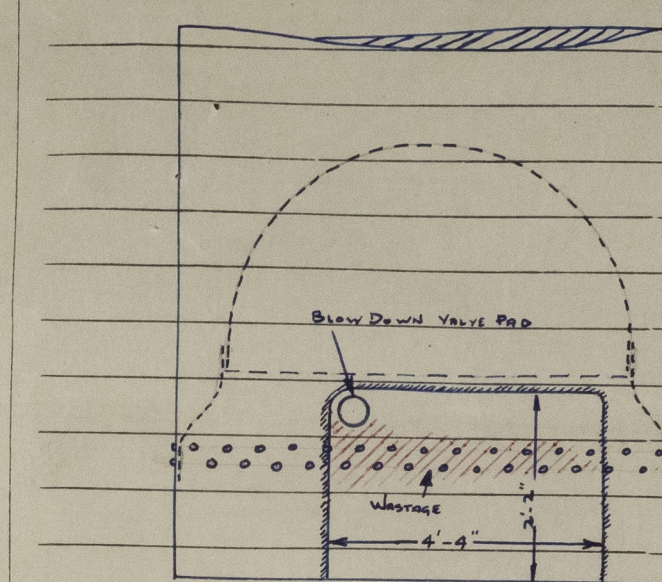
Donkey Boiler opened up for survey, during external examination, the shell plate below the blow down valve pad was found to be severely wasted, upon hammer testing a 2" dia. hole was made, all lagging round the lower half of the boiler was removed and upon further examination an area of general wastage was discovered in way of ogee ring riveting. A section of shell plate measuring 4'-4" by 2'-2" was cropped. Owing to the difficulty of riveting a patch in this position, it was decided to weld the new section of plate (tested material) in position, a certified welder being used for this operation, upon completion of welding, the plate was riveted to the ogee ring. The welding was subsequently ground flush and examined for defects and found satisfactory. Sundry minor repairs were effected to boiler mountings including the removal of a brass plug blocking the salinometer cock internally. Upon completion of all repairs the boiler was examined under hydraulic pressure and further examined under steam and found satisfactory.

In view of the nature of the shell plate repair, it is recommended that it be further examined by October, 1957 (6 months limit).
