REPORT OF SHIP SURVEYS AND REPAIRS

Ship's Name ~~MS~~ "HELGA SMITH" Gross tons 2089
 Is there a rpt. 9? No. Port Gothenburg. Rpt. No. 28453.
 No. of visits 1 First date and Last date 20/3-63.
 Interim Cert. issued & copy herewith? Yes. Damage rpt. issued & copy herewith? No. Last rpt. (H.Q. only) 8221 - Hfx
 Date of completing rpt. 26/3-63. Surveyed at, if different from Port above ---
 Surveyed afloat ~~on 26/3-63~~. Yes. Last date of examination in D.D. ---
 Has a Load Line Survey been held? No. Freeboard Marks verified ---
 State which additional Rpt. 8 is attached: (Cont); (PS); (DR); (EQ); (Rig) ---
 Survey fees --- Damage fee Kr. 70:- Expenses Kr. 3:-
 S.A. fee ---

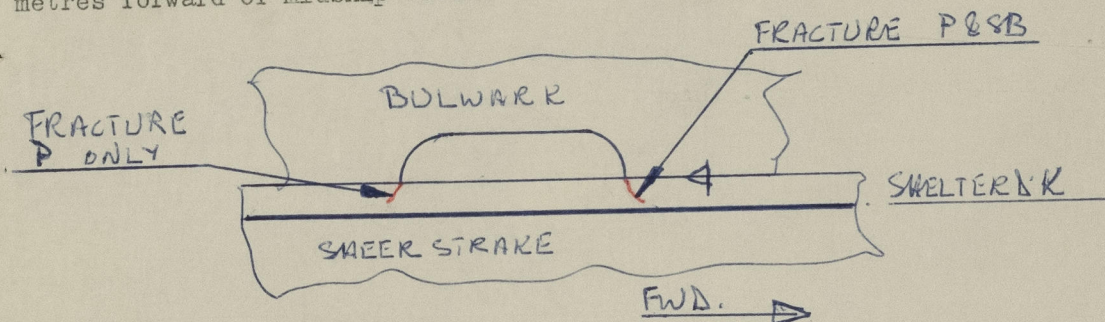
1. Sheerstrake found fractured in way of freeing ports port and starboard about 7 metres forward of midship deckhouse for a length of about 2". See sketch.

As a temporary repair a hole has now been drilled at the ends of the fractures.

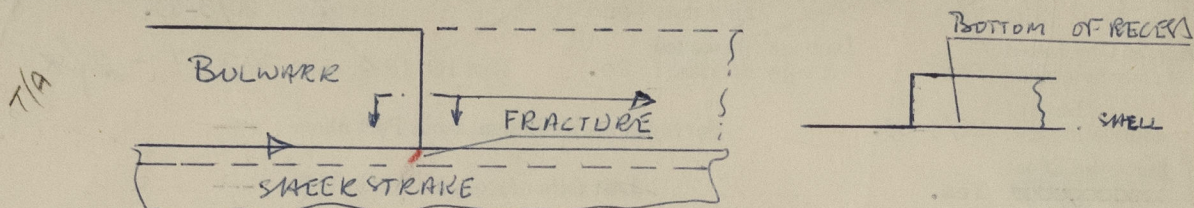
2. Sheerstrake found fractures at the aft end of the recess for the gangway on starboard for a length of about $\frac{1}{2}$ ". See sketch.

As a temporary repair a hole has been drilled at the end of the fracture.

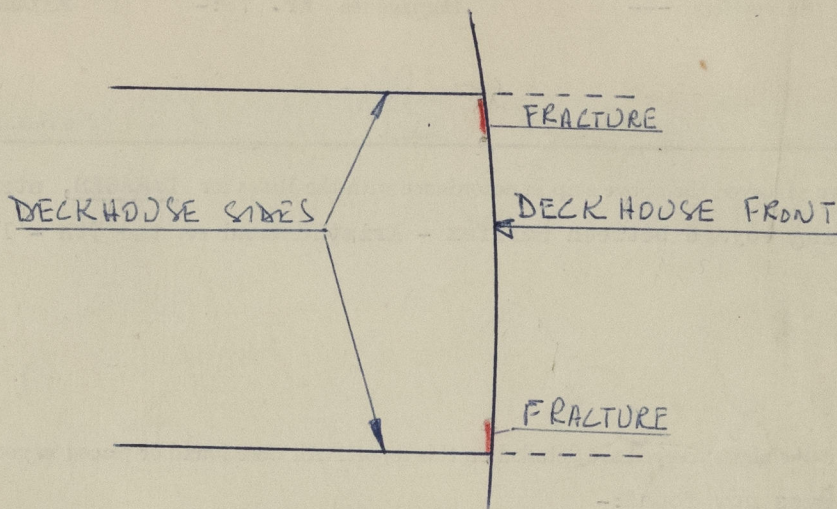
3. Shelter deck found fractured port and starboard in way of forward end of midship deckhouse. Each fracture about 1 feet long. See sketch.

As a temporary repair the end of the fractures were drilled. It was also arranged cement boxes to be fitted by the crew.

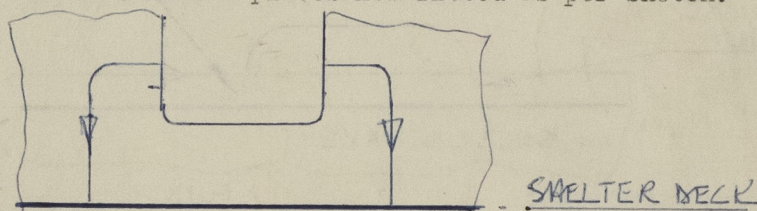
4. Longitudinal deckhouse side port and starboard fractured in way of door openings at lower end. Insert plates now fitted as per sketch.
