TEST REPORT

Name of Vessel : HIKOSAN MARU

Messrs. 4800 HP Propulsion Turbine

Repair work of HP 1st Gear

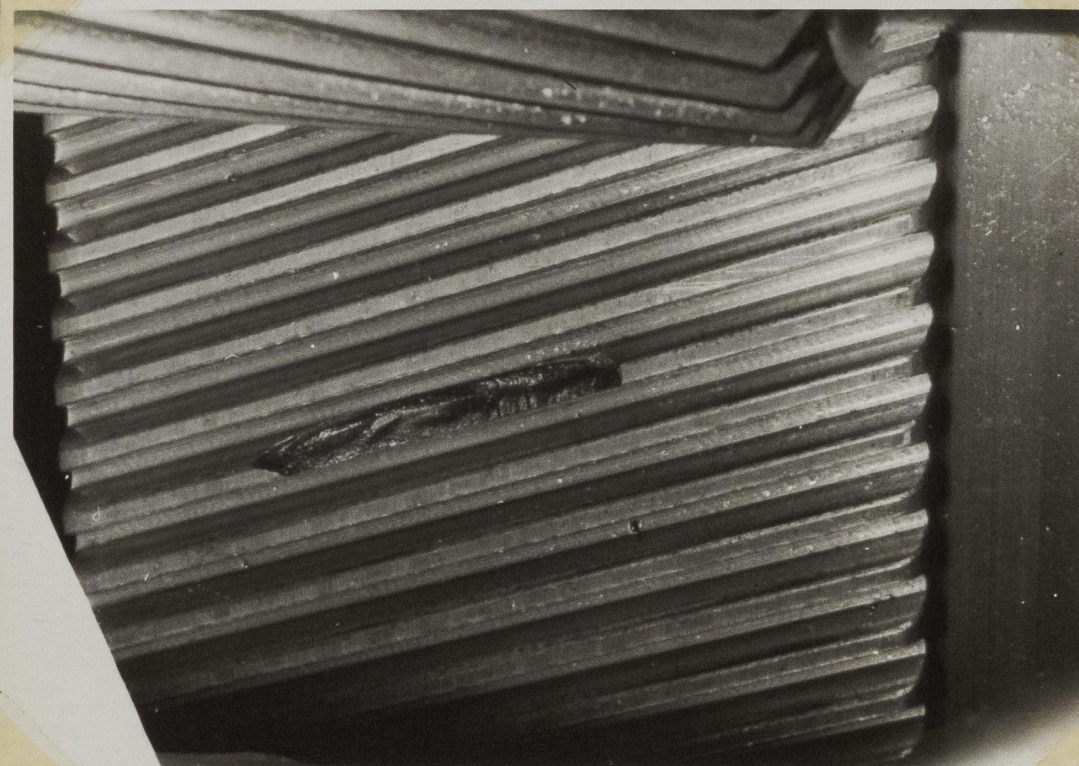
H.P. 1st Wheel aft Helix before Repair

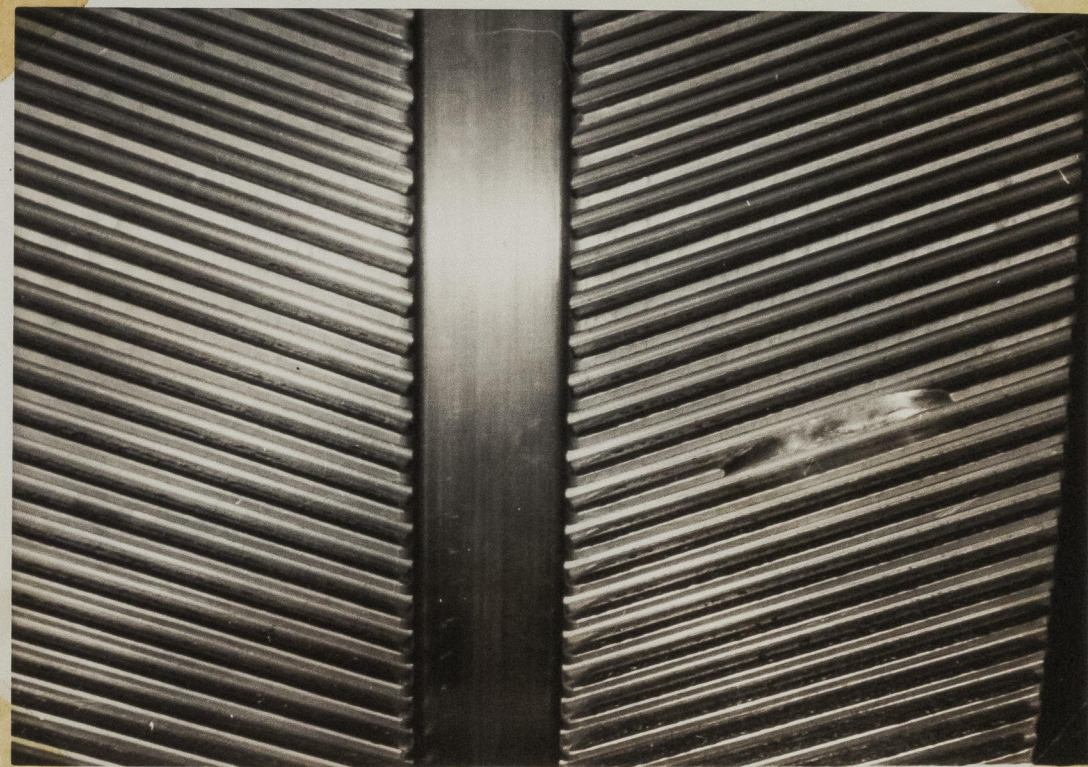
H.P. 1st Wheel Aft Helix after Repaired (Grinding)

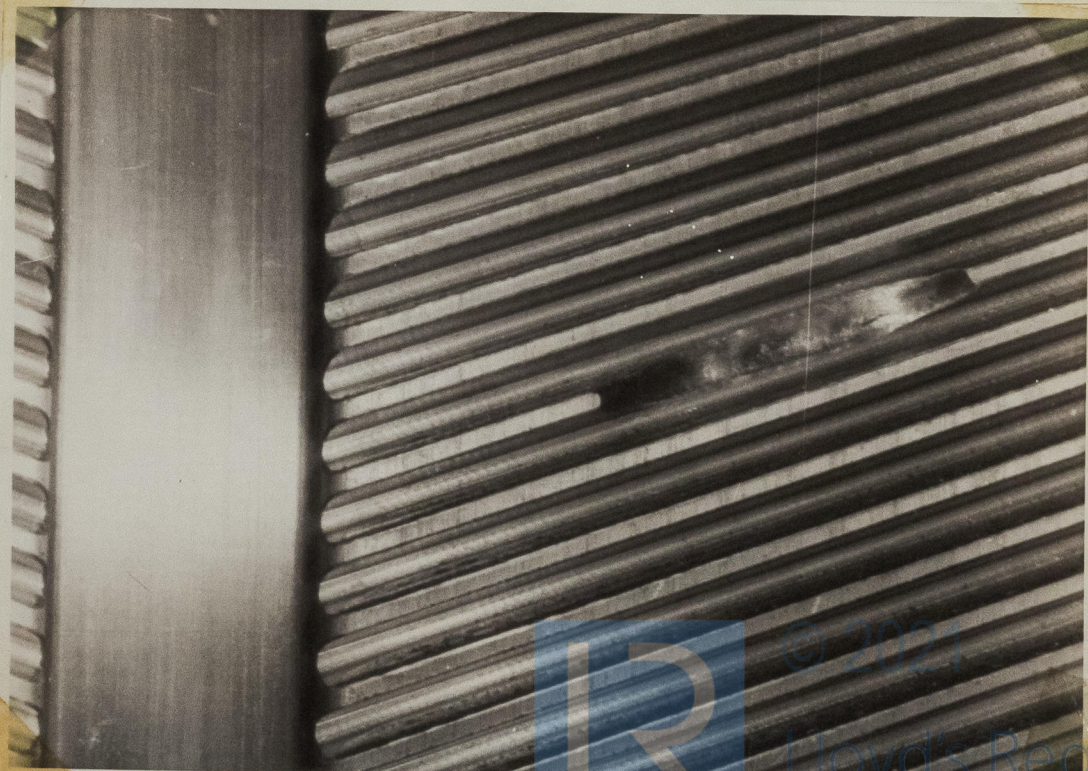
H.P. 1st Wheel Aft Helix after Repaired (Grinding)

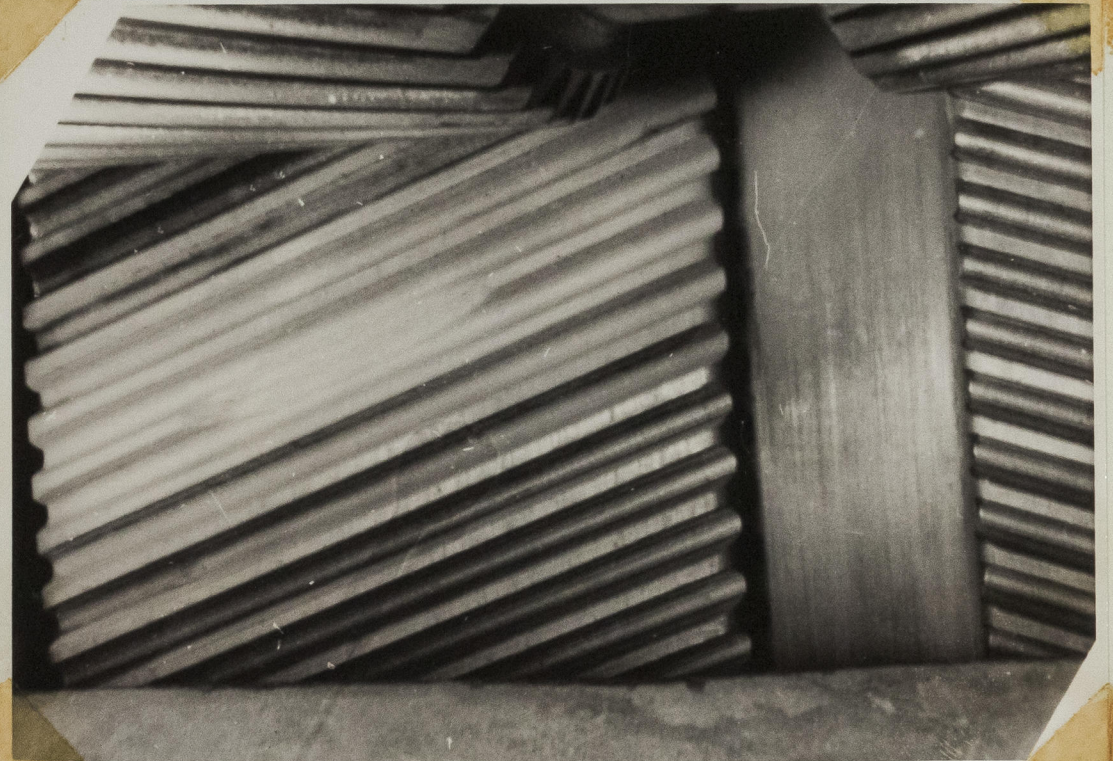
H.P. 1st Wheel aft Helix Dyecheck Inspection after Repaired.

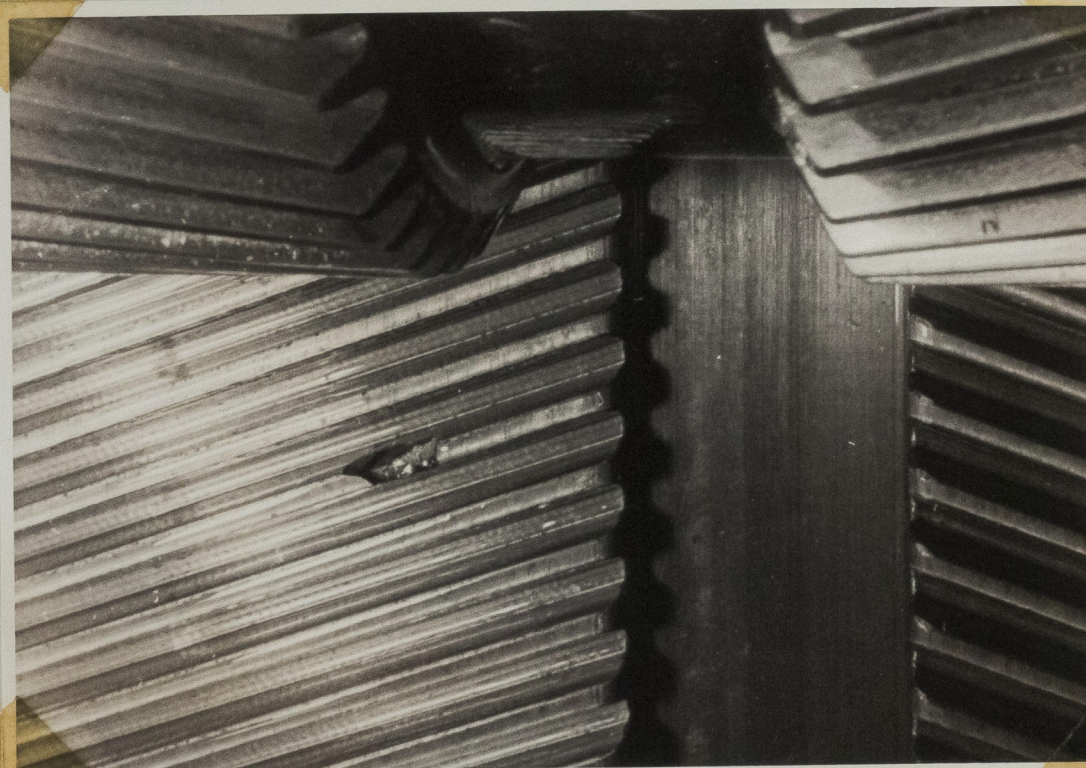
H.P. 1st Wheel aft Helix before Repair

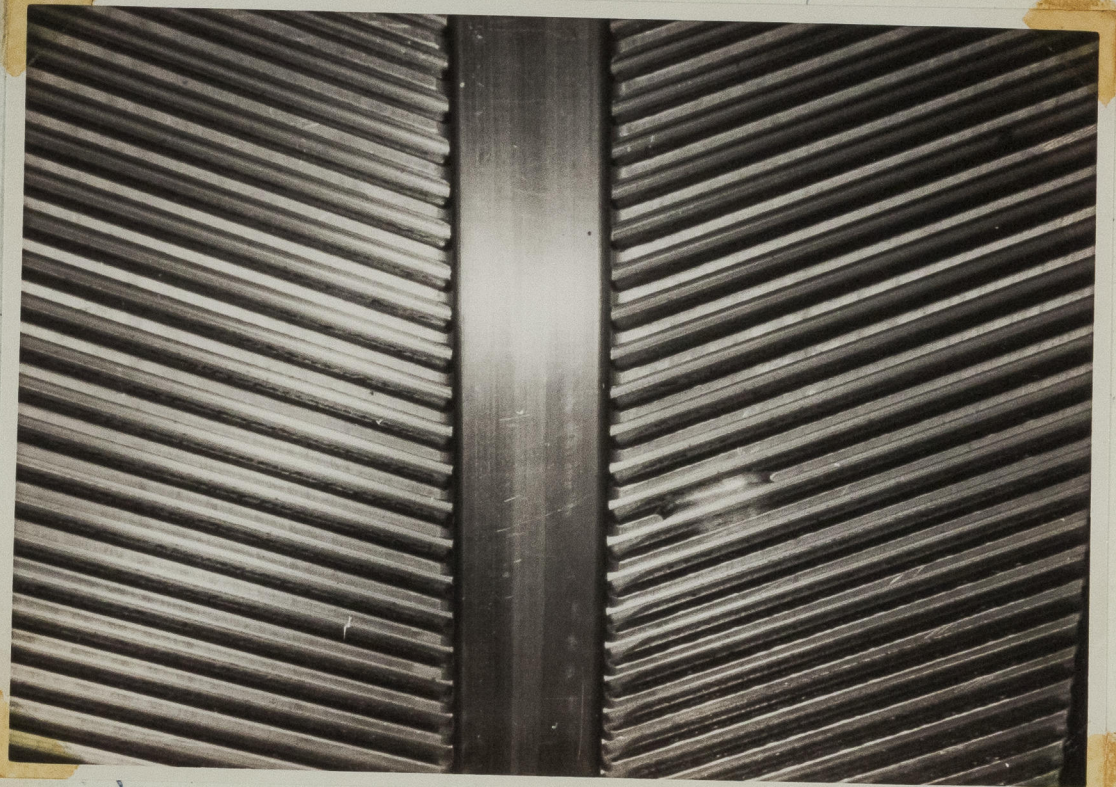
H.P. 1st Wheel Aft Helix after Repaired (Grinding)

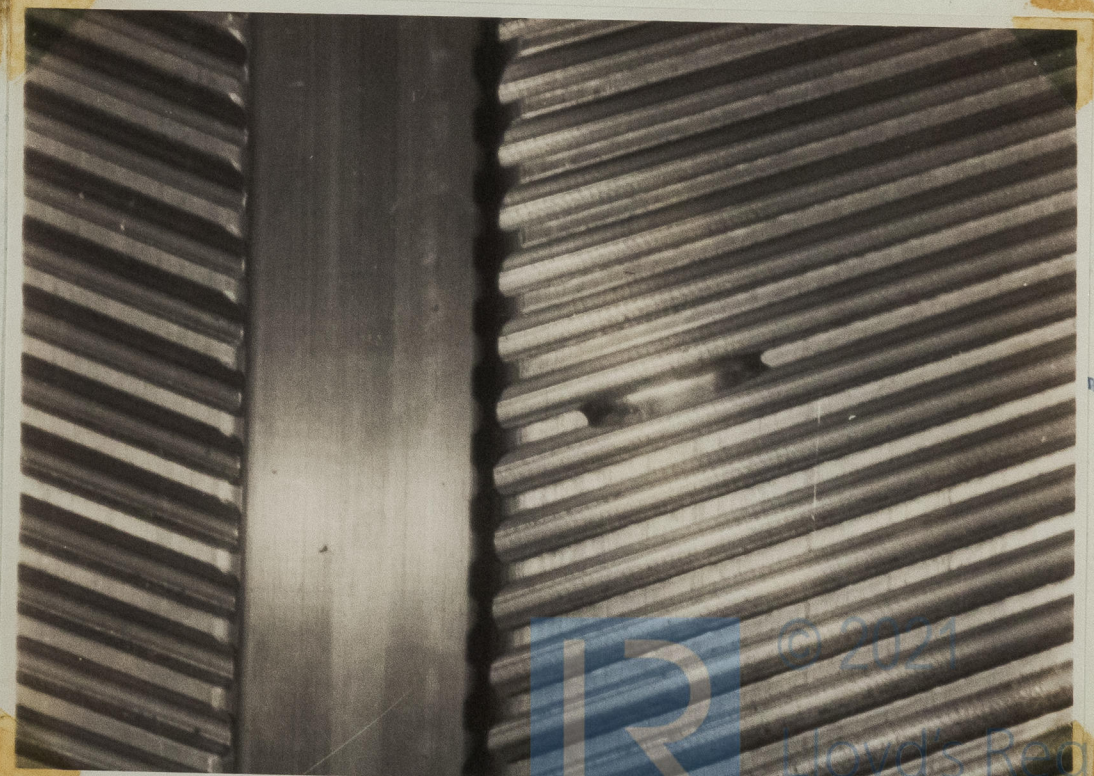
H.P. 1st Wheel Aft Helix after Repaired (Grinding)

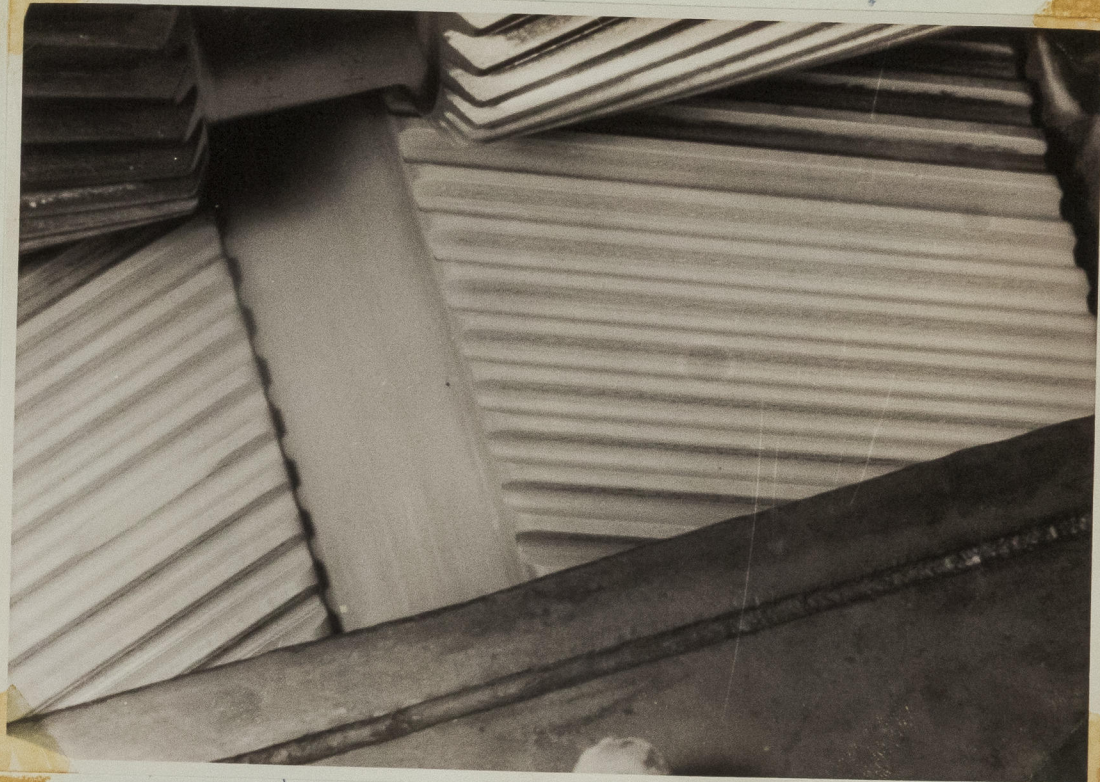
H.P. 1st Wheel Fore Helix Dyecheck Inspection after Repaired

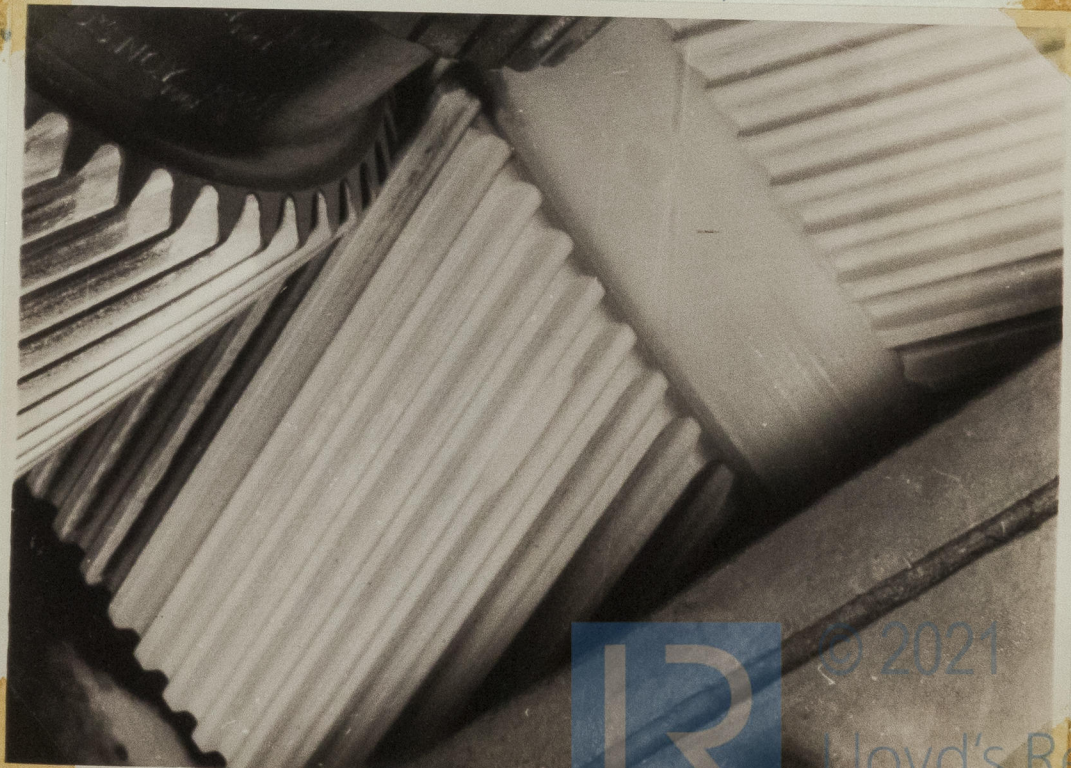
H.P. 1st Wheel aft Helix Dyecheck Inspection after Repaired

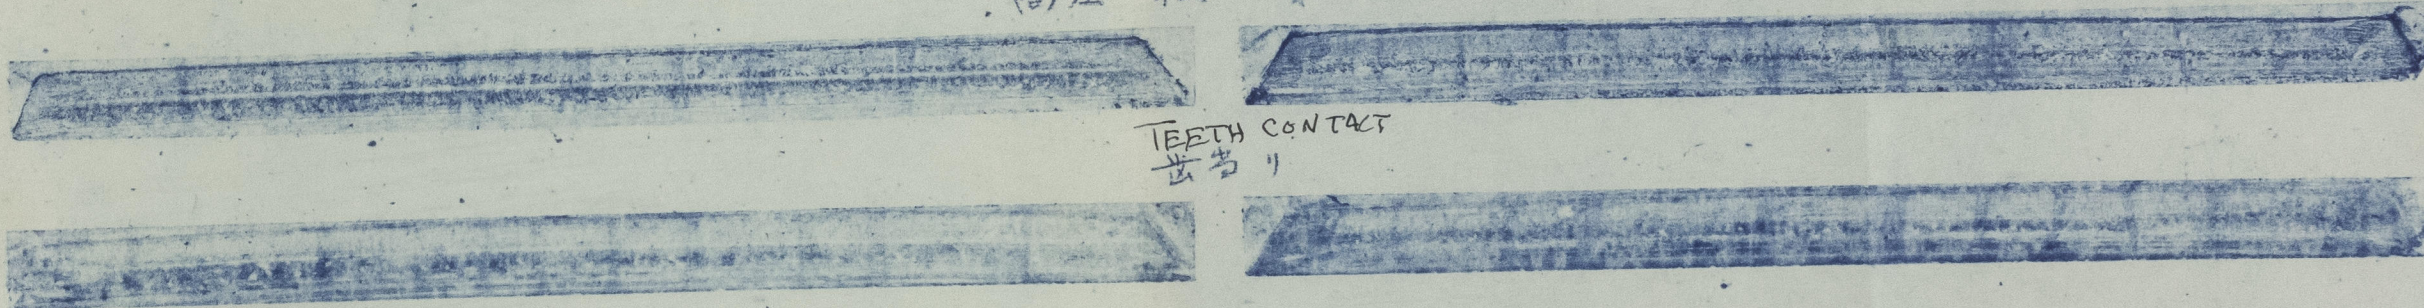
HP 1st PINION
高圧一段 $\angle = \alpha$

TEETH CONTACT
歯当り

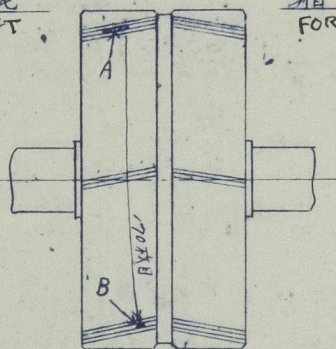
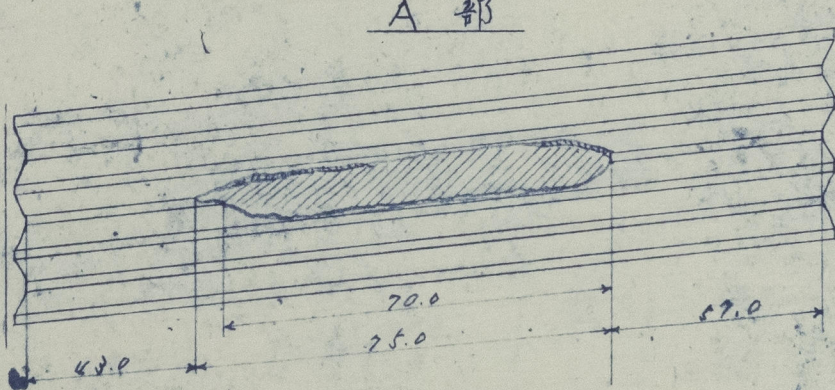
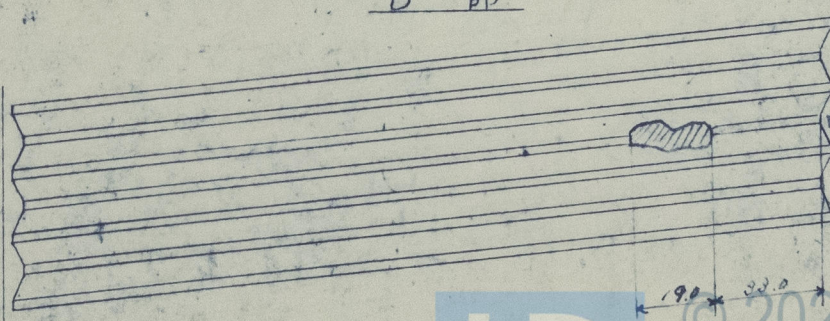
(手入前)
BEFORE REPAIR艀
AFT艀
FORE

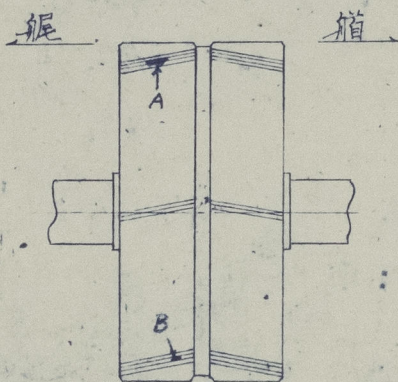
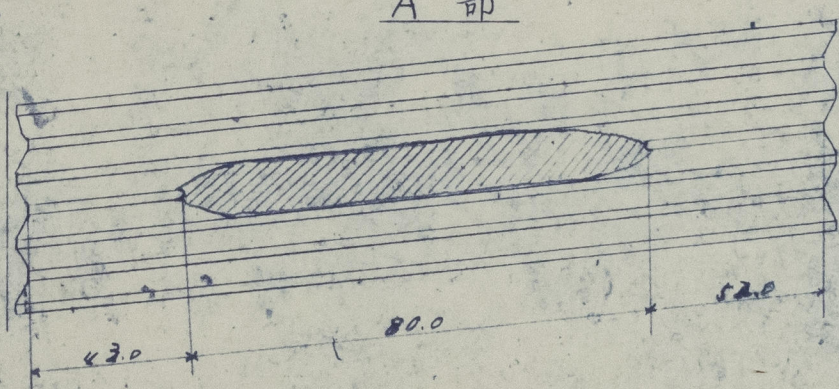
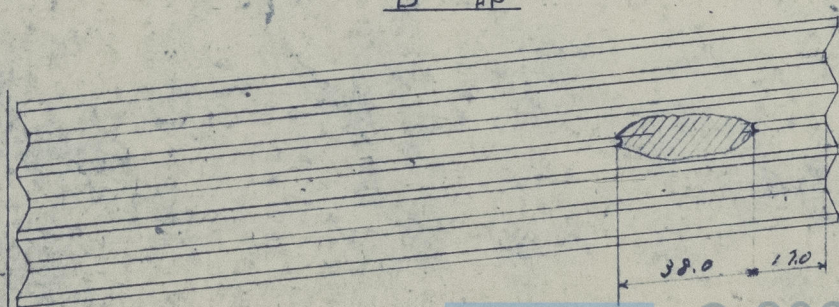
(手入後)
AFTER REPAIR
