T.S.M.V. "DIRECTOR MADARIAGA"

PARTICULARES OF DEFECTS & REPAIRS, ETC. (Damage repairs should be detailed separate from wear and tear repairs; state what action has been taken regarding items which are subjects of class)

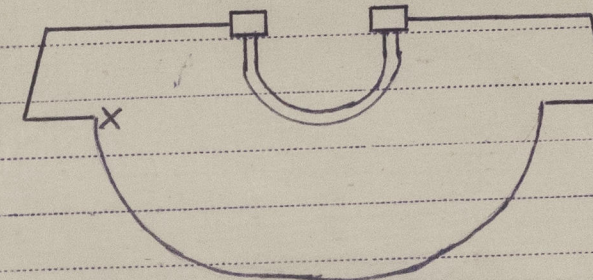
Two other fractures noted in this engine and positioned as in sketch, in way of Nos. 3 and 5 main bearings, port side.

"Further fractures" Port Main Engine On welded attachment of stiffener on inner face of column in way of N<sup>o</sup> 2 main bearing port and starboard, and in way of N<sup>o</sup> 5 main bearing starboard side only.

Starboard Main Engine As above in way of N<sup>o</sup> 2 main bearing starboard side. (Please see follower).

Now done:- The above "Further fractures" satisfactorily veed out and welded.

Subject to fractures in port and starboard main engine bedplates being re-examined before the end of 11,59 (12 months).-

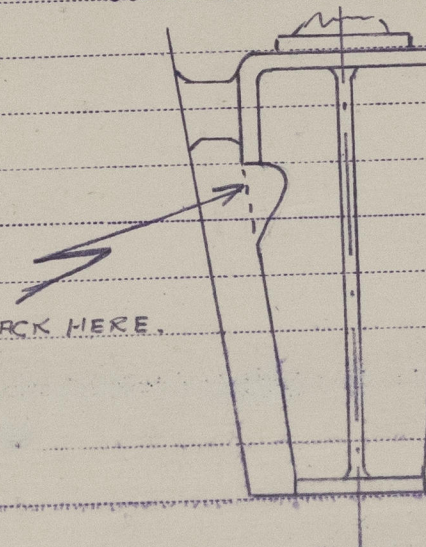
On the turbo blower supports for port and starboard engines it was seen that fractures had developed in the same place in all four supports and with the view of correcting this trouble the supports have been cut away, in way of fractures, as shown in sketch

SUPPORTS CUT BACK HERE.
