# Report of Survey for Repairs, &c., of Engines and Boilers.

Date of writing Report 22 juillet 1929 When handed in at Local Office 20-7 1929 Port of Brest  
No. in Reg. Book. 7450 Survey held at Brest Date, First Survey 11-7 Last Survey 19  
on the Machinery of the Wood, Iron or Steel Vapeur français Vendémiaire (No. of Visits)  
Gross 9117 Vessel built at Hambourg By whom Deutsche Werft AG When 1929 6  
Net 6732 Engines made at " By whom Portig When 1929  
Nominal Horse Power 545 Boilers, when made (Main) 1929 (Donkey)  
No. of Main Boilers 3 Owners Cie Nationale de Navigation Owners' Address 15 Rue Buciart Paris 8<sup>me</sup>  
No. of Donkey Boilers 2 Managers " (if not already recorded in Appendix to Register Book).  
Steam Pressure in Main Boilers 200 lb Port Rouen Voyage Gibraltar  
in Donkey Boilers " If Surveyed Afloat or in Dry Dock Afloat  
(State name of Dock.)

Some engine repairs effected.

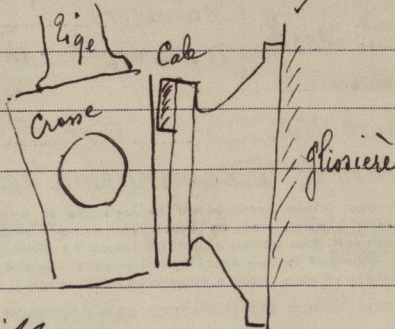
J'ai procédé, personnellement, à la vérification du parallélisme des fûts de piston et des glissières H.P. et ai trouvé des différences atteignant 0, <sup>mm</sup> 9 sur un mètre de longueur. La rectification fut faite en ajoutant, entre les cranes et la prothèse, des lames de laiton, comme indiqué par le croquis ci

Contre, opération acceptable seulement en cas

urgence.
