Survey held at PALERMO

REPORT OF SHIP SURVEYS AND REPAIRS

CONCA D'ORO

EXAMINATION AND REPAIRS AS PER RULE FOR DOCKING & TEMPORARY REPAIRS

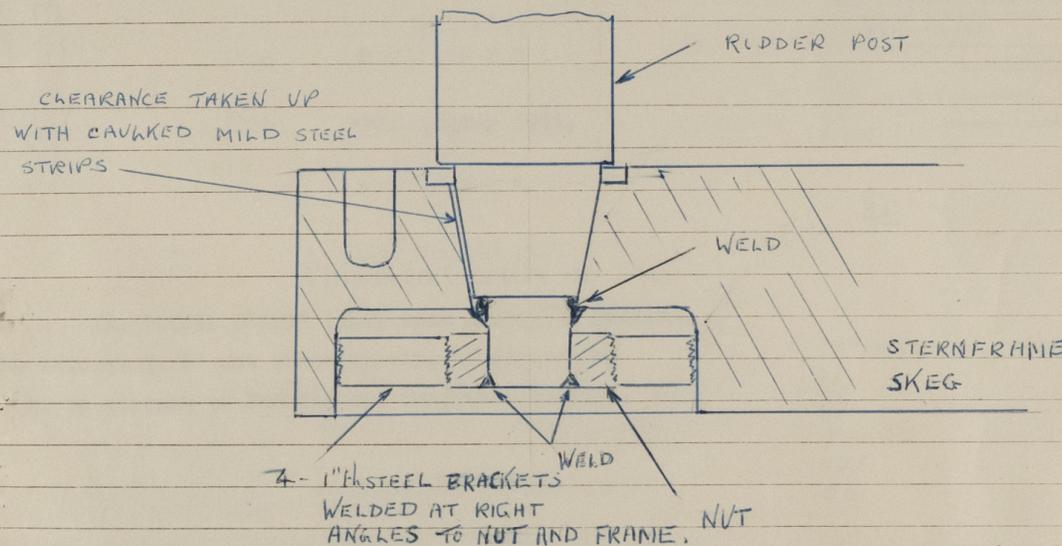
Upon examination the lower cone end of the rudder post, found slack in its socket in the skeg of the sternframe, approx' 6 m/m. The rudder post and nut, used to tighten the sternpost cone in its socket, found badly worn in way of the screwthreads.

The rudder post found fractured, port & starboard, immediately below the rectangular coupling at the top of the post at a point where the upper part of the forging narrows into the cylindrical part, in a sharp radius. The extent of the fractures was found by cutting the metal, in way, in a groove, and checking with magnaflux, until all traces of the fractures had disappeared. Each fracture was found to be approximately 300 m/m. in length and 15 m/m deep.

Rudder and post removed. Fractures in way of upper part veed and welded. Rudder and post replaced and wasted space between cone and socket caulked with mild steel strips.

Bottom and post then fillet-welded to skeg. Four brackets welded at right angles between screwed part of post and skeg.

Temporary repairs (continued):-
