Ship's Name SS/XX "OTAKOU"

Port DUNEDIN N.Z. Rpt. No. 6655

I have surveyed the above ship in accordance with the Rules for Docking; Special Survey and repairs.

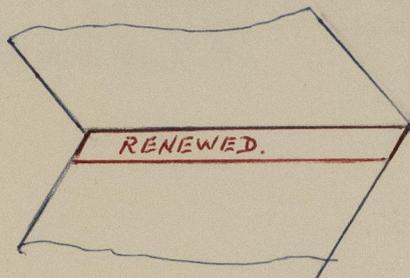
LADDER WELL:- Plate immediately under breakwater cropped back
and renewed on under side of knuckle full width x 15".

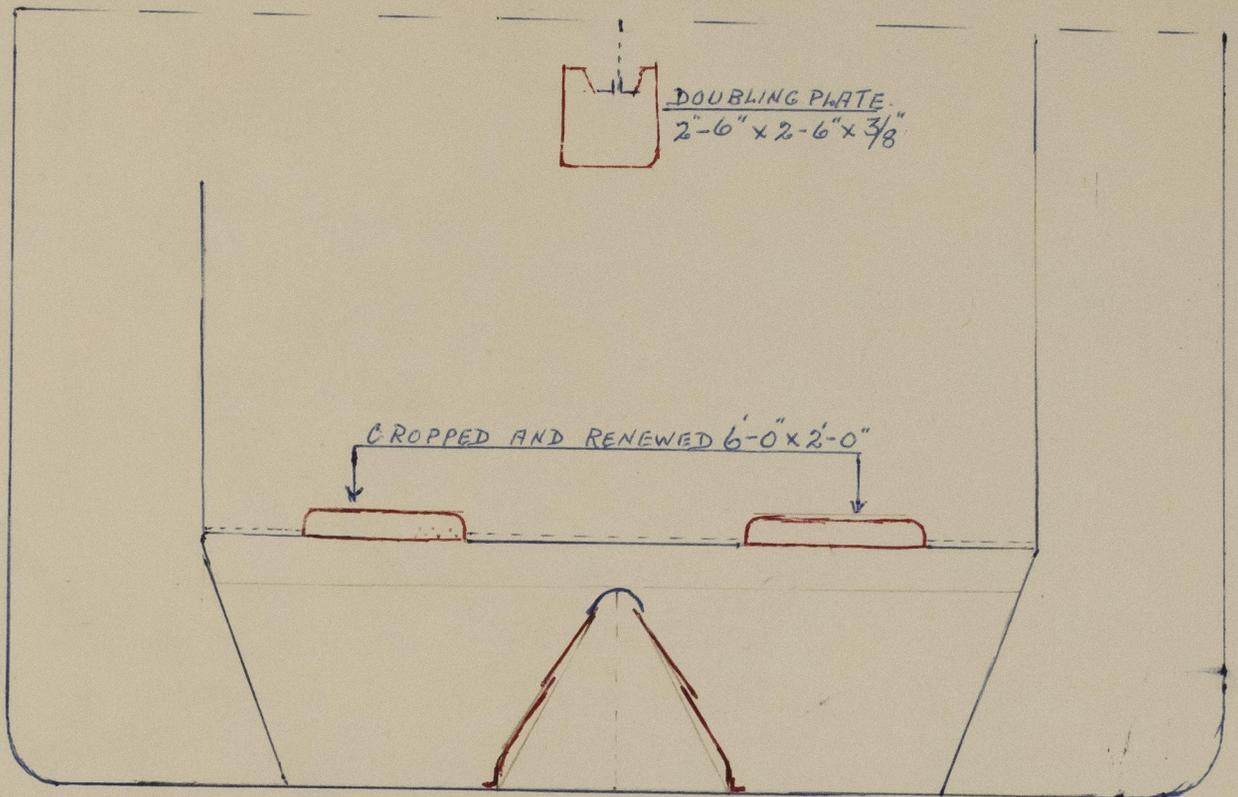
Oil fuel bunker Bulkhead at frame No 46:- Section of plating and lap thinned (again by dredging spoil) on both port and Stbd sides in mid position section on each side approximately 6'-0"x2'-0" cropped out and renewed. (See attached sketch) Fitted and welded a doubling plate 3'-0"x3'-0"x7/16" at centre line and immediately below the Hopper beam and on oil fuel bunker bulkhead.

Looking on aft bulkhead from within the hopper.
