REPORT of SURVEY for REPAIRS, &c.

Date of writing Report 29/5/25 When handed in at Local Office 29 May 1925 Port of Lisbon
 No. in Reg. Book. 2816 Survey held at Lisbon Date, First Survey 19th Nov 1924 Last Survey 29/5/1925
 on the Wood, Iron or Steel SSR "AMARANTE" Master -

AIRS, OR EXAMINATION AS PER RULE, FOR CONDITION SURVEY WITH A VIEW TO CLASSIFICATION IN LLOYD'S
in accordance with instructions contained in your letter M 16/4/25 pointing the fact
Lisbon in order to join the Lisbon survey in the survey of the above vessel with
view to her being classed with Lloyd's Register. Mr L.R. Gunner joined me
this morning and we report her with the condition of the vessel as far as could
be ascertained with vessel afloat.

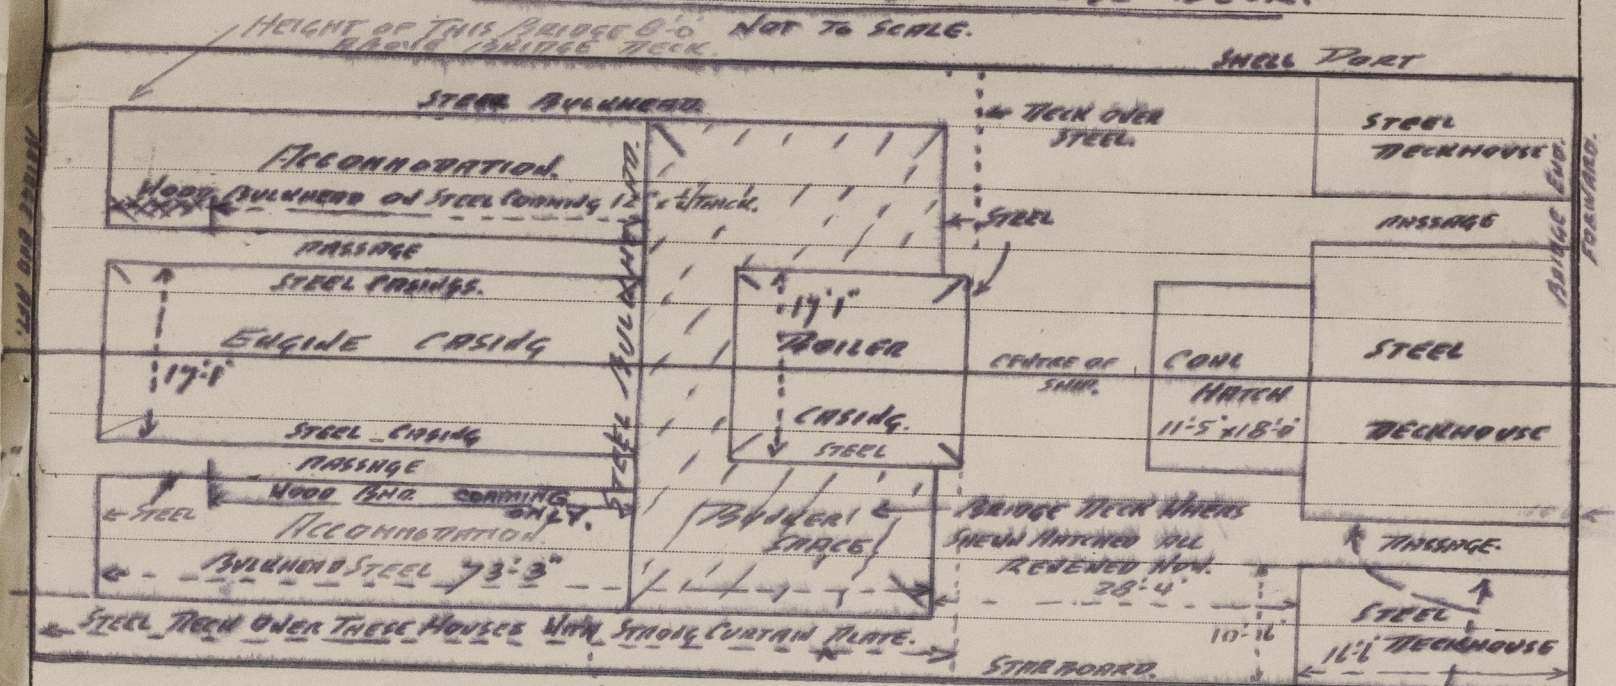
ROUGH SKETCH OF BRIDGE DECK.

provisions (agreed to) with regard to Doubling of Strake of Bridge Deck plating alongside casings this involves cutting up all the bridge chains and the owners prefer doubling either the bridge deck stringer plate or 1st strake (inner) below upper deck interstrake. As the plan submitted of bridge deck does ^{not} indicate the extent of erections we show here with a rough sketch the bridge deck.

STEEL BULKHEAD 2 1/2\"/>

IN VIEW OF THESE STEEL BULKHEADS BEING FITTED AND STEEL DECK OVER WE SUGGEST THAT THEY WOULD ASSIST IN RESISTING LONGITUDINAL STRAINS AND THAT THE QUESTION OF DOUBLING STRAKE OF BRIDGE DECK PLATING MIGHT BE RE CONSIDERED AS THE OWNERS TOOK EXCEPTION TO THIS AS BEING UNNECESSARY. NO SIGNS OF STRAINING WAS OBSERVED BY US AT THIS PORT ALTHOUGH VESSEL HAS BEEN IN COMMISSION SINCE 1914.
