Lloyd's Register of Shipping.

Port GDYNIA

4th June 1948.

the undersigned Surveyor to this Society did at the request of
Główny Urząd Morski, Szczecin, attend on board the Steel Screw Tugboat/Icebreaker
"SWAROZYK" 712 tons gross of Szczecin on the 3rd June for the purpose of
ascertaining the nature and extent of the damage cause not stated.
Upon examination

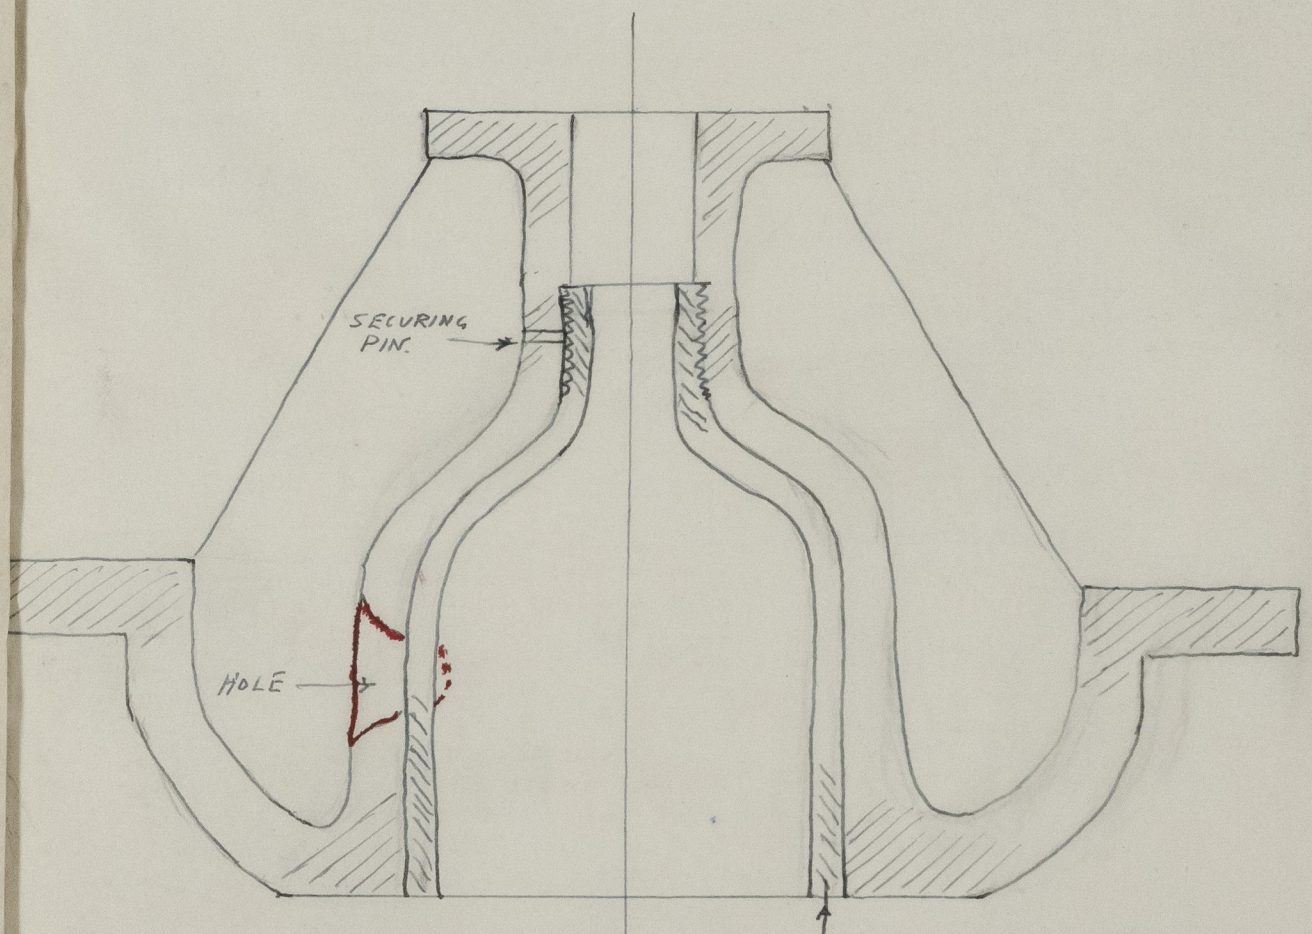
Forward high pressure cylinder.
Cylinder cover broken and holed in
clearance recess for piston rod end.
Hole approximately 4" x 2".
Piston rod end and nut badly hammered.

No docking facilities being available at Stettin it is further recommended that a temporary repair be effected to the broken cylinder cover by machining the piston rod nut clearance recess and fitting a hat sectioned mild steel patch (see sketch) which will enable the vessel to operate pending receipt of a new cover. Vessel to proceed to dry dock for the examination of screw shaft and oil gland.

COVER TO BE MACHINED AND
HAT SECTIONED PATCH SCREWED
HOME.
