BOILER EXPLOSIONS ACTS, 1882 and 1890  
REPORT OF PRELIMINARY INQUIRY  
(No. 3340)

Explosion from a Port Main Boiler on board the  
s.s. "BURMOUNT," O.N. 172789

Ministry of Transport,  
Marine Surveyors' Office,  
35, Seething Lane,  
London, E.C.3.  
9th August, 1949

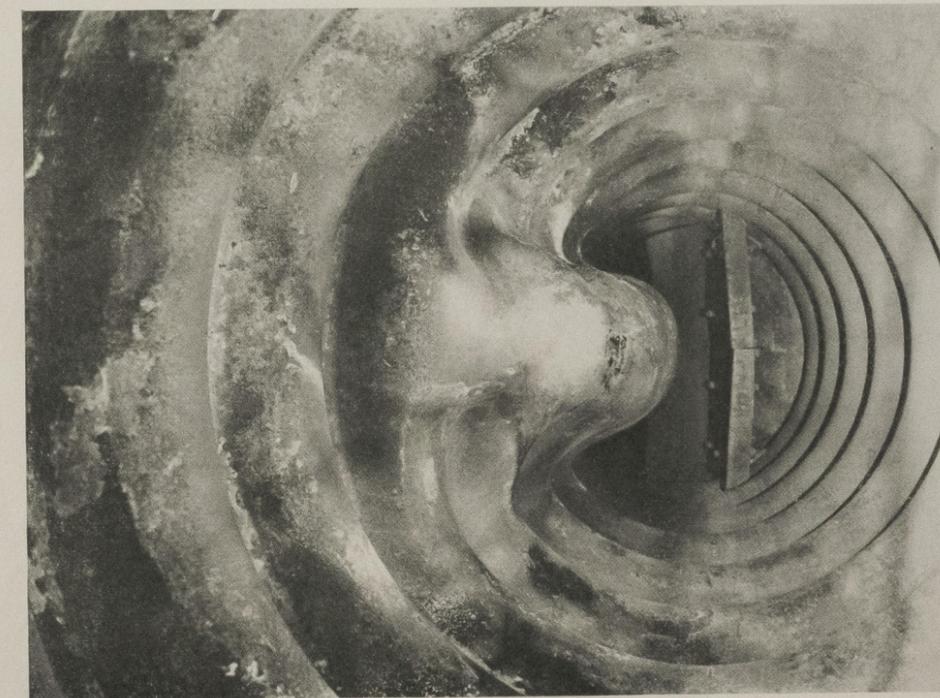
PLATE I.

6 inches; the port furnace ruptured at a point 2 feet 6 inches from the back end where distortion had reached a depth of 21 inches. The rupture was 1 foot 3 inches long measured circumferentially, and opened to a maximum breadth of 1½ inches. The contents of the boiler escaped, the greater part into the uptakes, little damage being done to the front of the boiler; no one was injured.

The crown of the starboard furnace collapsed to a maximum depth of 18¾ inches, but did not rupture. Plate I shows the damage to the port furnace, and Plate III shows the general arrangement of the boiler and details of the failures.

The explosion was due to the boiler becoming short of water while normal firing was continued, with the result that the port and starboard wing furnace crowns became over-heated and distorted. The port furnace eventually failed, as described.

PORT FURNACE.

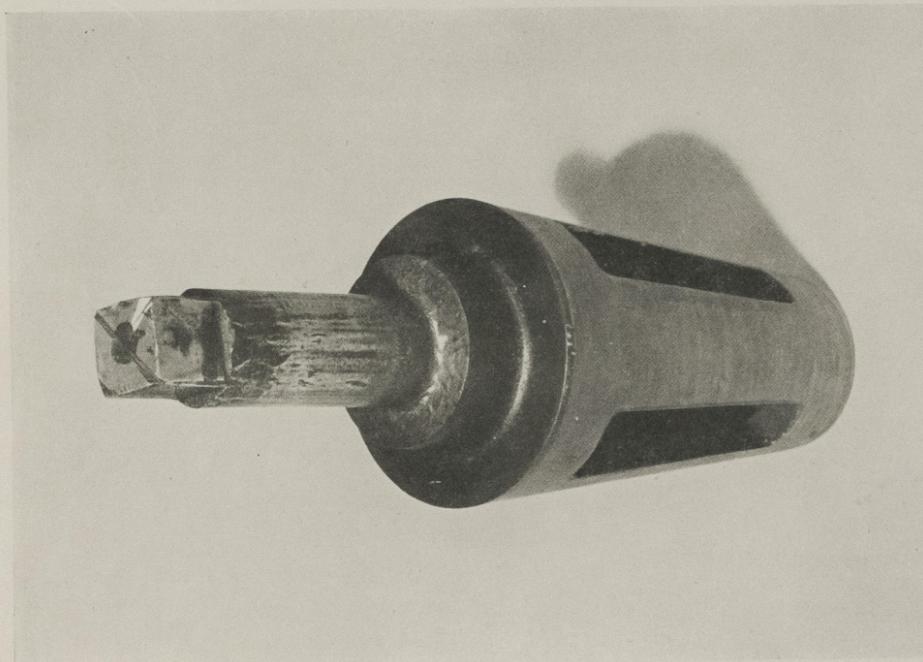
PLATE II.

DETAIL OF MARKING ON BREAST COCK PLUG ON STEAM END.

On visiting the vessel I found that both furnaces had been damaged as shown on Plate III, and on inspecting the water gauge that the steam cock had been left in the closed position although the marking on the cock was such as would lead one to believe that the cock was in an open position. From the appearance of the top of the square on the plug, it was obvious that an additional mark had recently been made, but I was unable to ascertain who had made it. Plate II shows the marking as it was found.

gauge steam cock, to indicate the position of the ports in the plug, had been added to during the overhaul of the boiler, by some person unknown. The cock had thereby the appearance of being open when, in fact, it was closed.

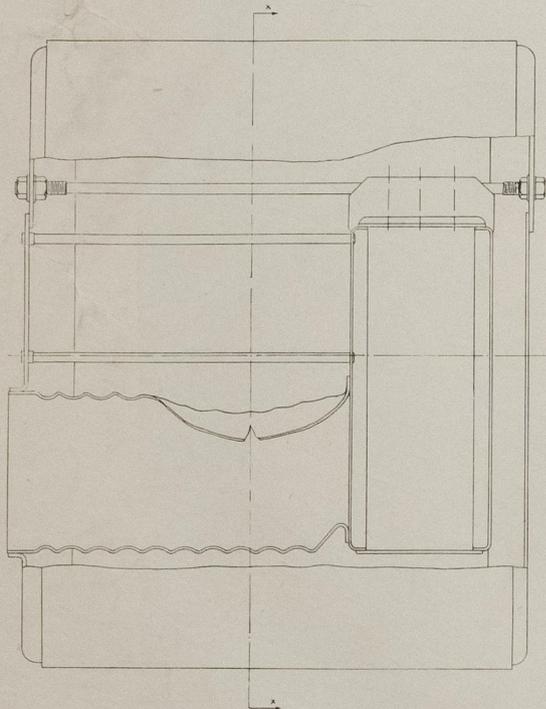
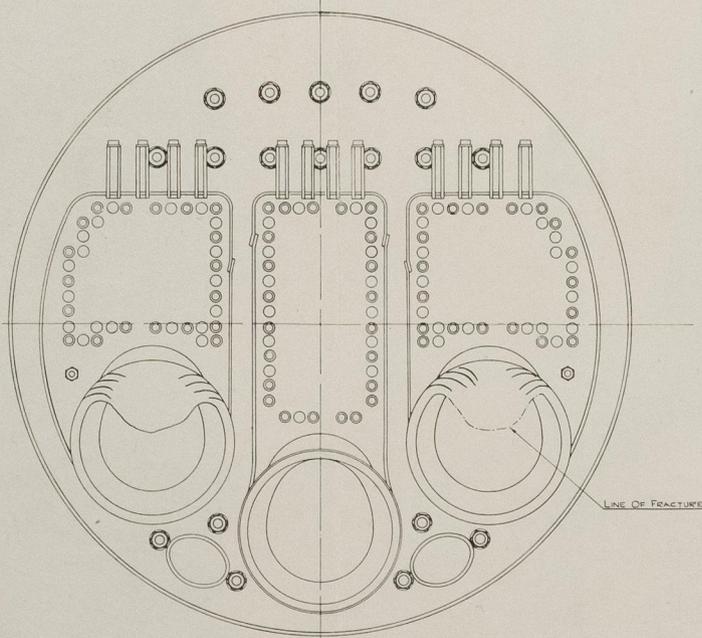
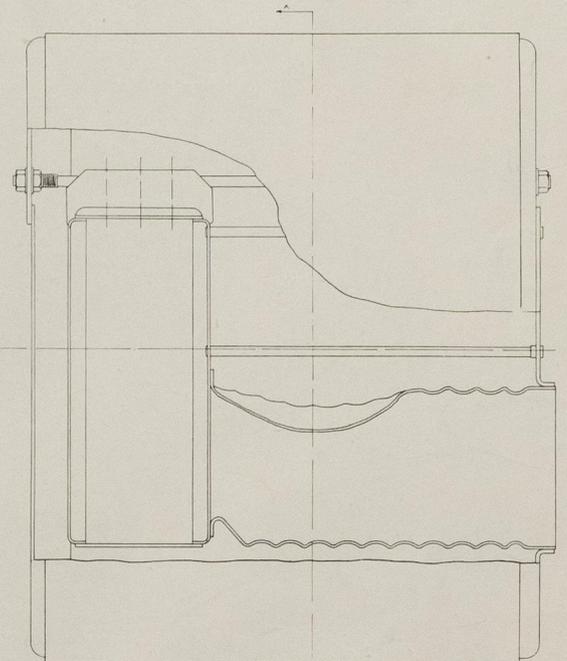
PLATE III.

SECTION THREE PORT FURNACE

SECTION ON X-X
