# Report of Survey for Repairs, &c., of Engines and Boilers.

82019. on the Machinery of the Wood, Iron & Steel Motorship "PUKEKO"

Particulars of Examination and Repairs (if any) DOCKING SURVEY (Annual). New Oil Engine Machinery

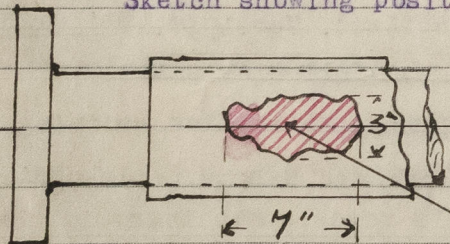
DRY DOCK. Tail shafts drawn, New propellers fitted, stern glands and bushes overhauled, all sea connections and discharges overhauled and put in order, 2. new cylr. circulating water cocks fitted, gratings fitted and all existing gratings and fastenings overhauled and put in order. Star Tail shaft repaired in way of liner, defective and non homogenous metal removed for an area of 7" X 3" by 1/4" average thickness and new metal fused and metal made solid where working in the packing gland and found defective, Rps. E.W. process.

Sketch showing position of defective metal. Made solid by fusion.

Note: The liner when examined was found to be continuous in Two sections, No indication that the junctions of the separate pieces had been made by fusion through the whole thickness of the Liner.
