S.S. "WILLOWBANK".

Inspection of original Propeller and Tail Shaft now removed from the vessel.

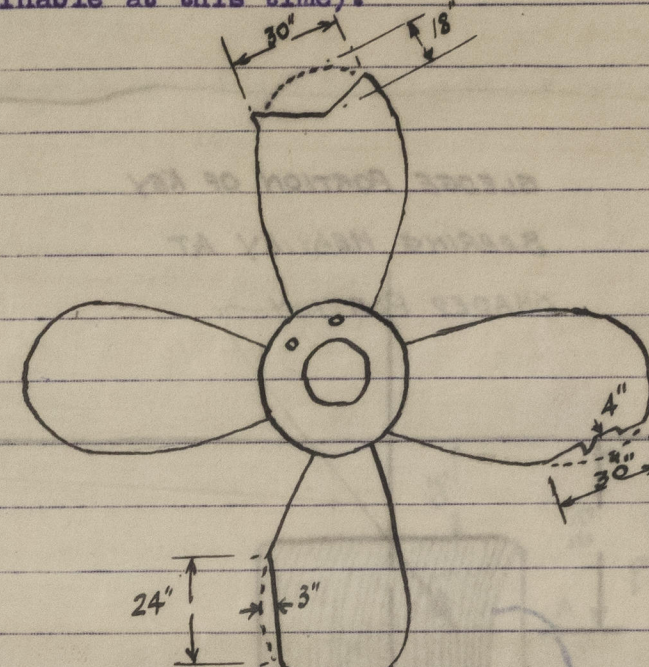
The 4 bladed Bronze propeller found damaged at 3 tips as shown on sketch below - (cause not ascertainable at this time).

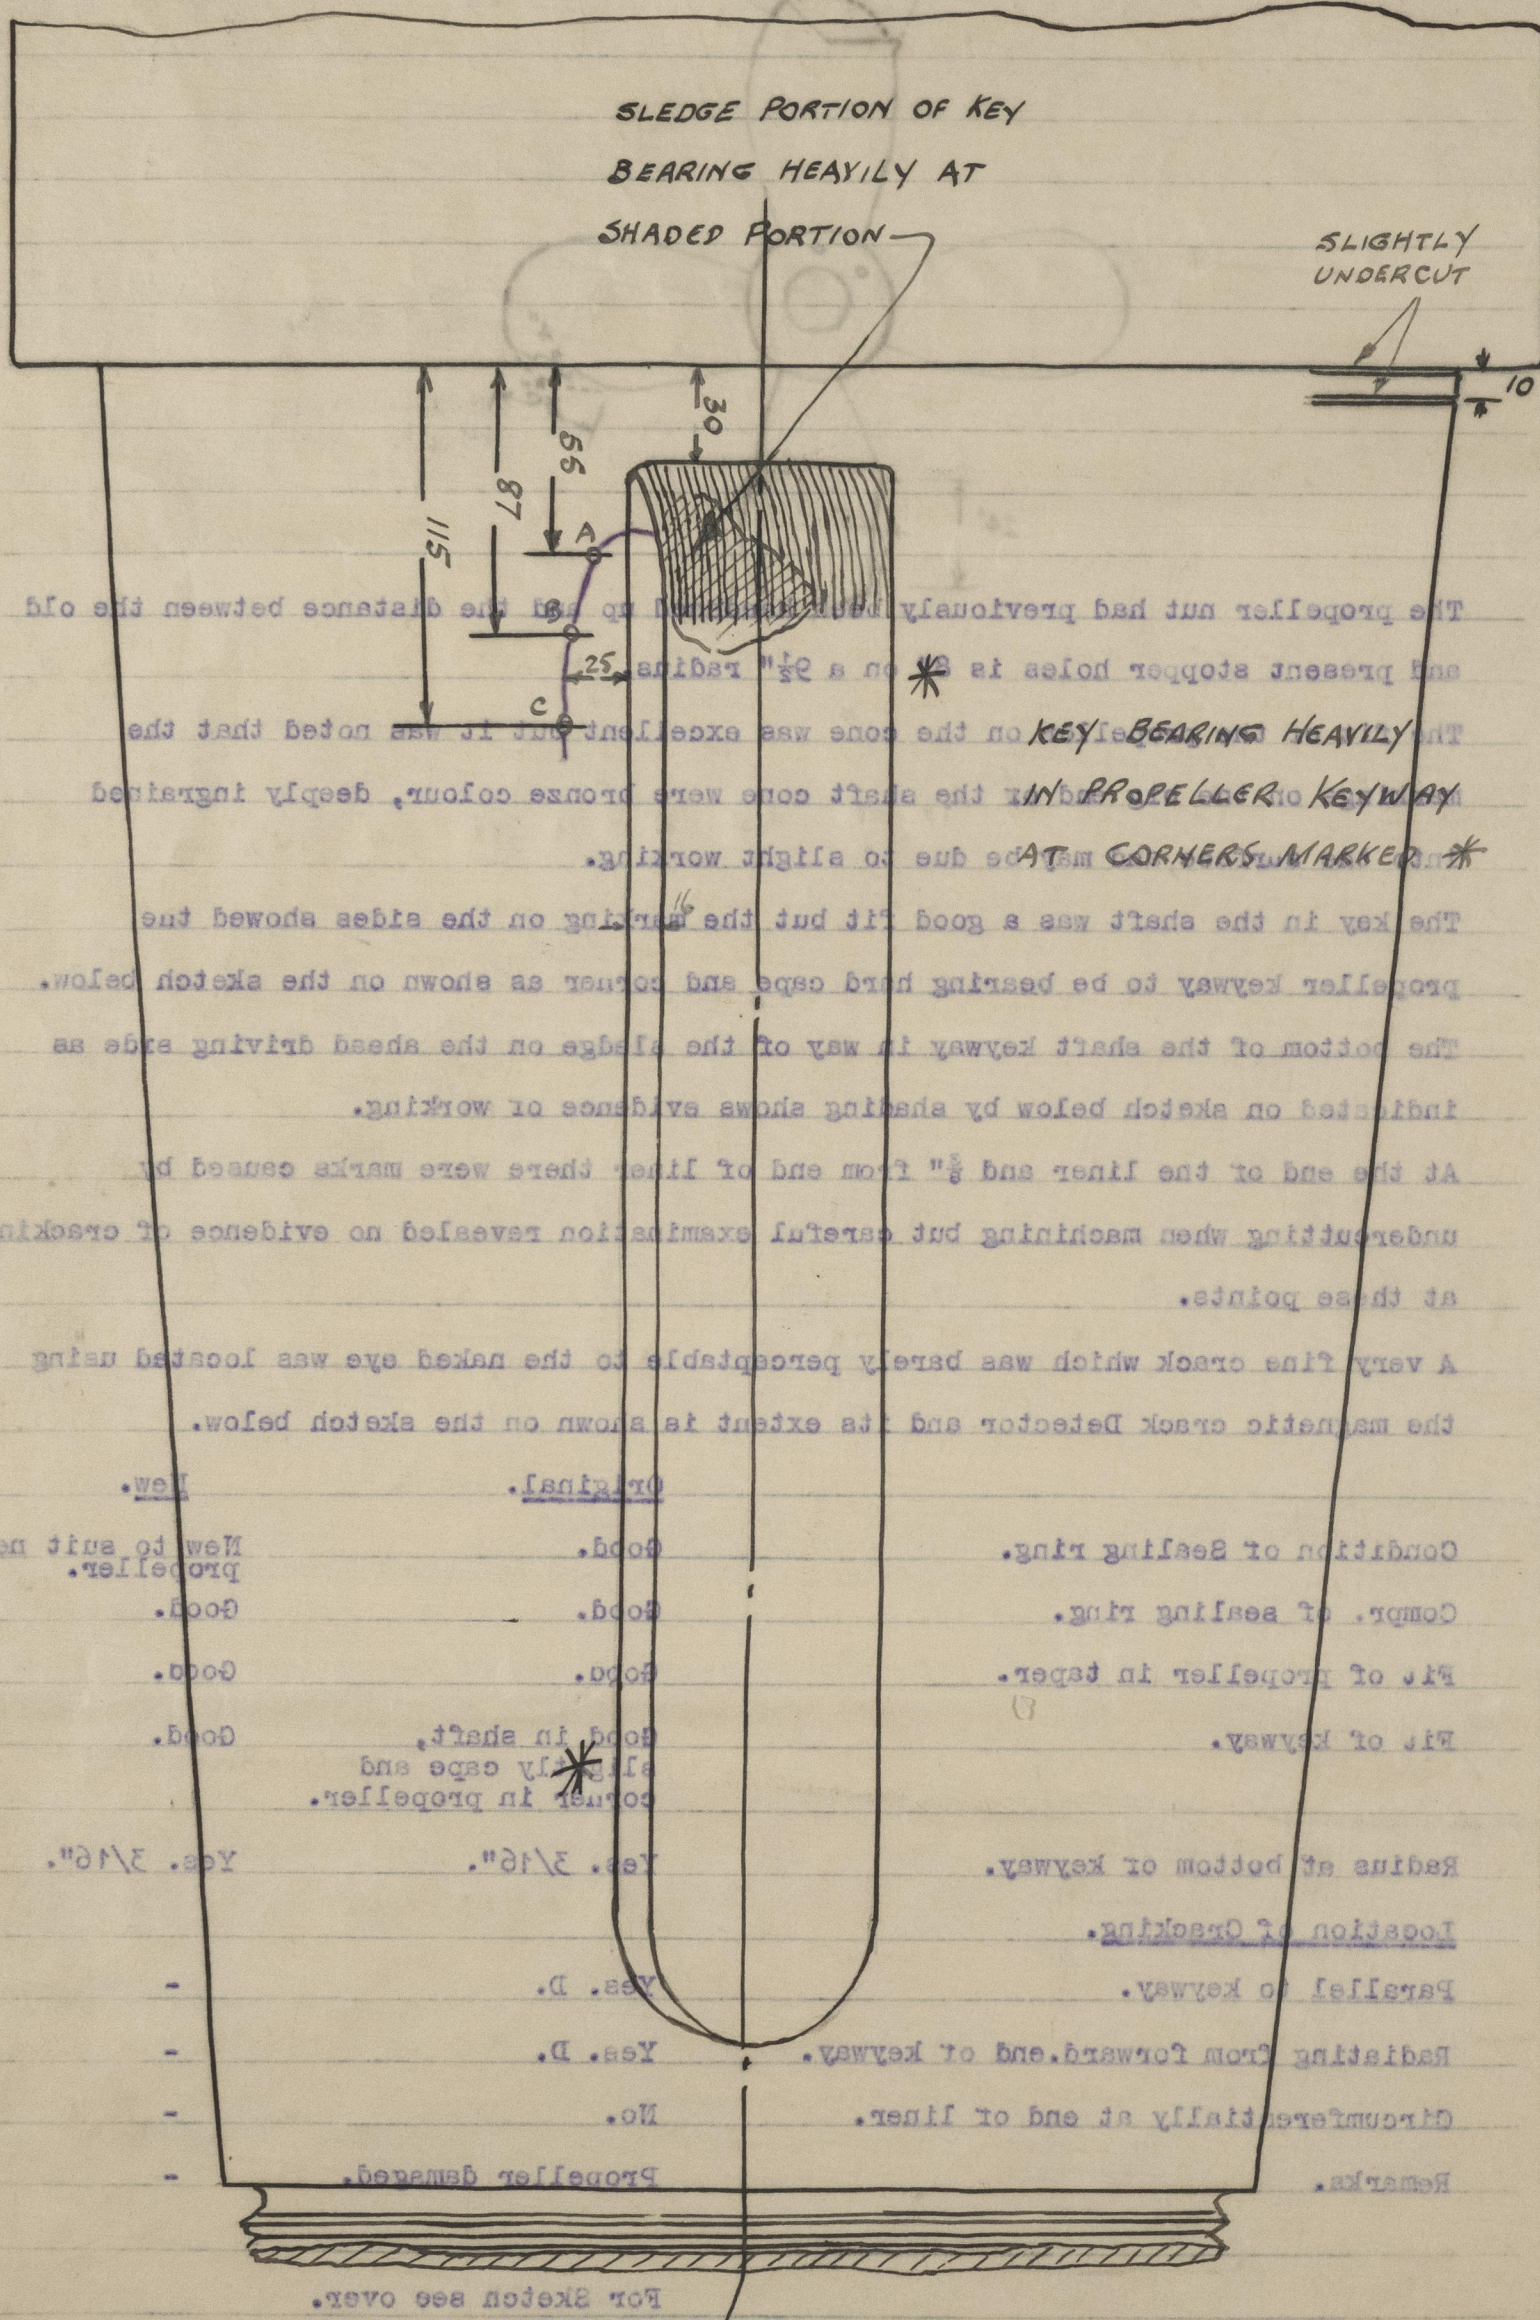
The key in the shaft was a good fit but the marking on the sides showed the propeller keyway to be bearing hard cape and corner as shown on the sketch below.

The bottom of the shaft keyway in way of the sledge on the ahead driving side as indicated on sketch below by shading shows evidence of working.

A very fine crack, which was barely perceptible to the naked eye, was located using the magnetic crack Detector and its extent is shown on the sketch below.

DRILLING 'A' - $\frac{1}{8}$ " CRACK NOT VISIBLE HAVING RUN TOWARDS KEYWAY.
 " 'B' - $\frac{5}{8}$ " CRACK VISIBLE FULL DEPTH.
 " 'C' - $\frac{3}{8}$ "
