Ship's Name ~~SS~~ "SAN FRANCESCO" LR 540847 Gross tons 3617
Is there a rpt. 9? Yes. Port Piraeus Rpt. No. 11424
No. of visits 4 First date 4.1.65 Last date 6.1.65
Interim Cert. issued & copy herewith? Yes. Damage rpt. issued & copy herewith? No. Last rpt. (H.Q. only) Ven 1043
Date of completing rpt. 7.1.65 Surveyed at, if different from Port above Syra
Surveyed afloat and/or in D.D. Drydock Last date of examination in D.D. 6.1.65
Has a Load Line Survey been held? No. Freeboard Marks verified No.

I have surveyed the above ship in accordance with the Rules for Docking Survey and Conditions of class and wear and tear repairs.

Rpt. 8 (P.S.) DRY CARGO SHIP

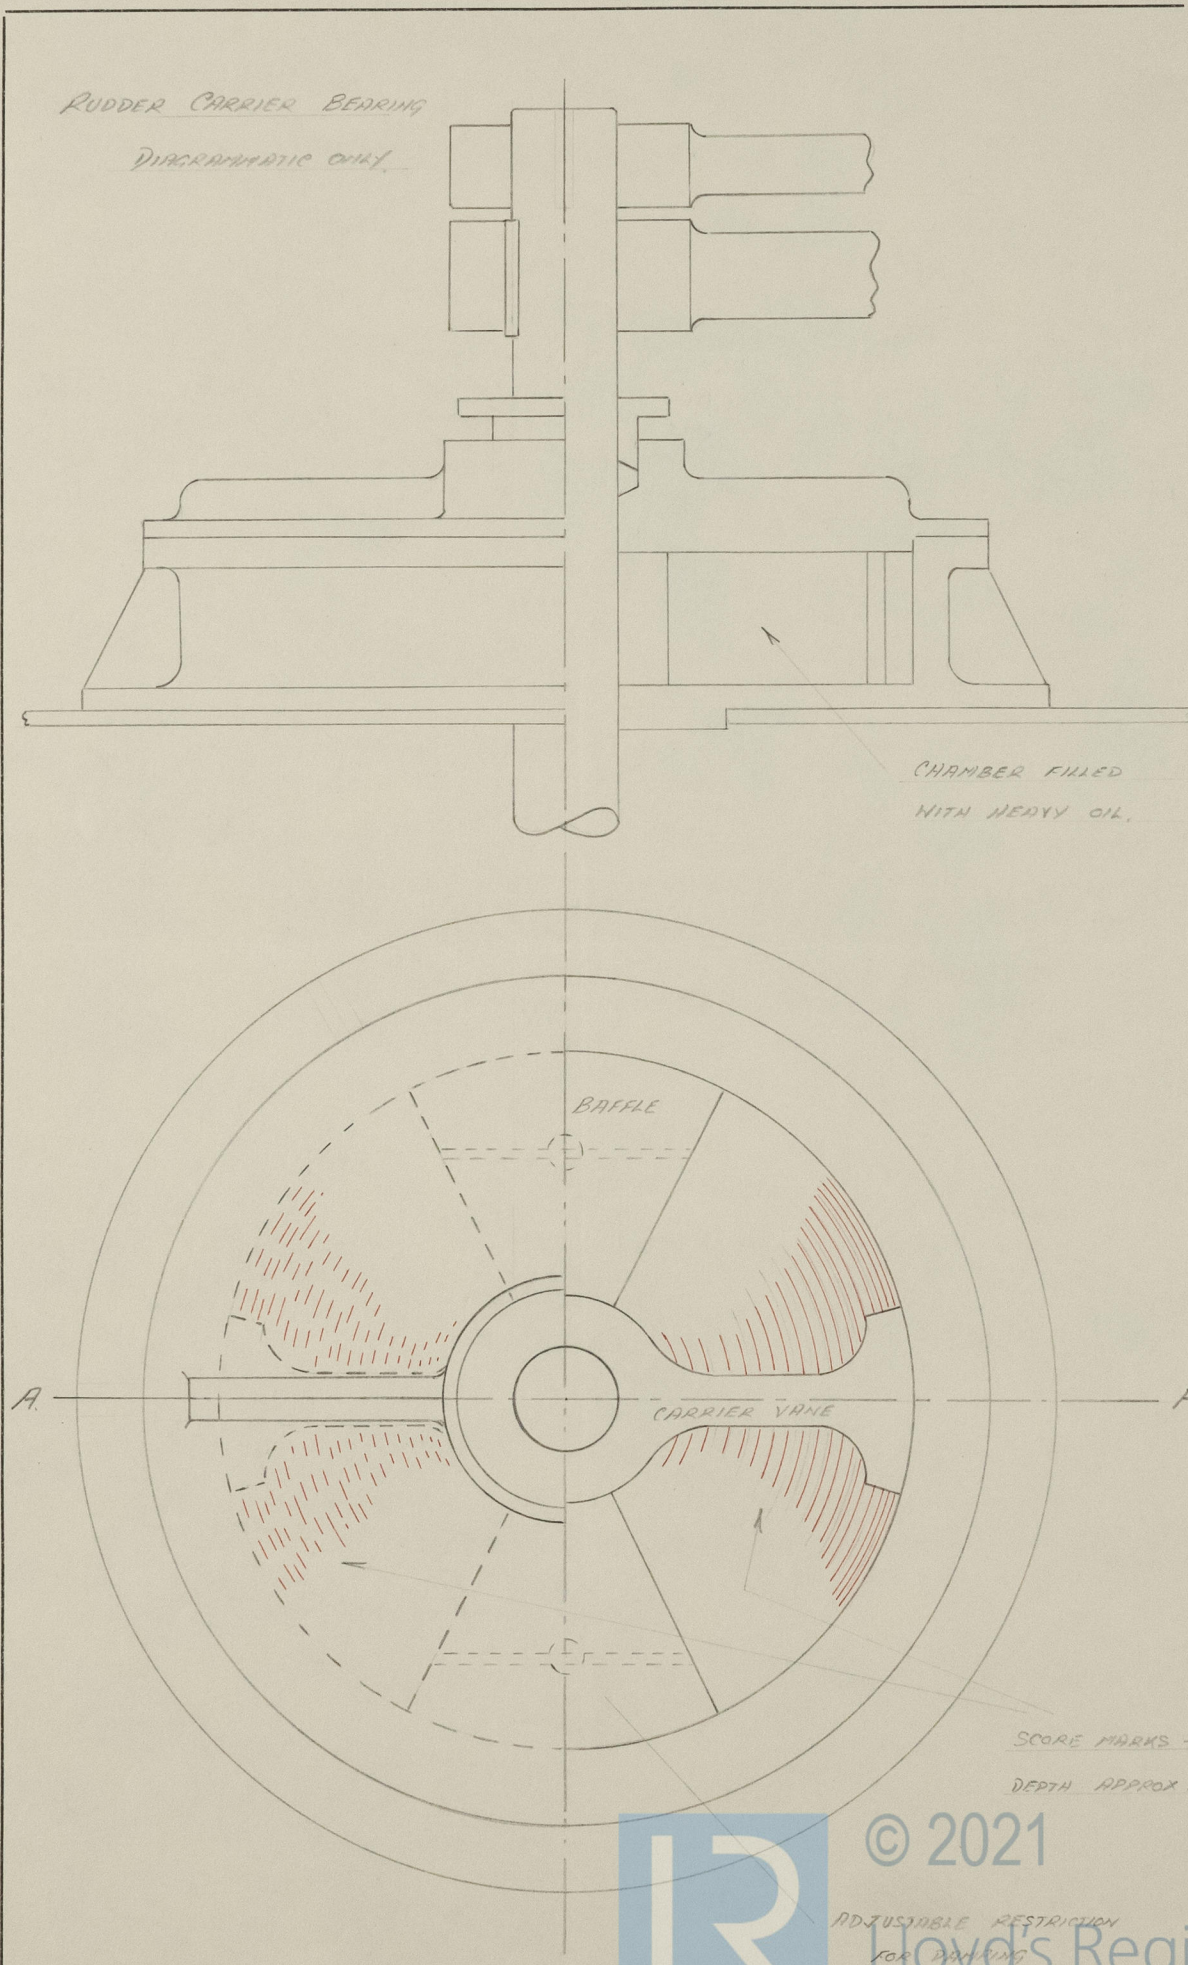
Now done: No details are held concerning this item and on dismantling the bearing, the only defect which could be found was a fairly pronounced scoring of the axial bearing surfaces, as shown in the attached sketch. The amount by which the rudderstock drops while in the midships or most worn portion has been measured as less than .5mm. This is considered to have little or no material effect on either the operation or serviceability of the steering gear and, since an estimated 6 days were required to dismantle this bearing for machining purposes, it was recommended that any repairs should be deferred until the next Special Survey. It is accordingly recommended that the entry in the SRL should be amended to read: "Rudder carrier bearing to be specially examined and dealt with as necessary by the next Special Survey".

I recommend that this ship remain as classed with ~~xxxx~~ fresh record of dry docking DS 1,65, subject to the rudder carrier bearing being specially examined and dealt with as necessary by the next Special Survey and to any other outstanding condition of class being dealt with as previously recommended, but without special condition in respect of set up bottom plate D4 (p.s.).
