REPORT OF SHIP SURVEYS AND REPAIRS

01595 on the ~~Iron~~ Steel S.S. "CARNIA" EX "ANKER"

EXAMINATION AND REPAIRS AS PER RULE FOR DRYDOCKING. (CHANGE OF OWNERSHIP AND FLAG.)

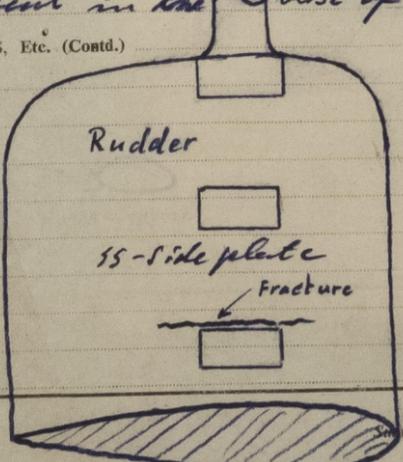
Found on examination in rudder side plate in SS a fracture about 16" long on top of the 3rd rudder arm (see sketch) which has been drilled off, weed out and electrically welded.
