Ship's Name SS/MX "AGHIOS NICOLAOS" Gross tons 757  
 LR 500504  
 Is there a rpt. 8? No. Port Piraeus Rpt. No. 11526  
 No. of visits 3 First date 27.2.65 Last date 2.3.65  
 Interim Cert. issued & copy herewith? Yes. Damage rpt. issued & copy herewith? No. Last rpt. (H.Q. only)  
 Date of completing rpt. 2.3.65 Surveyed at, if different from Port above -  
 Is a rpt. 9A attached? No. MN 126 Nature of survey Comm.MBS  
 Survey fees Comm.MBS £13.15. Damage fee - Expenses £ 3.12. 0  
 S.A. fee -

Ship's Name SS/~~MS~~ "AGHIOS NICOLAOS" LR 500504

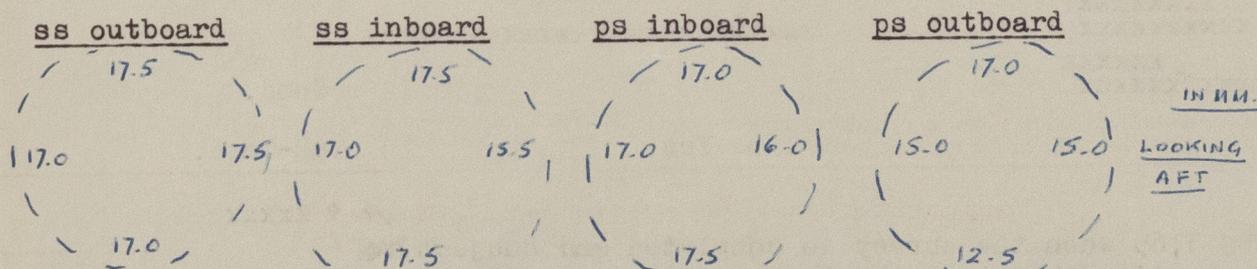
Back combustion chamber plate of port outboard furnace found somewhat distorted; no back stays were found fractured. Similarly in port inboard furnace, but in a lesser extent. In all four combustion chambers back plates were drilled in line with the furnace openings and measurements were as follows:

Also furnaces were drilled at lower side and all found about 12.5 mm thick.

From plans available original thickness of back plates is 17.5 mm and furnaces 12.5 mm.

Repairs were recommended in the port combustion chamber outboard by cropping and renewing the buckled & locally thinned portion of the back plate.

Owners requested deferment of this repair for three months and this was agreed subject to a condition being inserted against the ship's class stating "Combustion chamber back plate port outboard to be dealt with with by June, 1965 (3 months).
