REPORT OF SURVEY FOR REPAIRS, &c., OF ENGINES AND BOILERS

Date of writing Report 24. 3. 52. When handed in at Local Office 19. 3. 52. Port of HAMBURG.
 No in Reg. Book 19929 Survey held at KIEL Date First Survey 18. 3. 52. Last Survey 21. 3. 1952
 on the Machinery of the Wood, Iron or Steel M.V. "MORSKA WOLA" (No. of Visits 3)

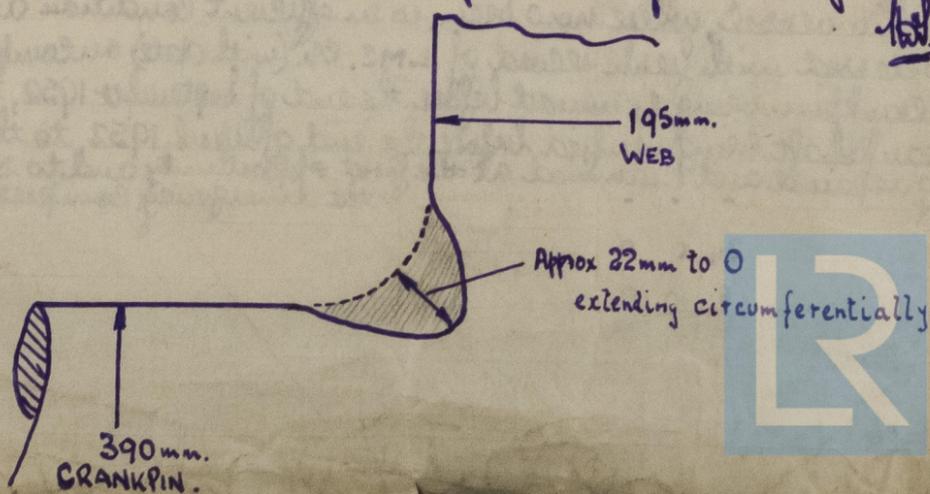
© 2021
approx 95 mm.

SPECIAL EXAMINATION. Examined: -
main engine nos. 5 and 6 crankpins and bearings,
nos. 6, 7 and 8 Crankshaft journals and bearings.
 The fillet at the after end of no 6 Crankpin had been ground out over a local area in order, it was stated, to remove a crack in the fillet. The position of this local area is at approximately 11 o'clock looking aft with the pin on bottom centre. The cavity formed is approximately 22 mm. deep and can be covered by a hand. It extends below the surface of the crankpin and the extremity of the cavity is well rounded into the original machined surfaces. The finish of the cavity is smooth and polished. The crankpin and web in and around this area has been etched with 2% nitric acid in acetone and found sound.

The forward fillet of the no 6 crankpin and the area around the oil hole was also etched and found sound.

The main engine is a Knupp type crosshead engine, 4 S.C.S.A., having a stroke of 1000 mm. The propeller is 4 bladed, solid and right hand. It is thought that the defect may have been caused by an uneven and excessive wear down of the crankshaft journal bearings.

It is recommended that no 6 crankpin be examined before the end of September 1952, being considered efficient meantime.

The design of the main engine crankshaft permits the shaft being turned end for end, the no 6 pin now in question becoming no 1.
