REPORT OF SURVEY FOR REPAIRS, &c.

70342 on the Wood, Iron or Steel Tmk Sc "CAPETOWN CASTLE" (No. of Visits 38)

PAIRS, OR EXAMINATION AS PER RULE, FOR Special Survey, damage repairs, and reconditioning

+ alterations to No. 1 double bottom tank top.

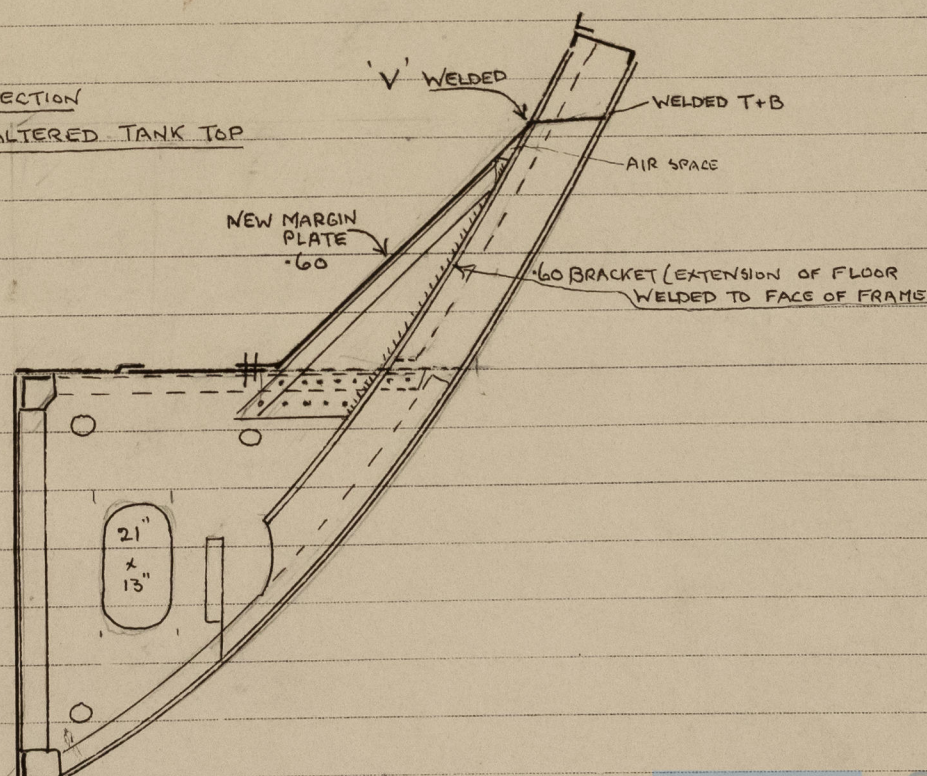
TYPICAL SECTION

Three main frames of this tank viz 106 F on port side + 104 F + 106 F on star side found fractured $\frac{1}{4}$ " below the horizontal margin plating now V'd out + welded. (Fractures ran across inboard flange + 3" into web of main frame.)

SHOWING ALTERED TANK TOP

On the Owner's initiative the following alterations effected in way of horizontal margin plating. The horizontal margin plating (port + star sides) dispensed with from collision bulkhead to fore end of No 1 bilge and new sloping margin plating fitted from collision bulkhead to fore end of bilge, the top of margin at collision bulkhead being taken up to 12'-6" approx above baseline + at the fore end of bilge to approx 10'. Each floor pos extended to suit by fitted brackets on top of floor.

To effect this repair it was found necessary to renew the forward middle line tank top plate and to dispense with the frame face brackets fitted in Jan '44. See New York Rpt No 44618.

The No 1 double bottom tank tested after repairs to rule pressure and found satisfactory. The alterations are similar to those shown on plan approved 28-8-46 for Messrs Harland + Wolff's Nos 1332-3 now building at Belfast.
