Report of Survey for Repairs, &c., of Engines and Boilers.

Date of writing Report *May 29th 1895* When handed in at Local Office *May 29th 1895* Port of *Aberdeen*
No. in Reg. Book. *50* Survey held at *Aberdeen* Date, First Survey *May 9th 1895* Last Survey *May 22 1895*
on the Machinery of the Wood, Iron or Steel *S.S. "James Hall"* Master *A. H. Donald*
Tonnage { Gross *360* Net *194* Vessel built at *Aberdeen* By whom *Hall Russell & Co* When *1870* - *4*
Registered Horse Power *65* Engines made at *"* When *1870* Boilers, when made (Main) *1892* (Donkey) *1892*
No. of Main Boilers *one* Owners *Aberdeen Lark & Moray* Port *Aberdeen* Voyage *Coast*
No. of Donkey Boilers *one* If Surveyed Afloat or in Dry Dock *Aberdeen & Co* Particulars of Classification (which must be inserted precisely as in Register Book & Supplements).
Steam Pressure in Main Boilers *70 lbs* in Donkey Boilers *70 lbs*

S. S. James Hall

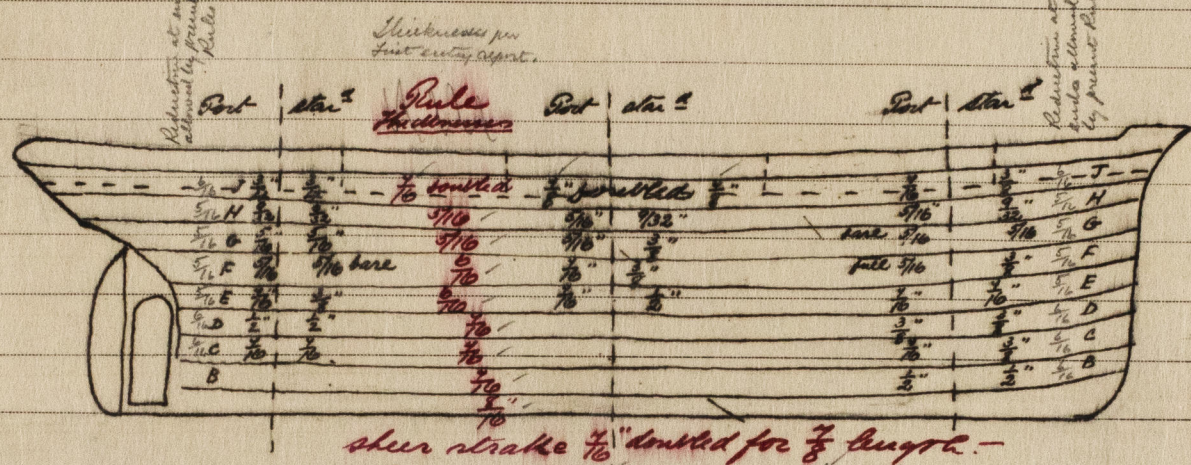
in three sections on each side of the ship & the thicknesses found to be as per sketch:-
