REPORT of SURVEY for REPAIRS, &c.

No. 310 Date of Writing Report 3rd Sept 1890 Port of Barrow Received in London Office. MON 8 SEPT 1890
 No. in Reg. Book. 99 Survey held at Barrow Date, First Survey 12th Aug (Last Survey 29th August 89)
 on the T. S. Daylight Master P. Morgan

S.S. "Daylight"

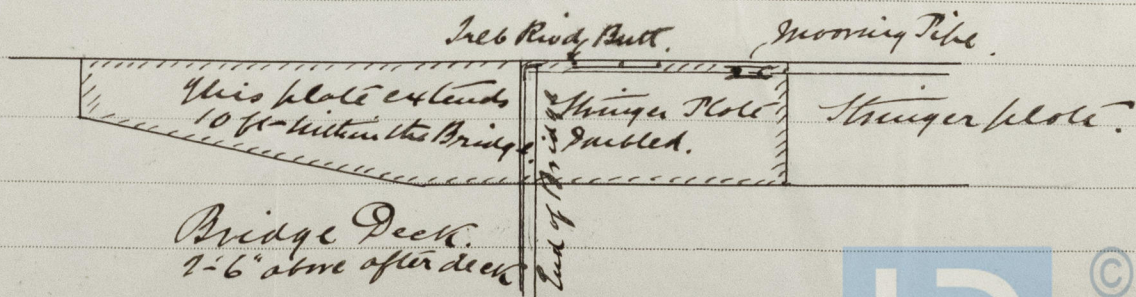
Sketch at after break of bridge.

The shell lugs at this stringer and in the frame rivetting between Band C the breast-hook has also been re-riveted and stiffened by angle bars an additional breast-hook has been fitted and a new beam put in, please see sketches. On examination of the alleged weakness in bridge side and bulwark plating, at after break of bridge, the rivetting in the after side of the butt stops and also six rivets in the gunwale bar each side, were found to have been renewed, see sketch in report showing arrangements at break of bridge.

It is further submitted that the weakness, said to have existed at the after break of bridge, in my opinion, has been of the most trifling nature. The Master states that on the vessel's second voyage to the Mediterranean, and after a heavy Atlantic voyage with a cargo of iron ore, a slight jar was observed in one or two of the butt and gunwale bar joints, and while other repairs were proceeding, it was deemed desirable to renew them as above.
