REPORT of SURVEY for REPAIRS, &c.

No. in Survey held at Cardiff Date, First Survey Oct 9th Last Survey Nov 3rd 1893
Reg. Book. NO on the Wood, Iron or Steel BR "John O'Connell" Master Davies

REPAIRS, OR EXAMINATION AS PER RULE, FOR part of S.P. No 3 (Second) & damage.
Damage stated to have been caused by grounding in the river "Shannon".

MS John O'Connell "CARDIFF" No 11994.

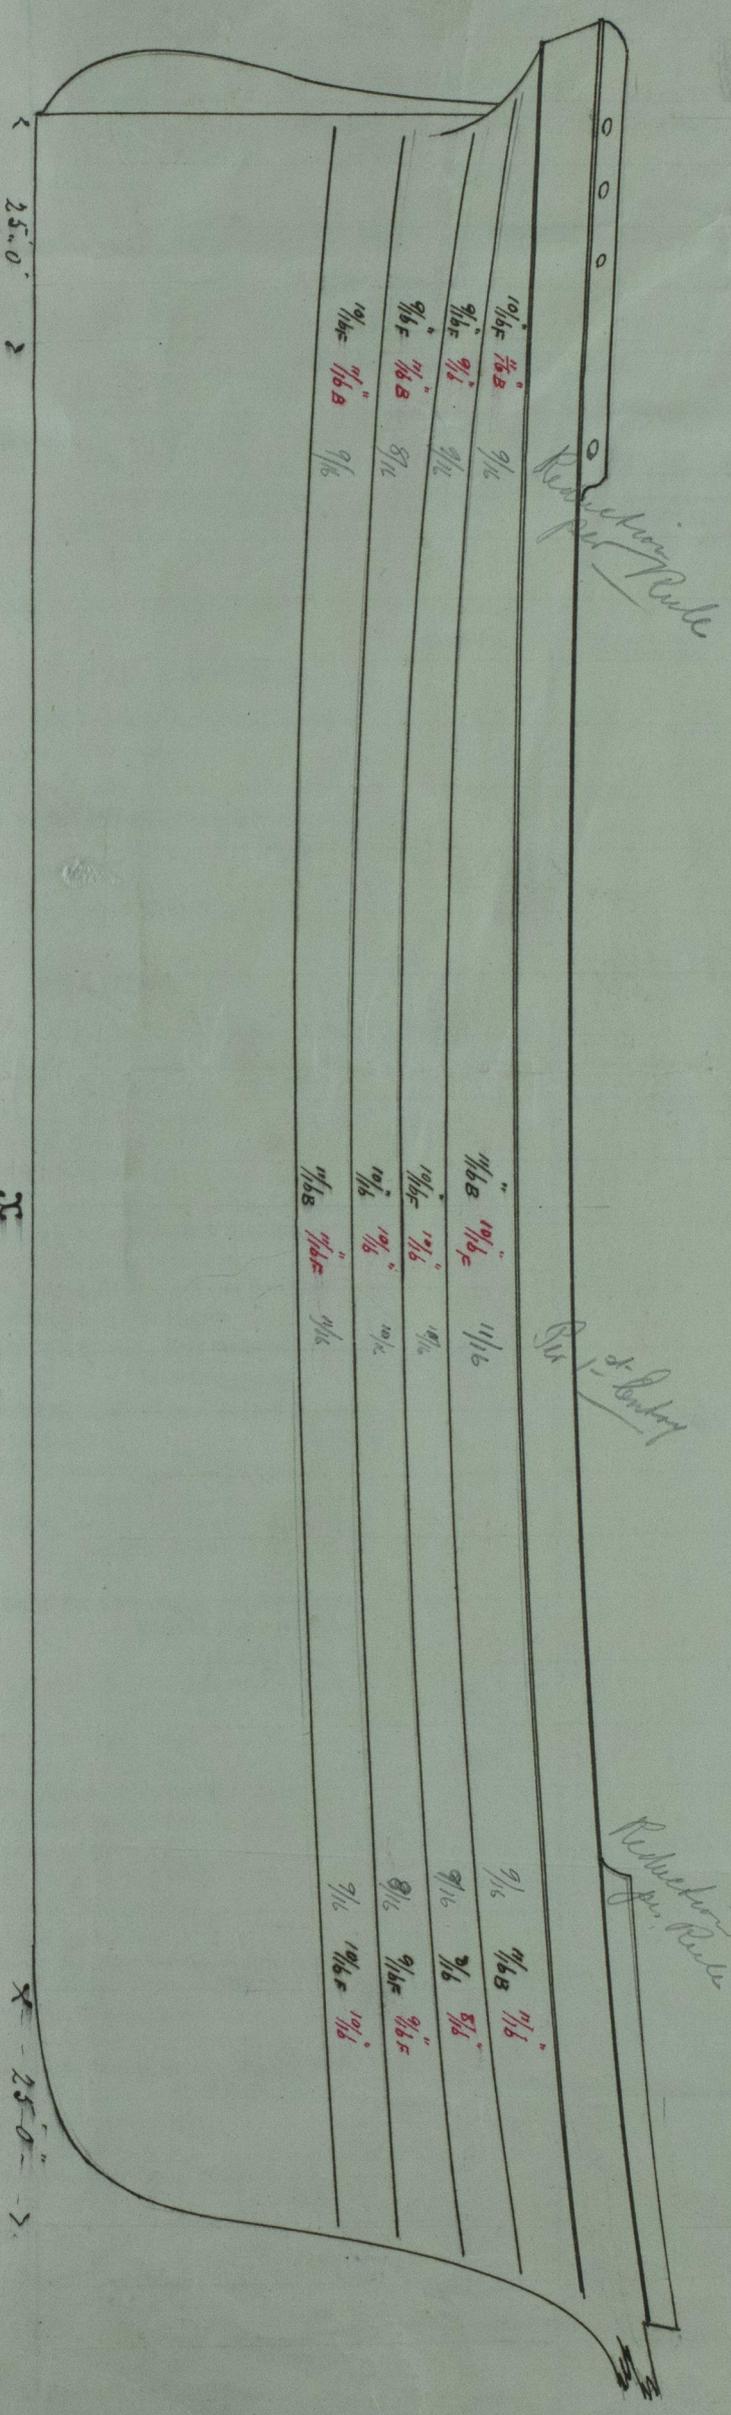
Sketch showing position of Drilling
 Port side Black; Starboard side Red.

satisfactorily to the iron, cement - made good where found somewhat worn. - Ceiling partly renewed. - Plating drilled as required by the rules, and scantlings obtained as shown in the accompanying sketch. - Chain cables sized and examined, found of sufficient size and quantity. - Moulds unhooked and stripped for examination, found in good condition. - Masts, spars, and general equipment - in good condition. -
