REPORT of SURVEY for REPAIRS, &c.

Glasgow

23rd Jan

593 on the Iron Steamer Tyne Queen

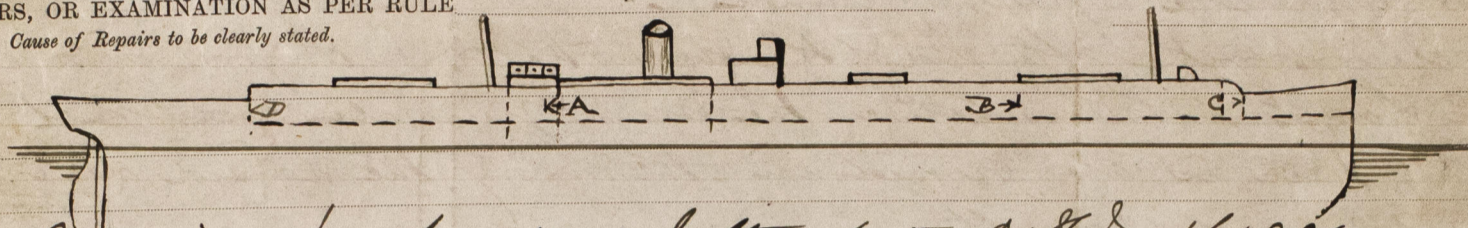
As desired per Secretary's letter dated 24th Jan 1882 and after the examination of the Liverpool report dated 23rd May 1870 with its appended sections and correspondence, a survey was held upon this vessel. The above sketch (3/4 scale as regards lengths) shows her present arrangements above the line of her main deck. She has a raised quarter deck and forecastle. The portion amidships from A & B appears to be the addition referred to in the Liverpool report, from B & C and from A & D the original hullwork plating iron main rail plate and hullwork stencils (shown on the tracing No. 1 attached to the Liverpool report) appear to have been retained, and from the main rail up, plated and completed to conform to the Swedish P.T.O.

Midship section No 2. The bulwark platings are $1\frac{1}{2}$ inch diam^{rs} and spaced five feet apart. The scuffers and mooring pipe holes have been riveted up but there is a port $24" \times 10"$ in this bulwark plating on each side ahead of the main and after hatchways. A sketch in pencil is added to section No 1 showing the arrangement of these covered in parts. The ports referred to are secured as cargo ports. The main and after hatchways of this deck are respectively 20 and 20 $\frac{1}{2}$ feet in length. The casings over the boilers and engine skylights are low (as they might have been on a deck house in 1870). There is a small house and bridge before the funnel.

Ahead of the after end of the main hatch on the port side one of the frames is broken between the main gunwale and rail. The plating there is also pressed in. The whole of the raised deck has been renewed recently.

The continuous erection between the raised quarter deck and Forecastle cannot in my opinion be considered as an "awning deck" within the intention and requirements of the rules. I have therefore deferred sending to the Owners a notice of the requirements of the Society's rules relating to "awning decked vessels as regards the load line". If a draught of water considerably less than 10 $\frac{1}{2}$ feet aft in fresh water was proposed by the Owners and adhered to, such a superstructure as above described might be considered as a "shade deck" for which a load line is not now required by the rules. but I respectfully remark that I cannot recommend her as an "awning decked vessel".
