# REPORT of SURVEY for REPAIRS, &c.

on the Iron S.S. "Gilana" (ex)

"Immacolata Concezione"

Part S. S. No. 3 for Re-classing and requirements of Circular No. 771

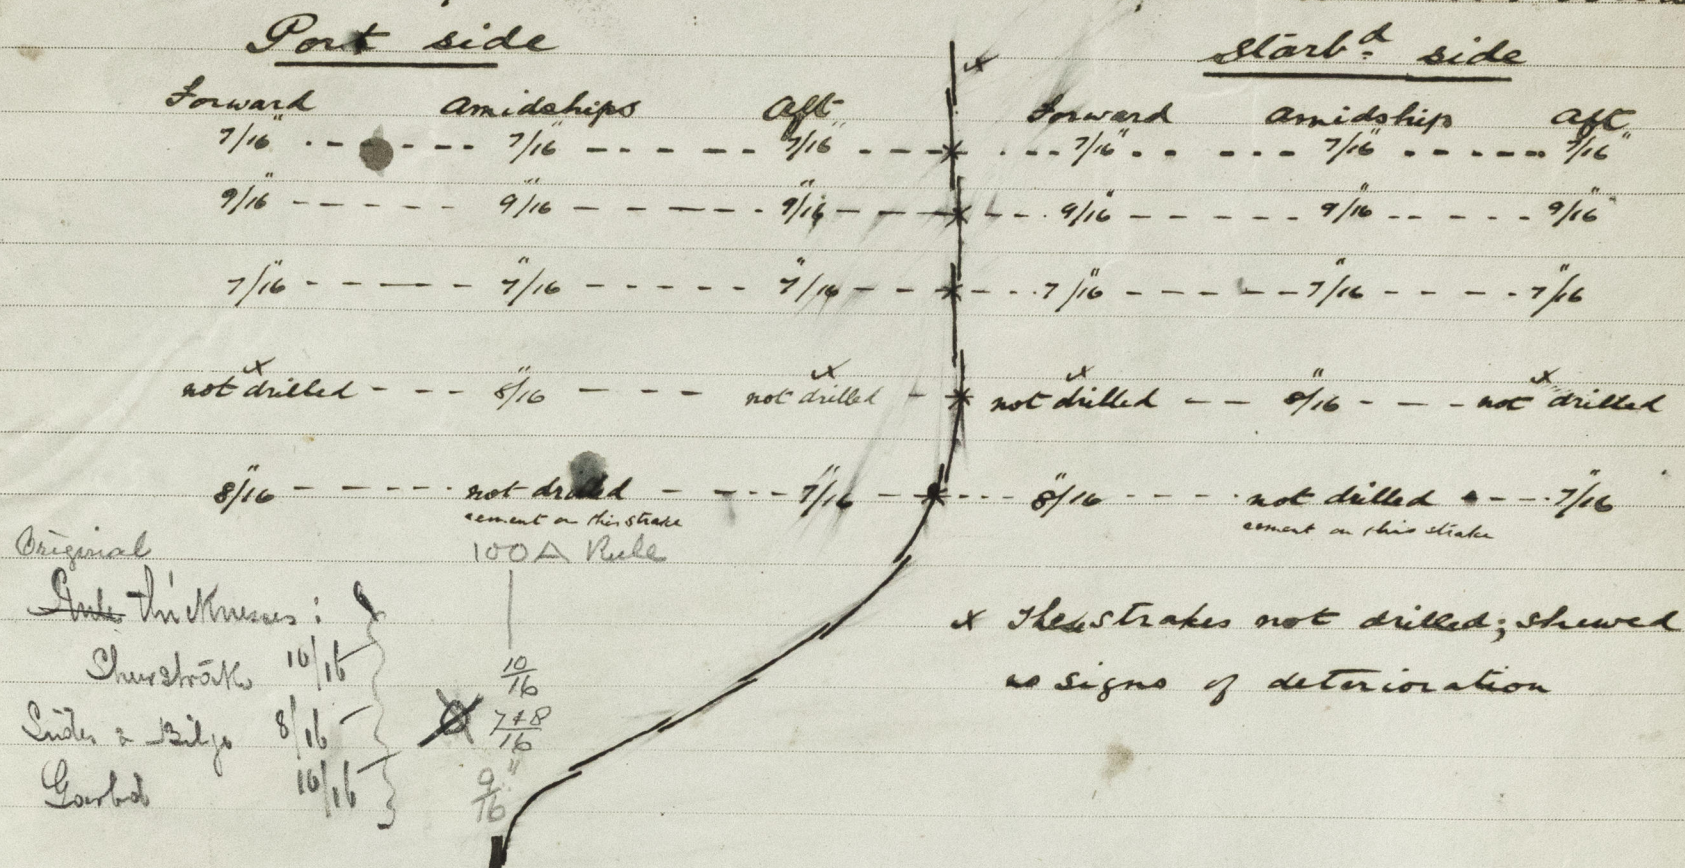
cement were not examined owing to the stoke hole plating at this part not having been removed. Beams examined and found to be in good condition. The plating and frames in <sup>decks</sup> are in good condition, only slight oxidation at a few places which has not yet been removed. The side plating has been drilled as shown by sketch below and measured. The thicknesses as stated
