REPORT of SURVEY for REPAIRS, &c.

No. in Reg. Book. 490 Survey held at Glasgow on the Iron Bk. "Nor'wester"

REPAIRS, OR EXAMINATION AS PER RULE, FOR S.S. N°3.

Iron Bk. "Nor' Wester."

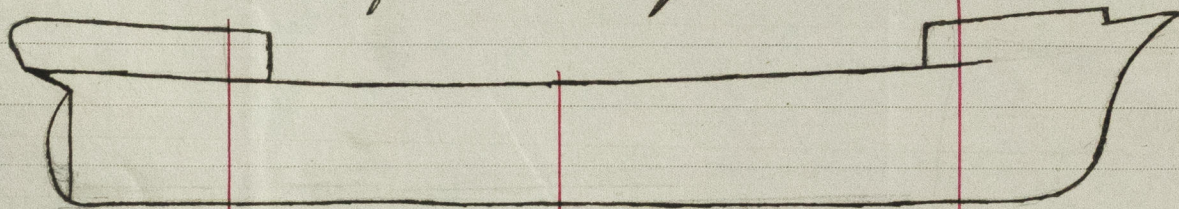
In sixteenths		In sixteenths originally			In sixteenths	
	P	S	P	S		P	S
C Strake	-	-	10	9	9	-	-
D "	-	-	9	9	9	-	-
E "	8	8	9	9	9	8	8
F "	8	8	7	7	7	8	8
G "	8	7	7	8	8	8	7
H "	6	6 bare	6	7	7	6	6
I "	8	8	8	8	8	8	8
J " sheerstrake	8	8	8	8	9	8	8

5 Four foremost plates each side new.
17 plates starboard side new
16 Port - - -
