REPORT of SURVEY for REPAIRS, &c.

Date of writing Report 12 March 1896 When handed in at Local Office 13 March 1896 Port of Glasgow
 No. in Reg. Book 57 Survey held at Paisley & Glasgow Date, First Survey 28th Jan 1896 Last Survey 6th March 1896
 on the Wood, Iron or Steel S.S. "Maggie" (No. of Visits) 10 Master Thos Campbell

REPAIRS, OR EXAMINATION AS PER RULE, FOR Second S.S. No 3 Reclassing and alterations

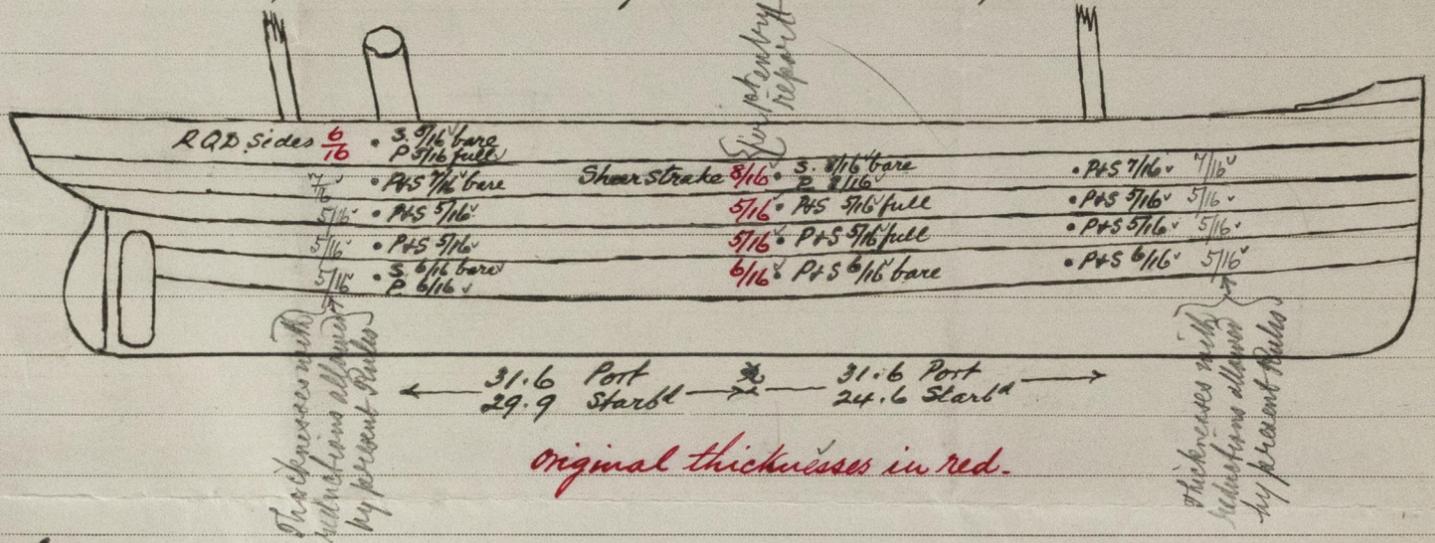
Alterations - Bridge reduced in length, now made 5 1/4 feet long, but the side plating has not been removed. Main hatch increased in length now 29'9" x 7'4". Division bulkhead at centre of original main hatch cut out & converted into a web frame. In way of the new hatchway the beams plated between Coamings and stringers with 4/6 plates and wood deck renewed at this part. Two additional web frames (making three in all) fitted in way of long hatchway, also ^{large} brackets ^{to be braced} at the ends of the hatchway. These webs are bracketed out to the hatch coamings. The side coal bunkers reduced in length.

The Gross & Net tonnages will be altered, particulars will be sent as soon as received - a plan is attached showing the strengthening in way of the lengthened hatchway -
