REPORT of SURVEY for REPAIRS, &c.

5- on the Wood, Iron or Steel S.S. John Pender, now named Master Francisco Aldaco. 99
TONNAGE: - Built at Inverkeithing By whom J. Scott "Landa". When 1875-11.

S. Landa. ex John Pender

S.S. "Landa" ex John Pender, ex Saigon.

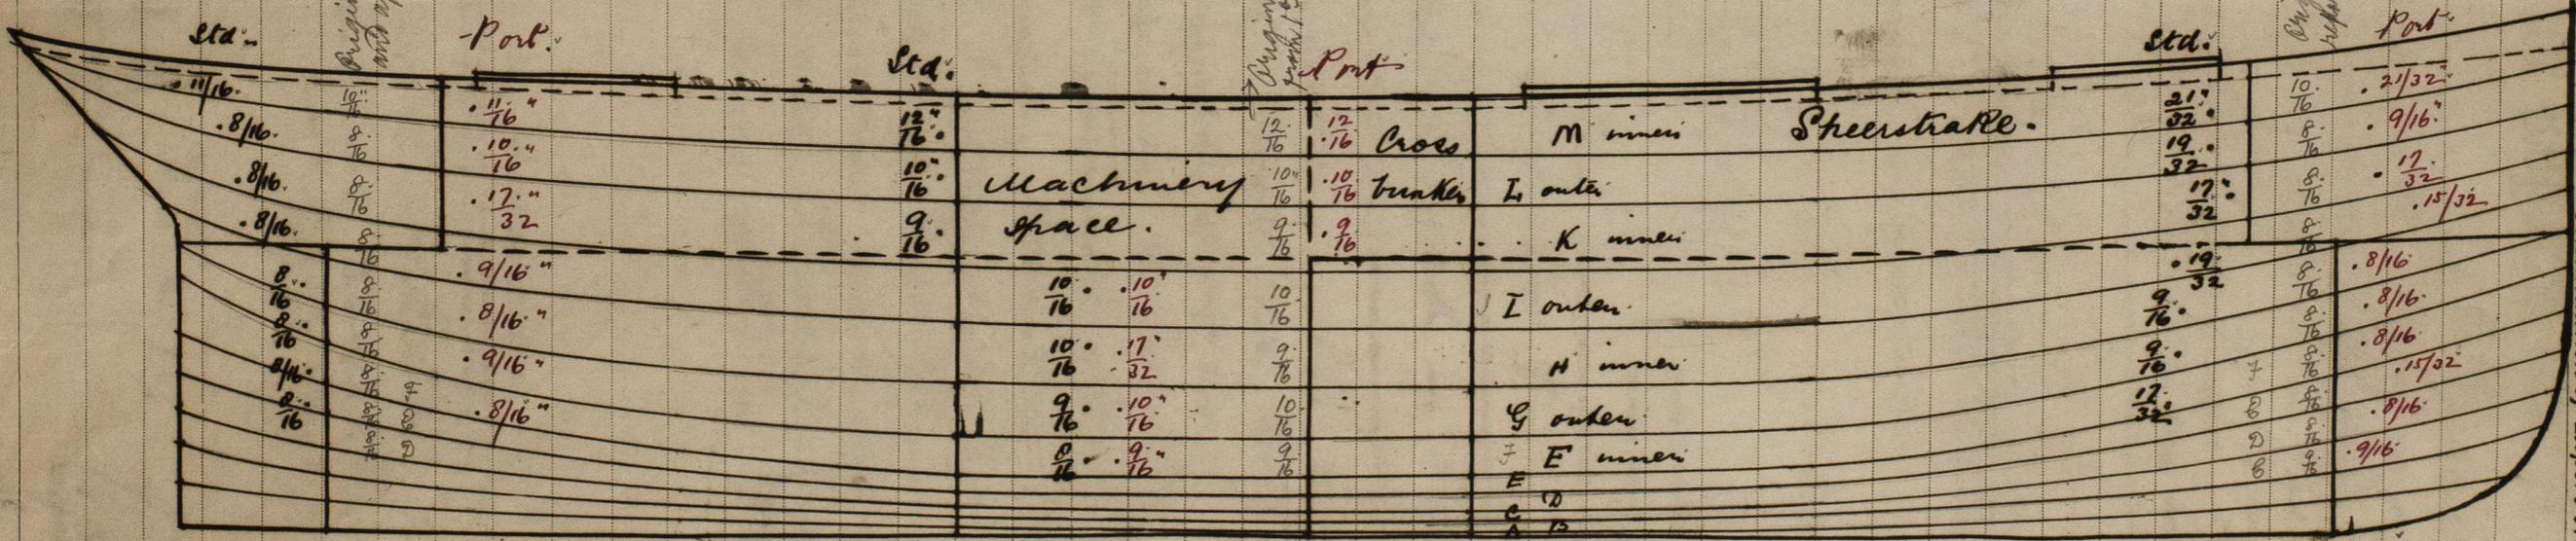
Rough sketch showing thicknesses of outside plating where drilled, for 2nd S.P. No 3.

Shell plating drilled, in three tiers of holes, each side, above height of cement, and thicknesses measured, as shown on rough sketch, attached hereto.

Original thicknesses, as per First entry Rpt.

Sheerstrake	M	12-10/16	Inner Strake	H	9-8/16	Inner Strake	D	9-8/16
Outer Strake	L	10-8/16	Outer	G	10-8/16	Outer	C	10-8/16
Inner	K	9-8/16	Inner	F	9-8/16			
Outer	J	10-8/16	Outer	E	10-8/16
