s.s. "Clam".

General view of repairs wood

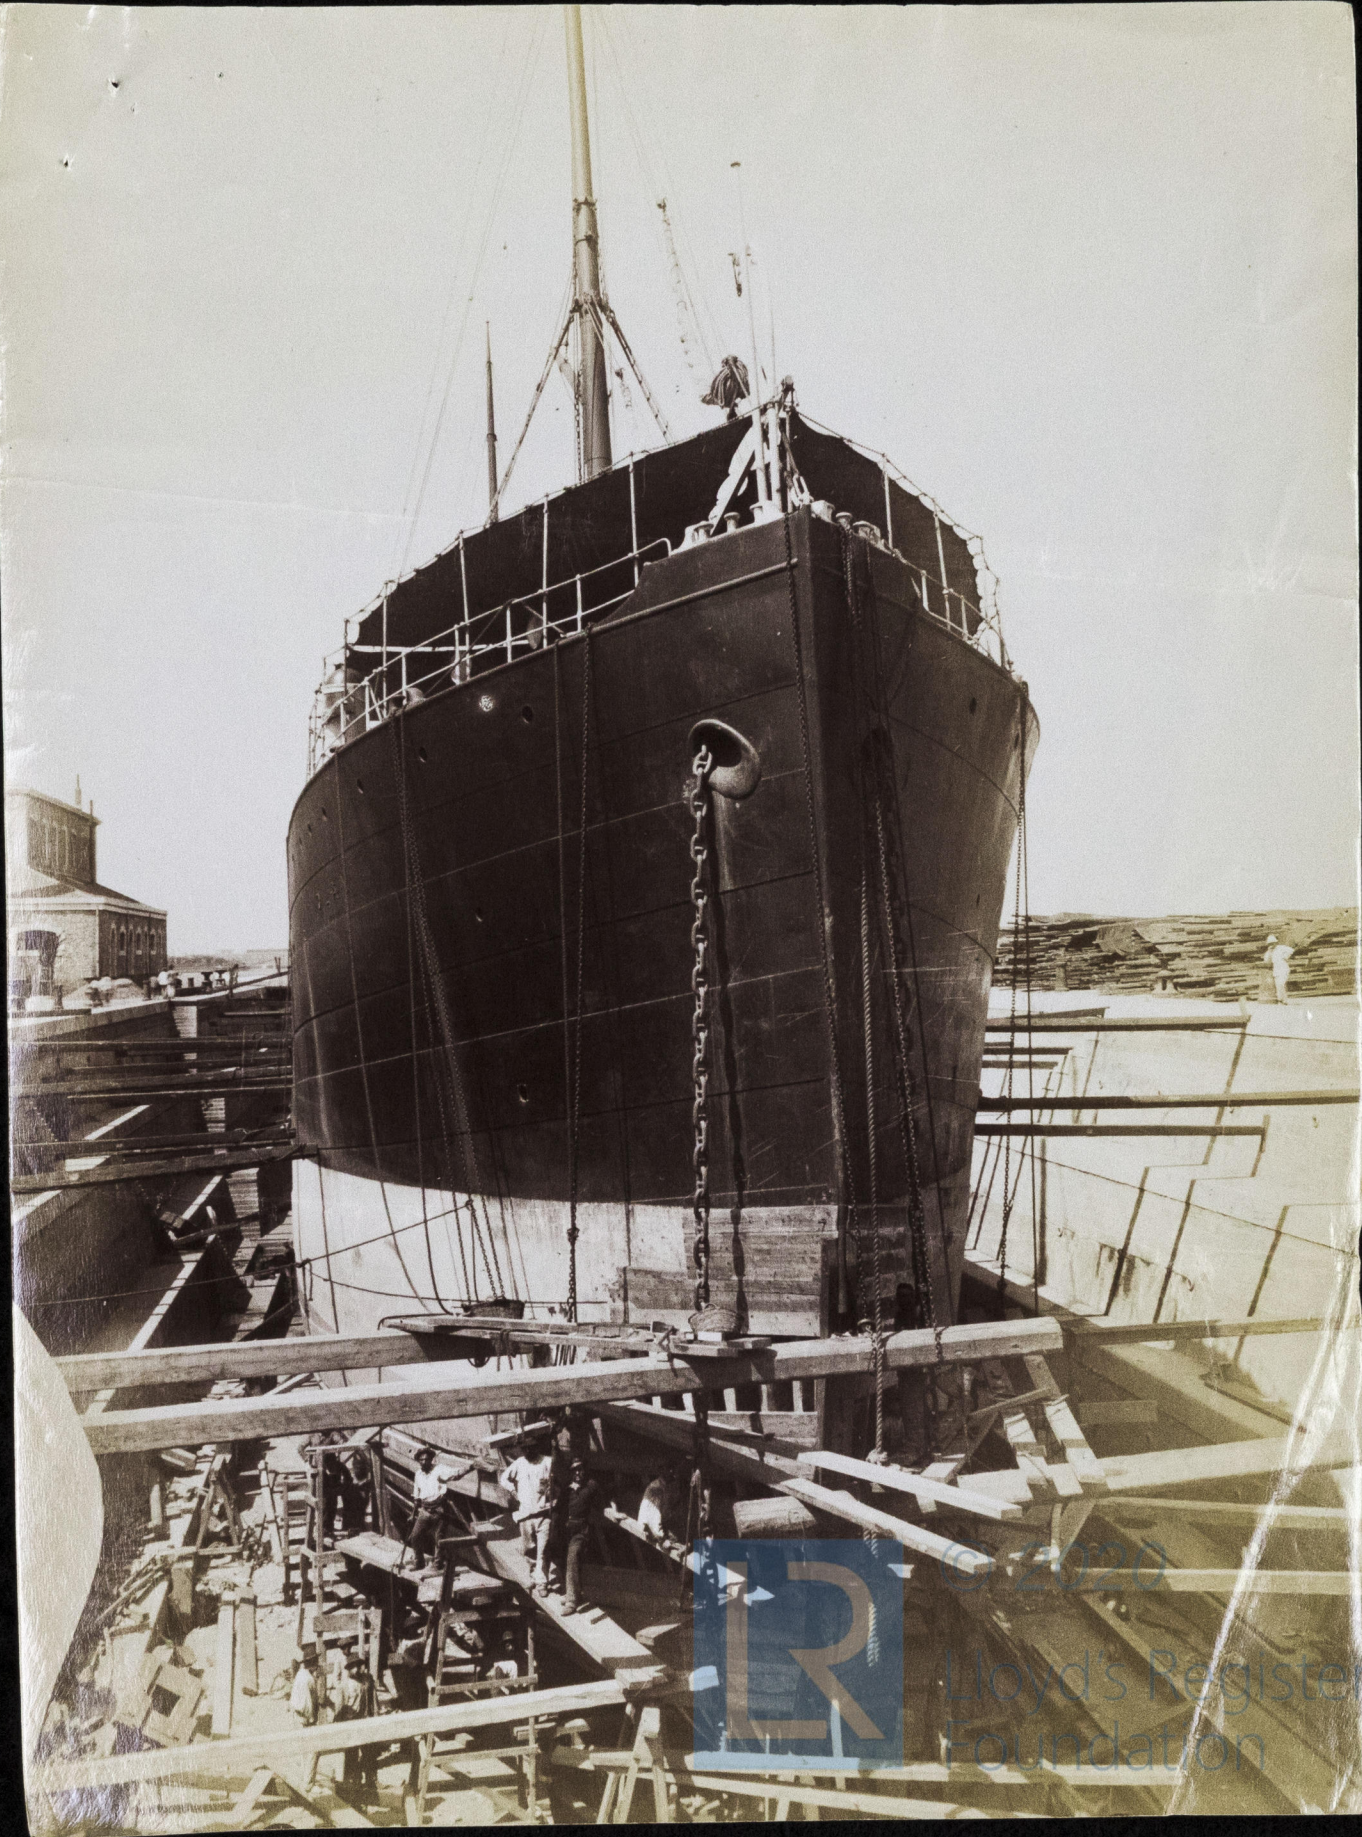
HPL387-0140 (1/2)

See plan for details bottom damage.
