Continuation of Report No 11245

11th July 1900

Iron SS "Malaga"

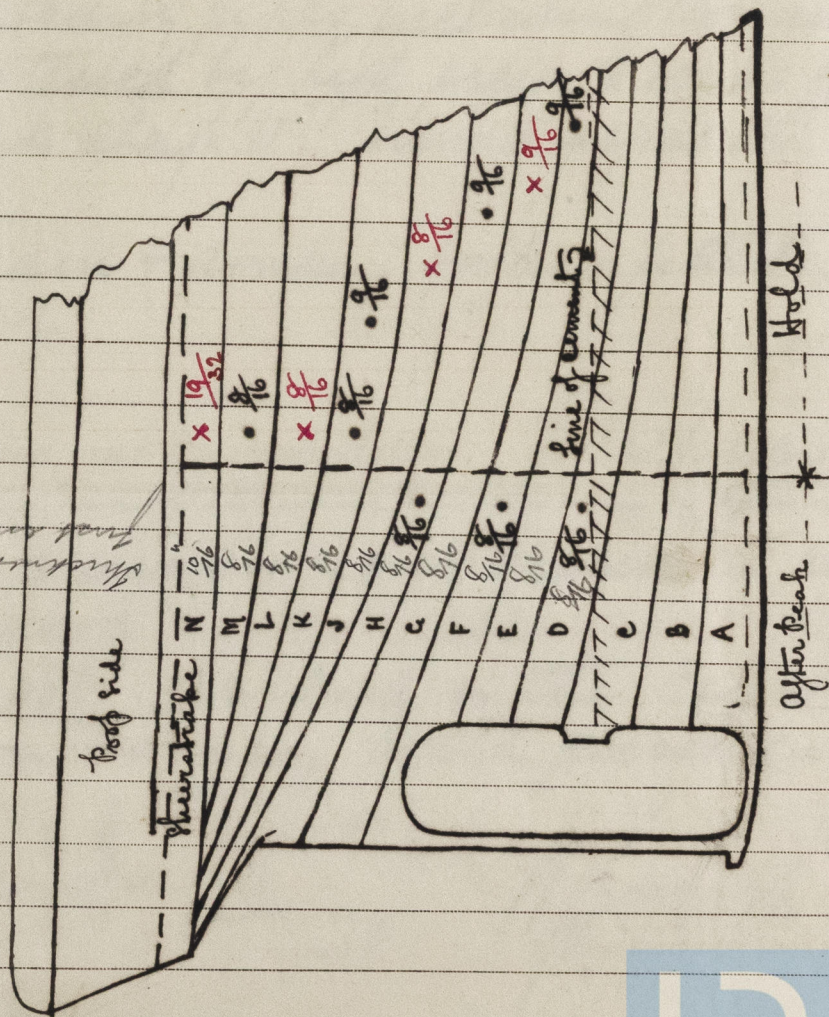
Rough sketch showing thicknesses of outside plating where drilled for SS. No 3

Shell plating drilled and thicknesses ascertained, see sketch attached hereto.

Thickness at each angle
from survey report
